## **Complex Oil Spill Remediation beneath Operating Hospital, Montfort Hospital, Ottawa, ON**

Project Entry Binder for  
2013 Canadian Consulting Engineering Awards

Environmental Remediation

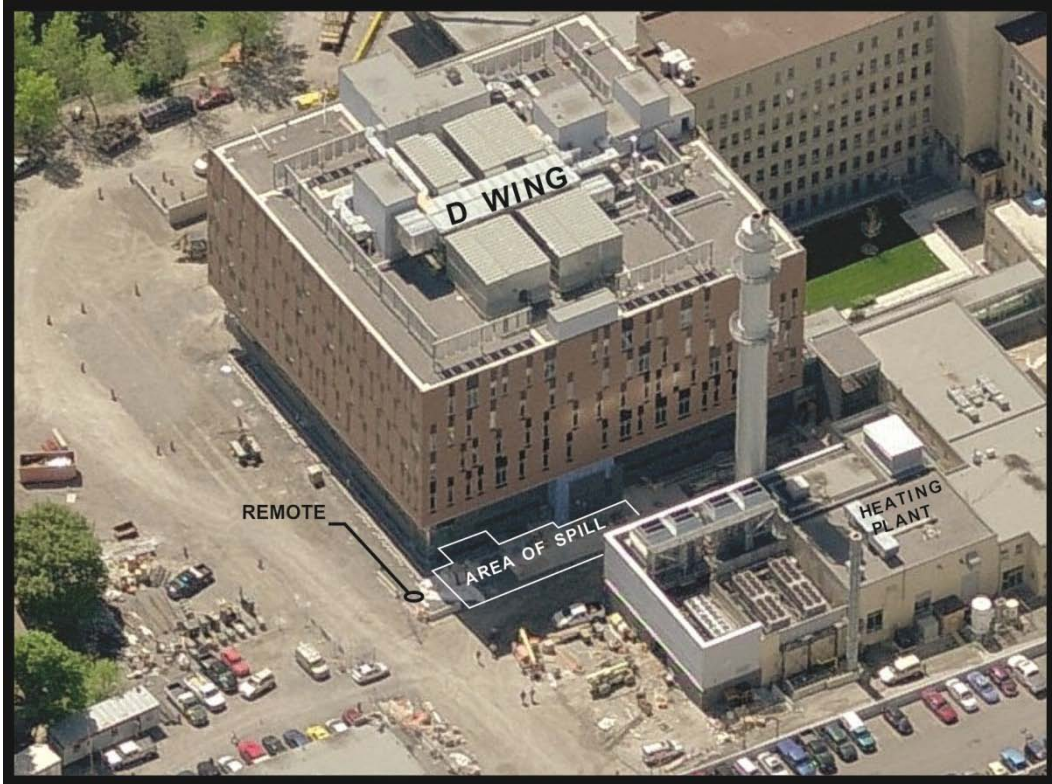
**Photo 1** - Aerial view of the Montfort Hospital showing the brand new \$50M D-Wing building and the furnace oil spill location.

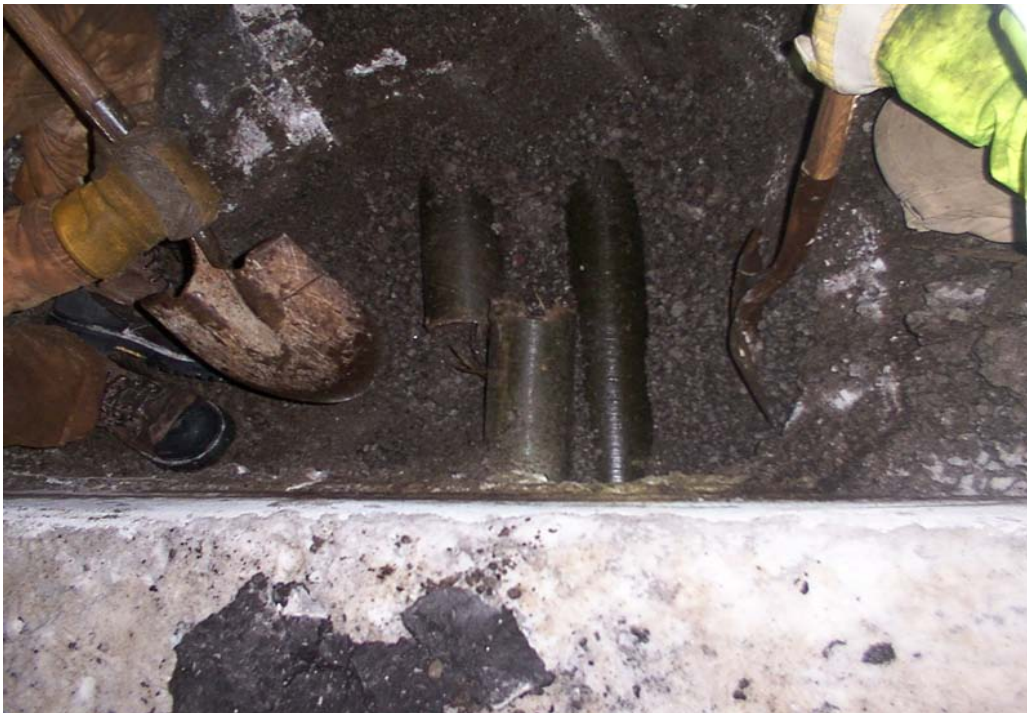
**Photo 2** - View of furnace oil pipe break where 22,000L of furnace oil leaked into the subsurface.

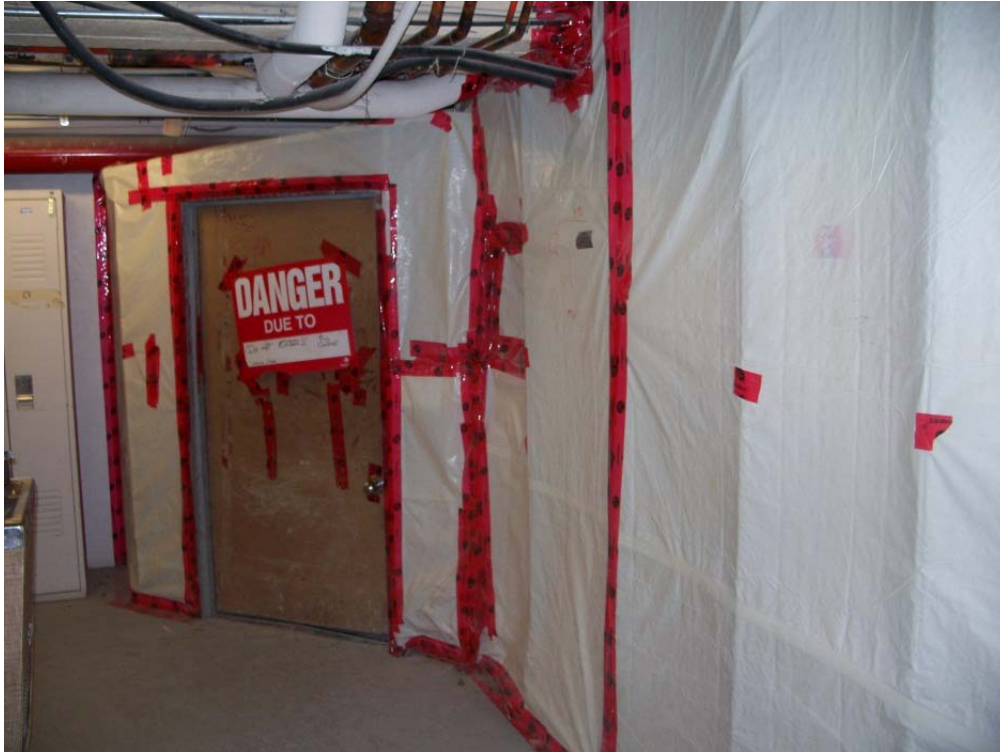
**Photo 3** - View of elaborate infectious control system set up to permit the interior drilling of the 16 MPE recovery wells within the operating hospital.

The MPE system involved the installation of 16 interior recovery wells within the basement of the building and 13 exterior recovery wells along the southern property boundary to prevent off-site contaminant migration. Several interior drilling techniques were tried before settling on a modified one. The location of the recovery wells was carefully chosen based on the subsurface oil plume geometry, subsurface concrete slabs, high security areas of the hospital, and the presence of hospital utilities embedded in the concrete floor. Once constructed, all of the recovery wells were equipped with pneumatic submersible pumps which recover oil, water and vapours from beneath the building and direct them to an exterior, on-site facility for treatment (Figure 2).

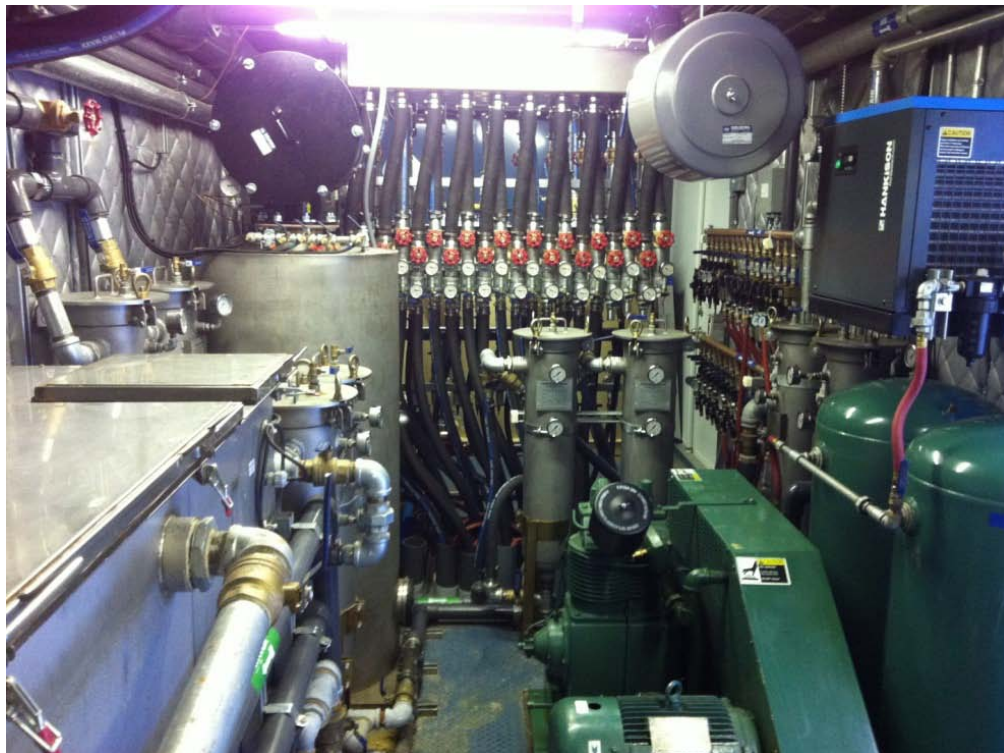
**Photo 4** - Interior view of MPE treatment system contained in a stand-alone, sound proof, building situated next to the hospital's heating plant.

The pilot test successfully demonstrated that a full scale MPE system would be effective at this location. The site specific soil parameters were calculated and used in the design of a full scale, permanent MPE system. The final MPE system design included: 3 large vacuum blowers, 29 pneumatic submersible pumps, a large air compressor, an elaborate sediment filtration system, liquid and vapour phase granular activated carbon, an oil/water separator, and a sophisticated control system with remote access and alarm capabilities (Photo 4). The entire treatment system was contained within a stand-alone 3m x 10 m, sound proof building situated next to the heating plant. The treatment system building had to be sound proof so as to not disturb the adjacent community.

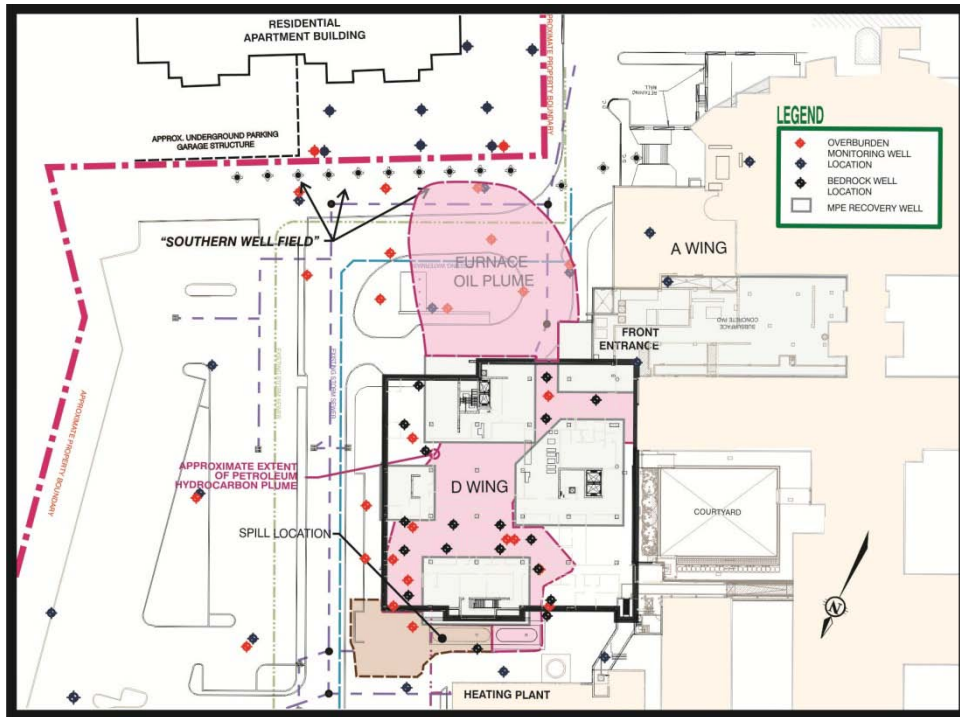
Figure 1 - Site plan showing the extent of subsurface petroleum impact beneath D-Wing of hospital.

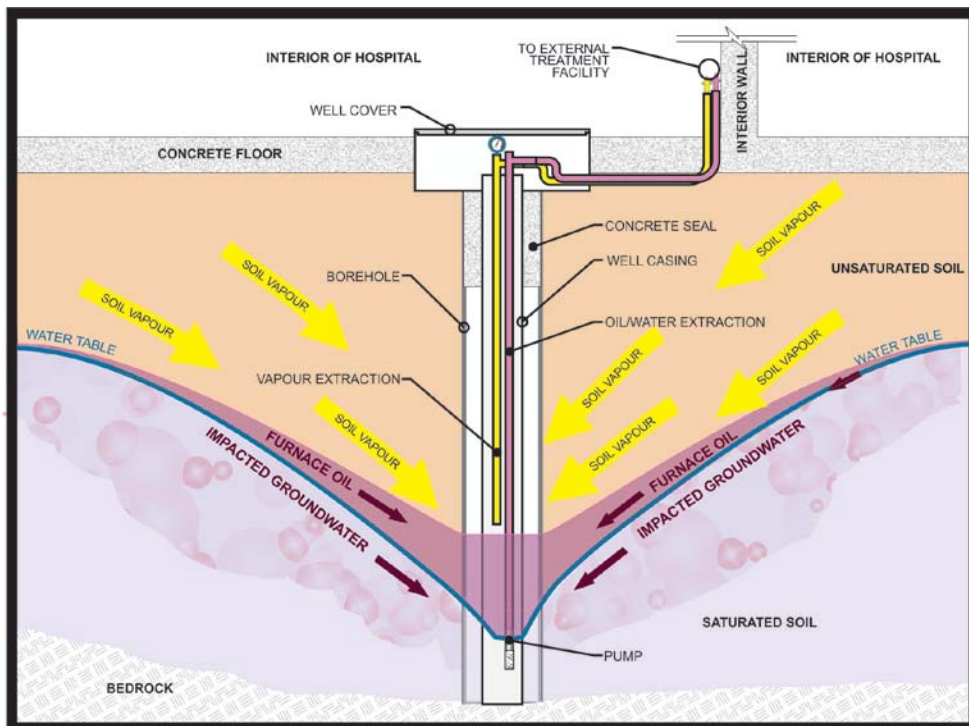
The pumping of impacted groundwater from the subsurface depresses the local water table with the lowest point being centered at each recovery well. The cone shaped depression forces the furnace oil, which is floating on the water surface, to flow into the depression where it is recovered by the pneumatic pumps. In addition to the oil and water recovered from beneath the hospital by these recovery wells, an elaborate subfloor vacuum system was also incorporated into the MPE system to withdraw and treat petroleum vapours. These vapours were considered to be the highest potential risk to the safety of the hospital's patients, staff, general public and tenant.

Figure 2 - Cross section of a typical MPE recovery well showing how the withdrawal of impacted groundwater promotes the flow of oil along the water table surface into the recovery well for collection. Petroleum vapours are also withdrawn by these recovery wells which safeguard the hospital staff and promotes the natural biological degradation of the petroleum impacted soil beneath the hospital.

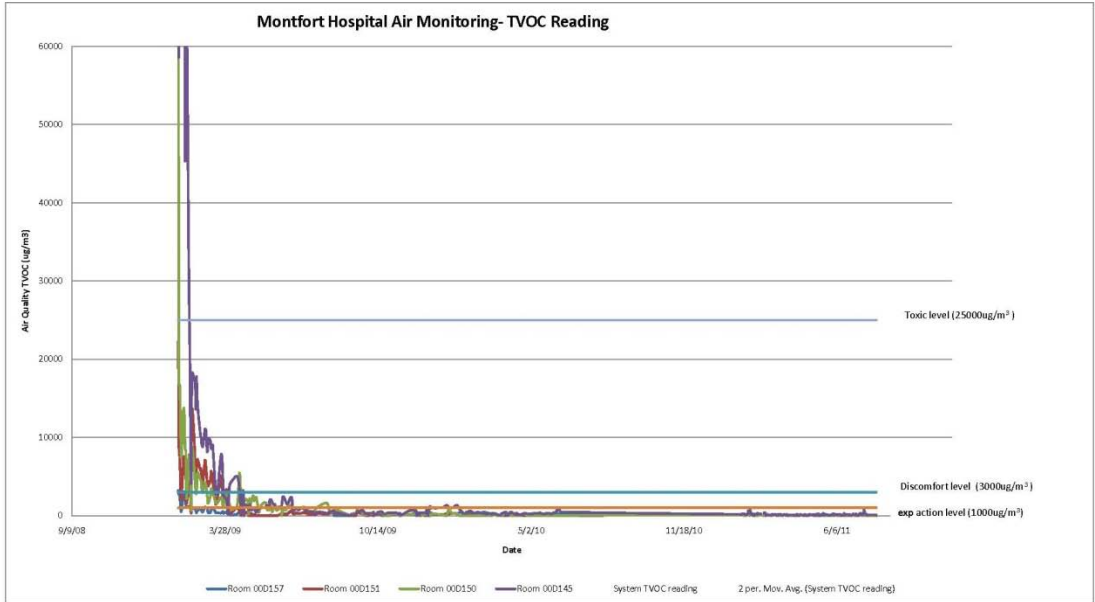
In addition, two sophisticated, real time TVOC monitors were installed in the D Wing basement, which provide continuous readings and records all readings on a data logger. These two units are equipped with audio/visible alarms in the event of elevated readings. Although, at present, there are no Canadian or U.S. standards for TVOC, the Health Canada guideline indicates target and action levels of 1,000 and 5,000  $\mu\text{g}/\text{m}^3$ , respectively, are being discussed. The European Community indicates that at a TVOC exposure over 3,000  $\mu\text{g}/\text{m}^3$ , symptoms such as odours, irritation, and discomfort may occur and complaints may be expected. Since the operation of the pilot, and subsequent full scale, remediation system, the concentrations of TVOC have decreased and have remained stable in what is considered to be a normal range (Figure 3).

**Figure 3** - Graph of Total Volatile Organic Compounds (TVOC) concentrations within the hospital. Significant reductions in TVOC concentrations were achieved after the implementation of the MPE system.
