GEOTECHNICAL INVESTIGATION OF THE MOUNT POLLEY DAM FAILURE

CARIBOO REGION, BC

2016 AWARD SUBMISSION
KLOHN CRIPPEN BERGER

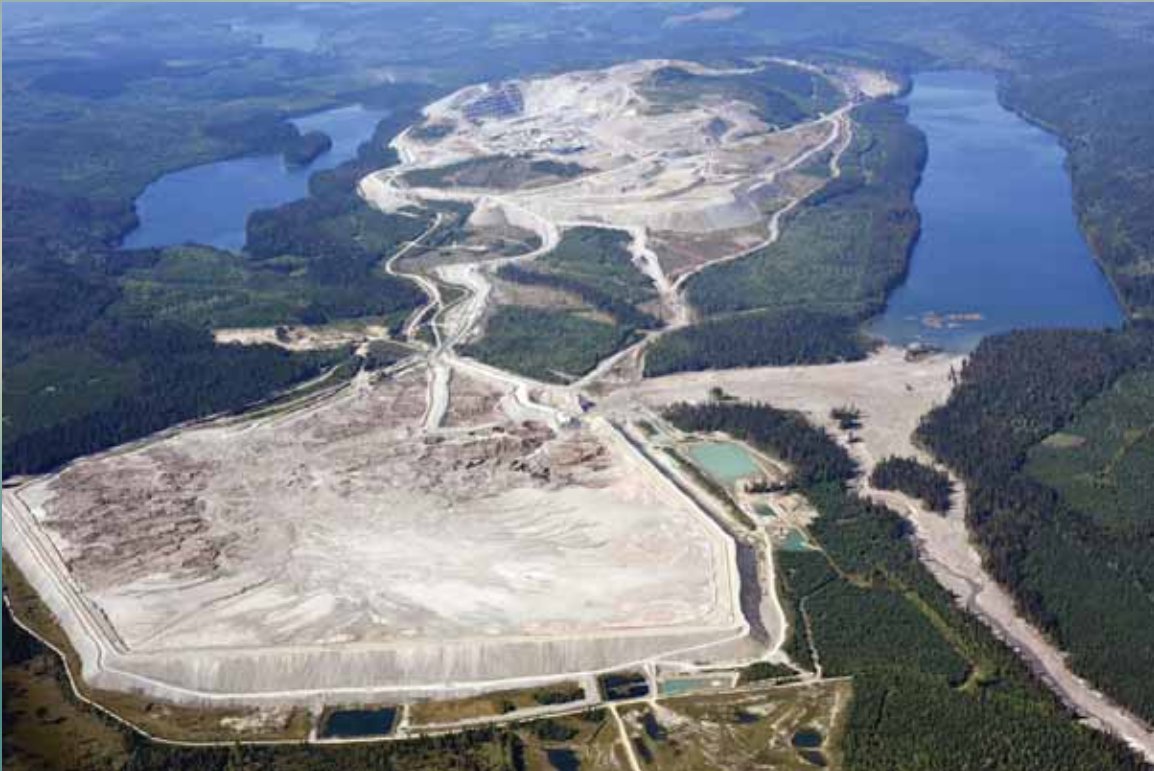
MOUNT POLLEY TAILINGS IMPOUNDMENT POST-FAILURE

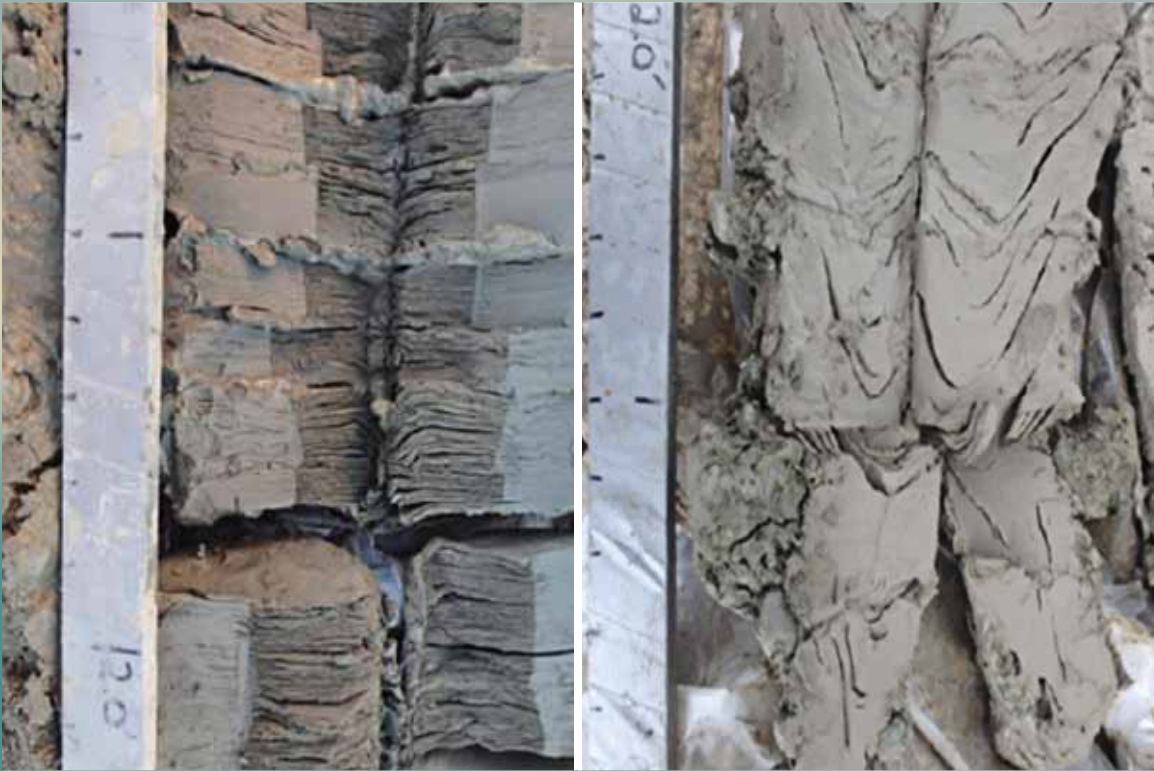
UNDISTURBED UGLU CLAY OUTSIDE FAILED DAM AREA (LEFT)
AND DISTURBED UGLU CLAY BELOW FAILED DAM (RIGHT)

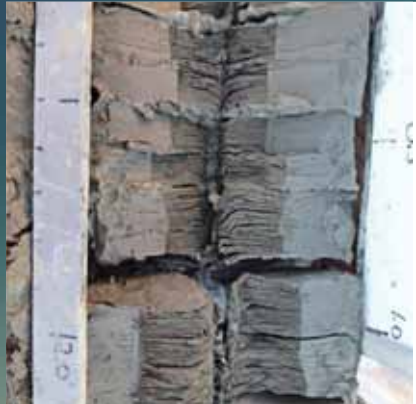
Undisturbed UGLU clay outside failed dam area

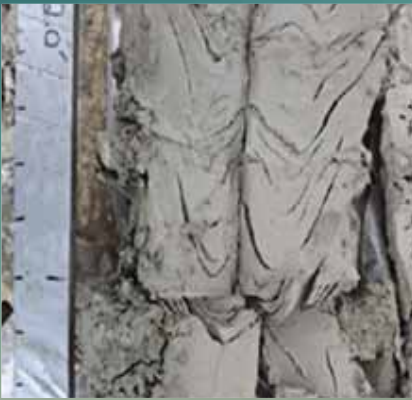
The site geology is complex with multiple glacial till and glaciolacustrine layers deposited during several advances and retreats of glacial ice sheets over 10,000 years ago. The dam ultimately failed on a weak high plastic clay layer in the foundation referred to as the Upper Glaciolacustrine Unit (UGLU). This clay layer is only 2 m thick and located 10 m below the dam.

Disturbed UGLU clay below failed dam

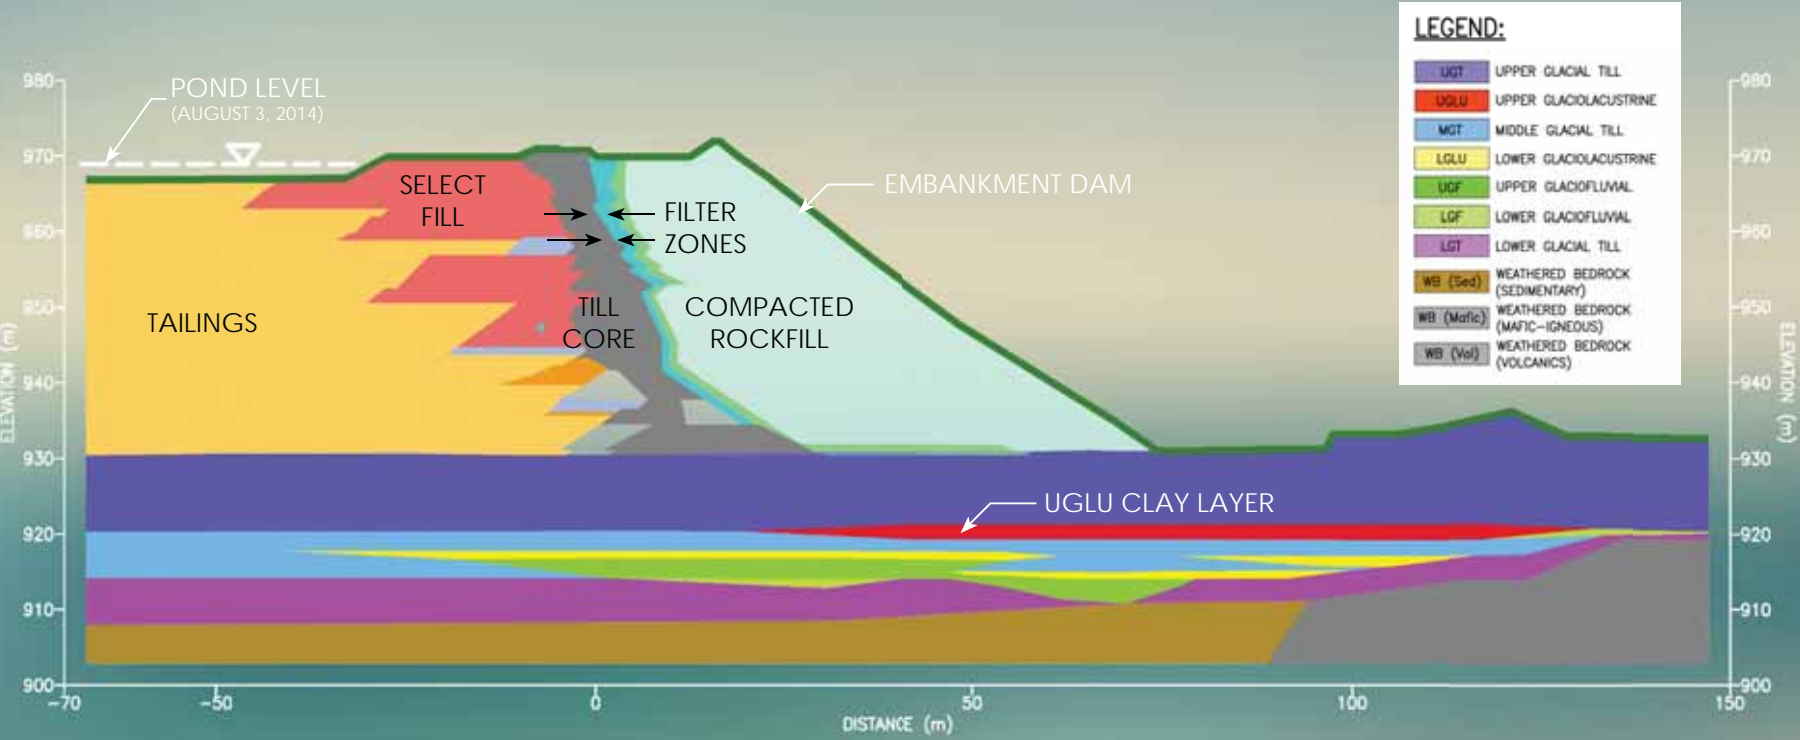
RE-CONSTRUCTED EMBANKMENT SECTION AND FOUNDATION GEOLOGY

The results of KCB's work provided the definitive basis for understanding the geology of the dam site and, ultimately, how the dam failed by sliding on a thin layer of glaciolacustrine clay at a depth of 10 m below the dam. The methods of the investigative studies and determination of the failure mechanism will be an essential reference for the future design of tailings facilities not only in British Columbia, but across Canada and worldwide.

The geology is complex involving multiple glacial till and glaciolacustrine layers deposited during several advances and retreat of the glacial ice sheets over 10,000 years ago. The dam ultimately failed on a weak clay layer in the foundation referenced as the Upper Glaciolacustrine Unit (UGLU). This clay layer was only 2 m thick and located 10 m below the dam.
