Canada's Four Corners Envelope Conservation

John G. Cooke & Associates Ltd.

Canadian Consulting Engineering Awards 2021 – Entry Binder

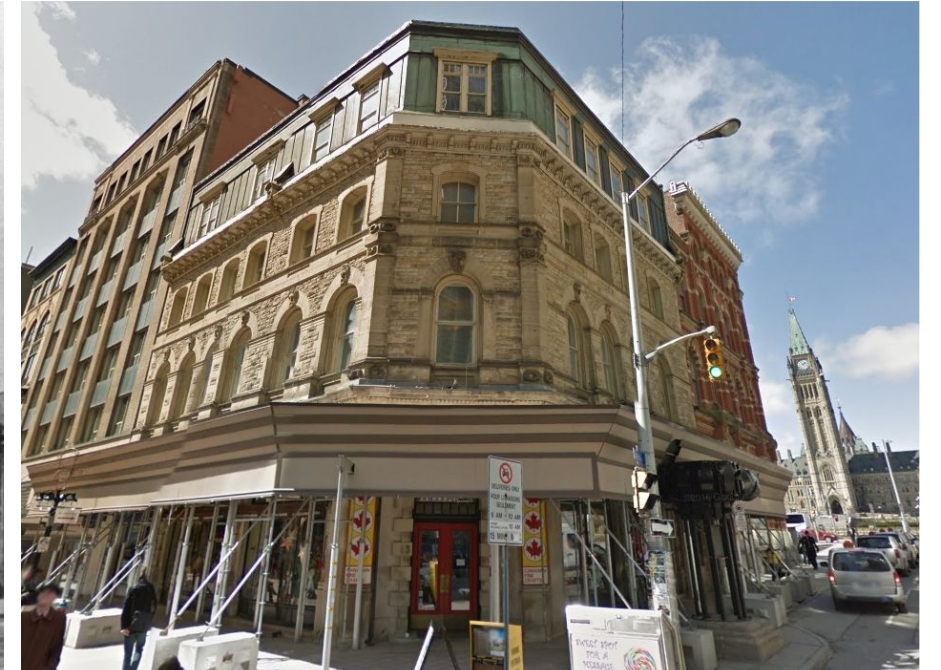
▲ Existing Precondition – 2014

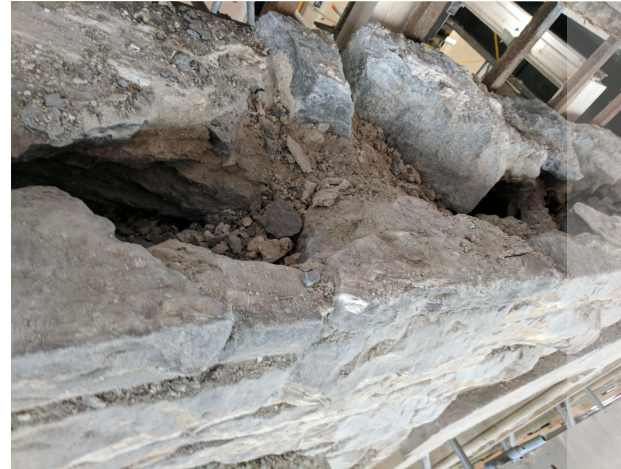
▲ Condition of Wall During Dismantle

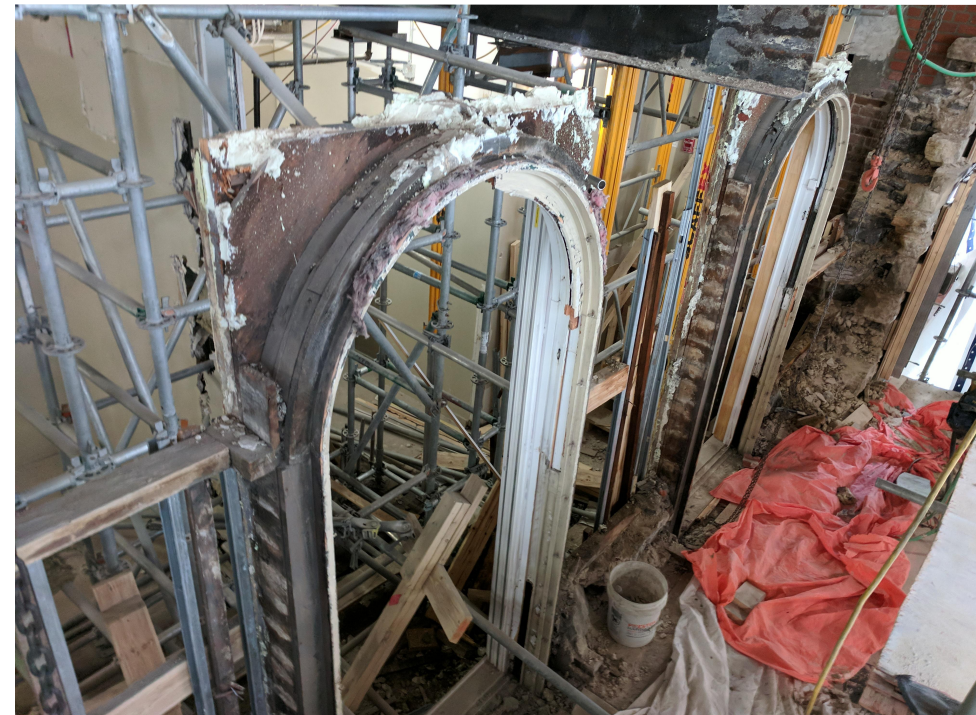
▲ Dismantle at Windows

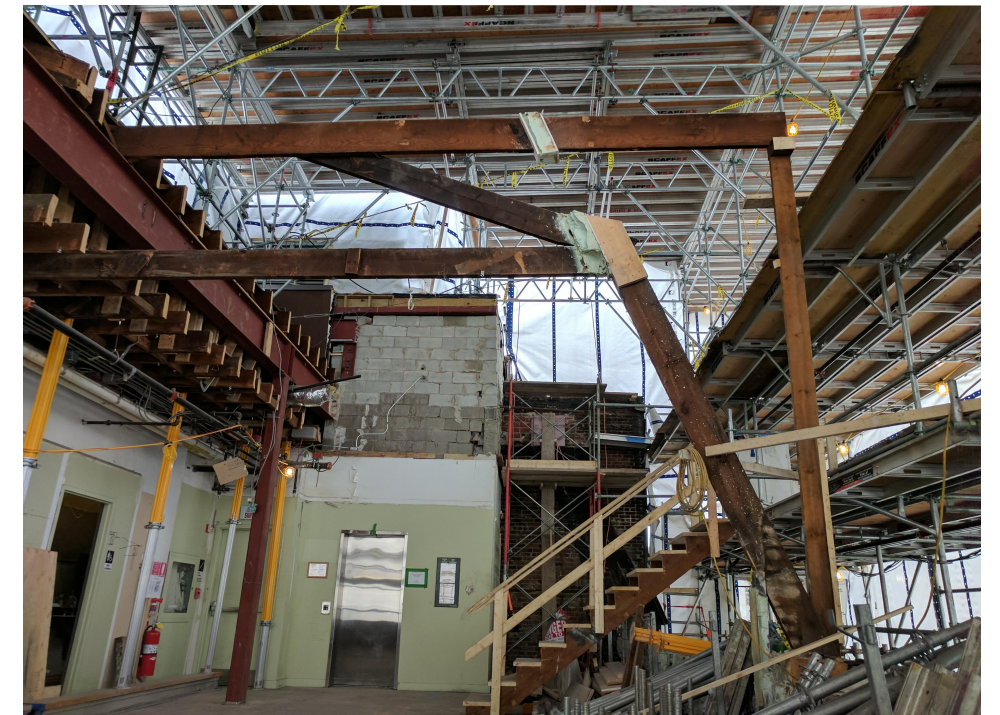
▲ Existing Roof Structure Evolution
