# HWY 535

## WATER MANAGEMENT PLAN

### PROJECT HIGHLIGHTS

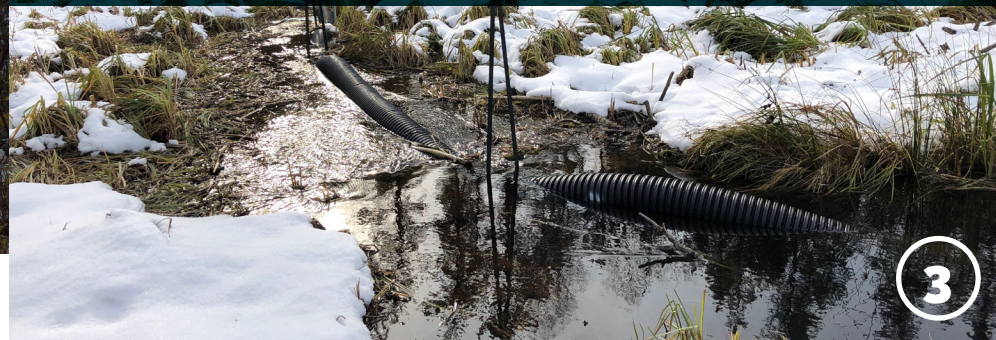
Photo of Beaver Dam #1, with beaver deceivers/water level control devices installed by MTO, November 2019.

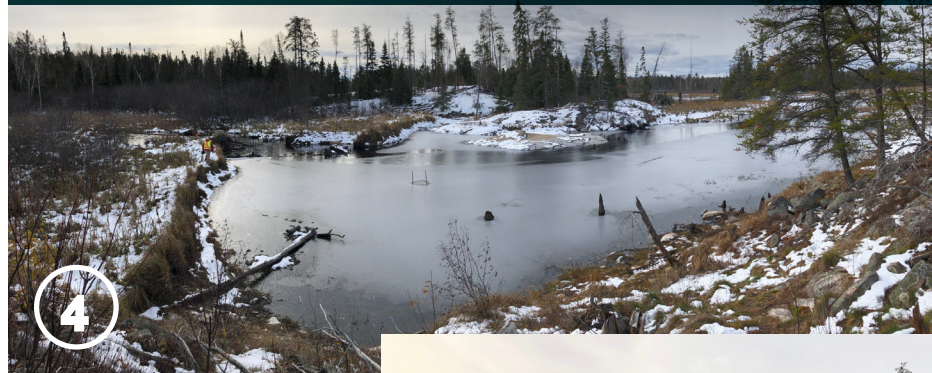
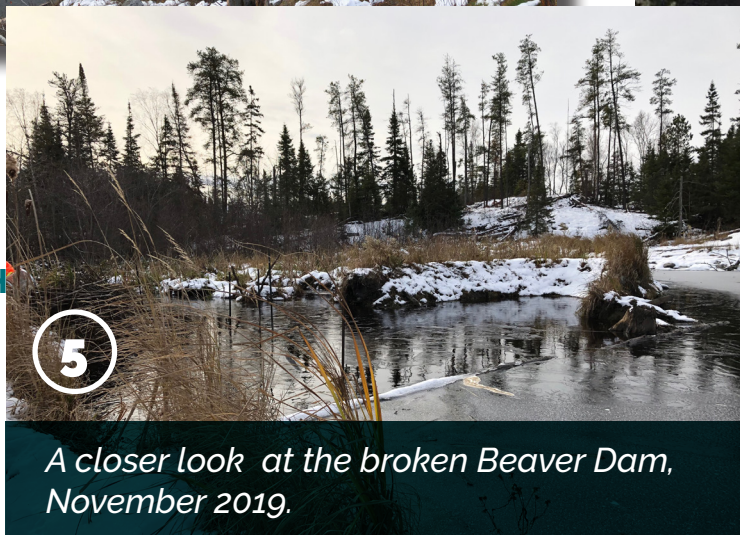
Photo of Beaver Dam #2, facing south, November 2019.

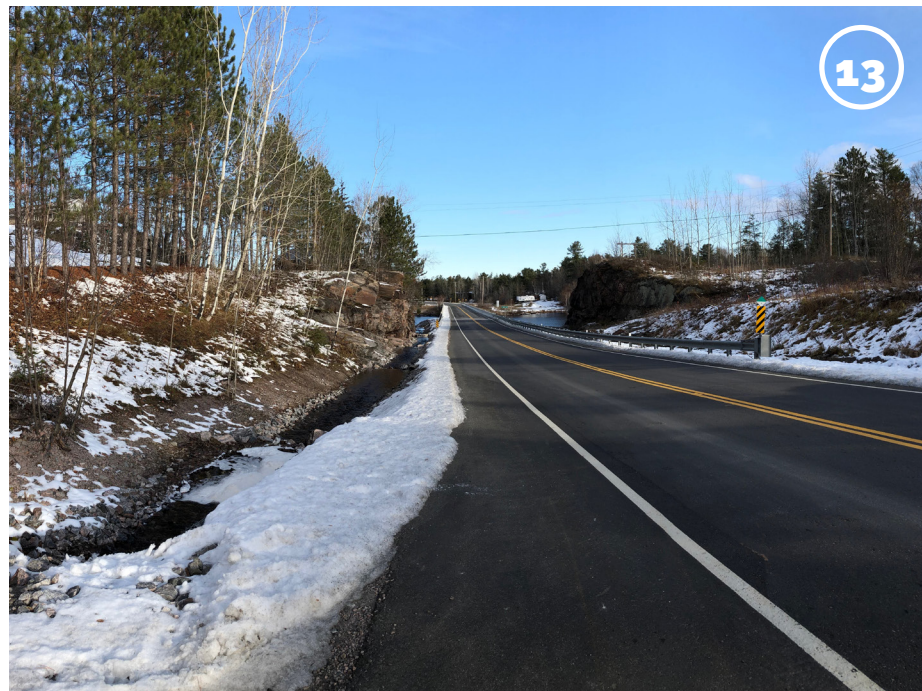
*Photo 1: on Hwy 535, facing north, November 2019.*

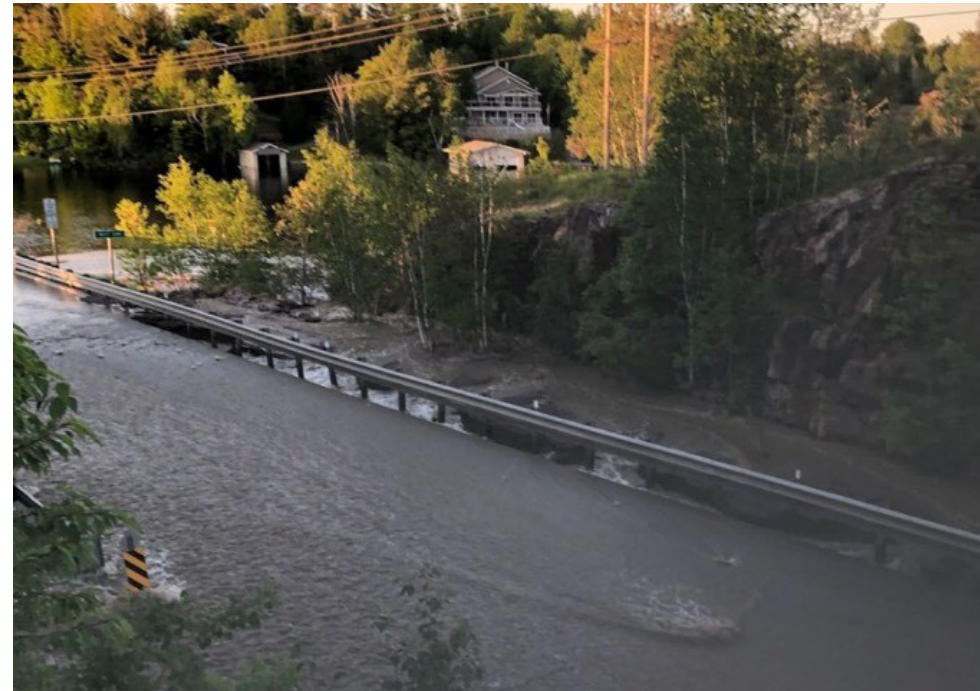
*Photo 2: similar direction to photo 1, during the 2019 washout*

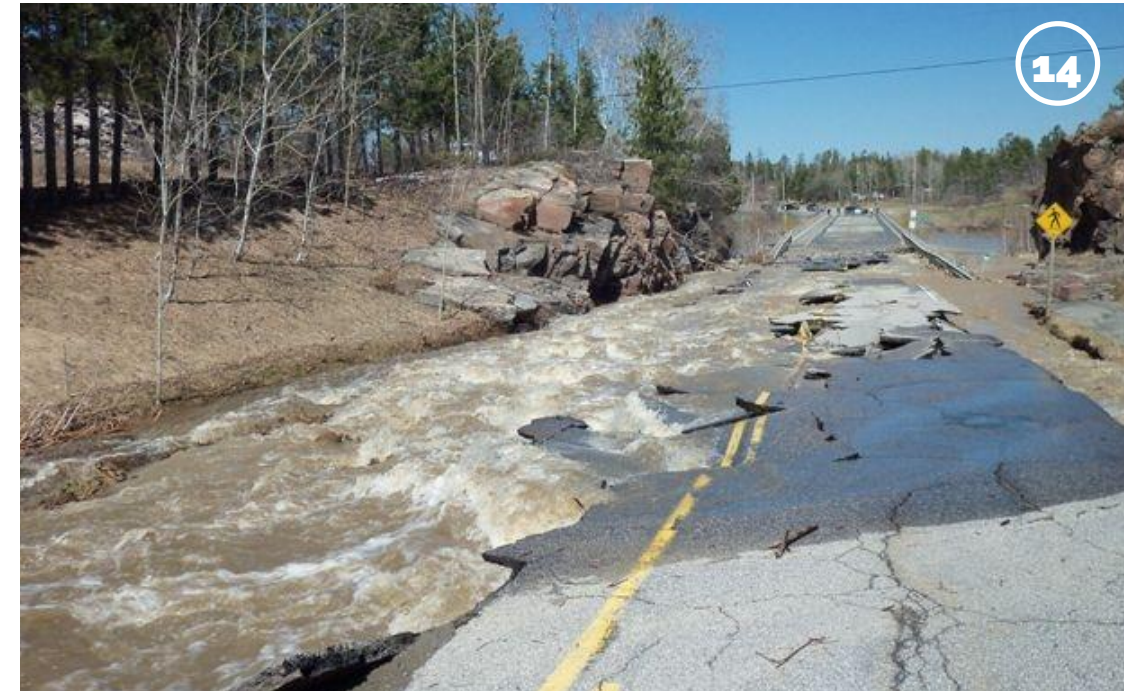
*Photo 3: similar direction to photos 1 and 2, during 2011 washout*
