## 2023 CANADIAN CONSULTING ENGINEERING AWARDS

C  
is one of four earthfill block dams that contain the reservoir for the Caribou Falls

G  
The station and the dams were originally built in 1958 and have been operating reliably, only requiring routine maintenance and upgrades over the years. However approximately 60 years into its service life, Block Dam 2 sustained unexpected slope movements initiating the Caribou Falls Block Dam 2 Reconstruction Project.

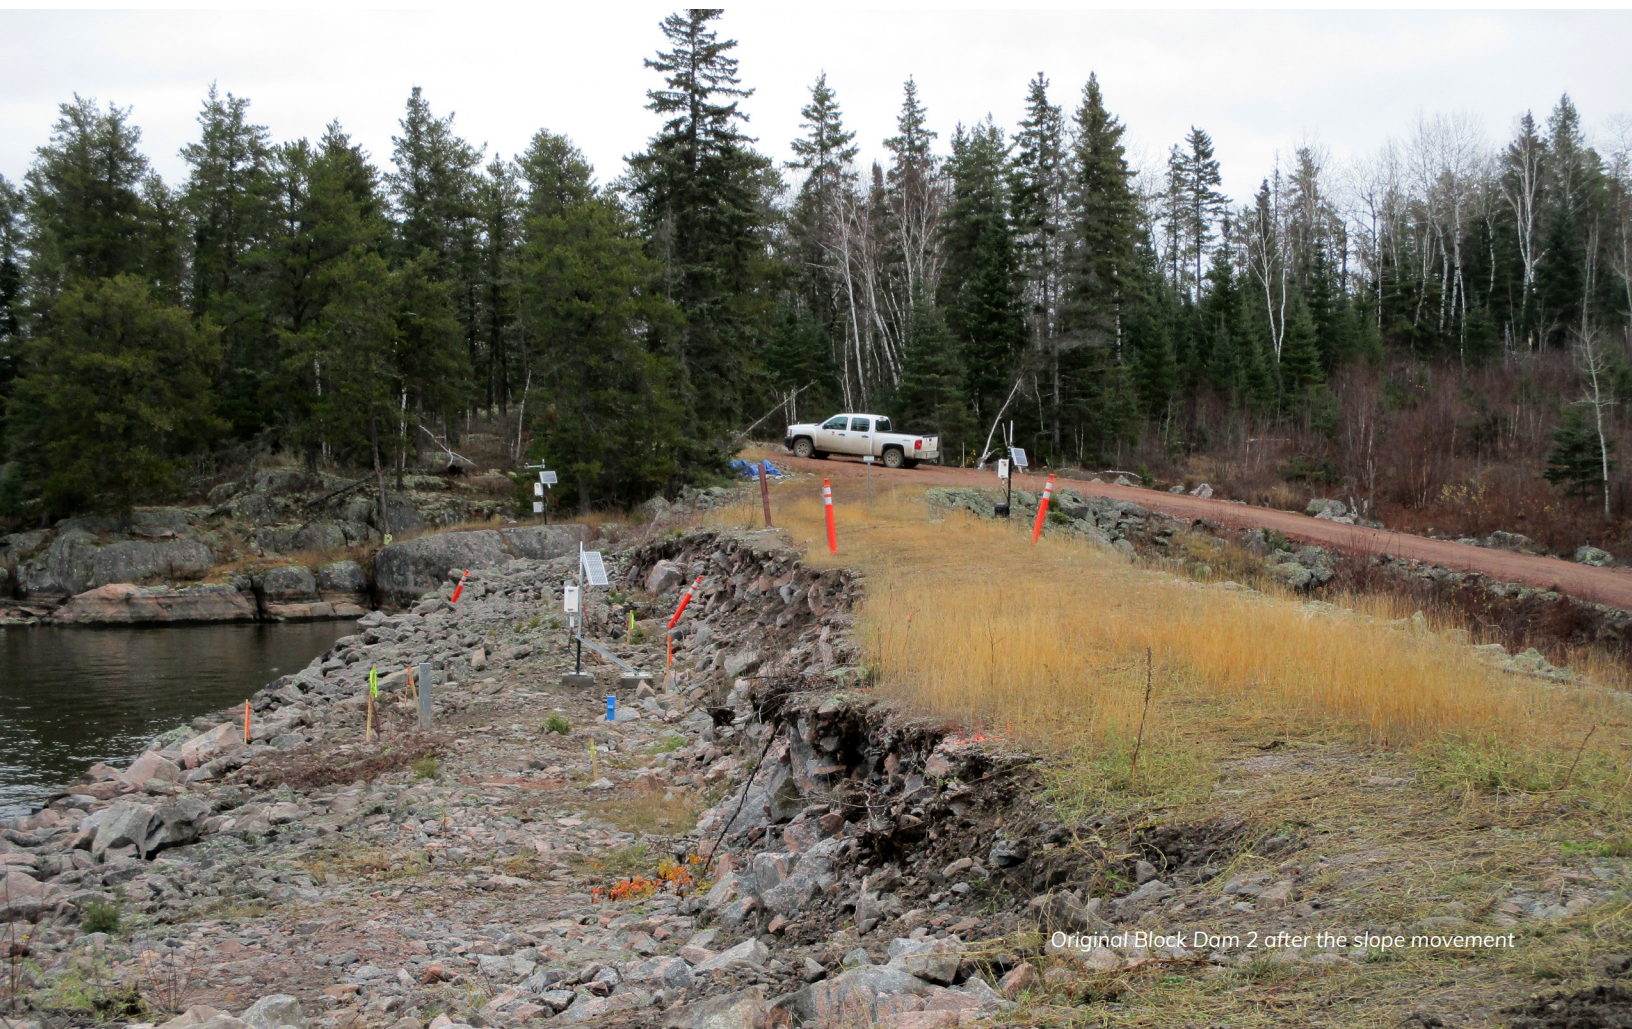
After approximately 60 years since its original construction, significant movement suddenly and unexpectedly occurred on the slope of Block Dam 2. The upstream half of the crest dropped approximately 1.5 m in the eastern section of the dam, exposing internal fill materials and potentially compromising the integrity of the core beneath. For safety reasons, OPG lowered the headpond which resulted in lost power generation capacity. OPG immediately began an intensified surveillance and monitoring program. Investigations and studies to understand the root cause of the slump were initiated and remediation measures were explored.

Through review of original as-constructed documents and back-analysis using numerical slope stability modelling software, it became obvious that the slide must have occurred through the embankment clay core and the clay blanket. The precise root cause or event that triggered the upstream slide after almost 60 years remains unclear, and the stability of the rest of the dam was unknown. Given the high importance of maintaining the integrity of the dam, and not fully knowing why the slide occurred, OPG sanctioned the complete replacement of Block Dam 2.

Original Block Dam 2 after the slope movement

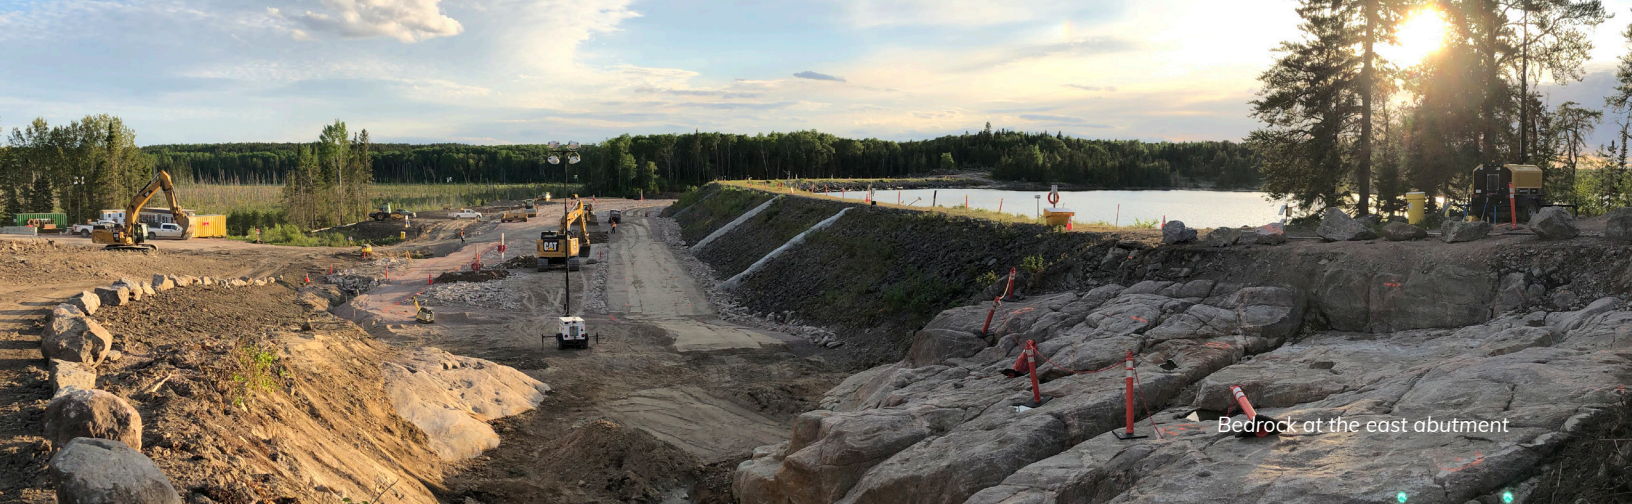
Upon stripping the overburden and exposing the east abutment, it became clear to the team that the Precambrian granitic bedrock surface and jointing was more irregular and problematic than anticipated. This area was originally covered in coarse shot-rock which is impenetrable to seismic refraction surveys and impossible to drill through. The east abutment was highly irregular with sub-vertical faces and a 15 cm wide open fracture that could create a preferential seepage path through the abutment. The team reacted immediately to minimize impacts to the already tight schedule. Kiewit provided a topographic survey and digital surface superimposed over a georeferenced air photo taken from a drone that Kiewit had dedicated to the project. The data was expedited to KGS Group's design team who immediately prepared the required design change that optimized the dam alignment and narrowed the core detail to avoid the irregular surfaces. A customized grouting program was designed to infill the open fracture and make it watertight.

Bedrock at the east abutment
