Victoria Memorial Museum Building Rehabilitation Project

Submitted by Halsall Associates
May 8, 2012

NEW APPLICATION OF EXISTING TECHNIQUES/ORIGINALITY/INNOVATION

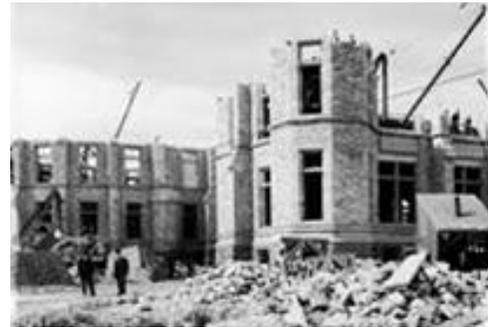
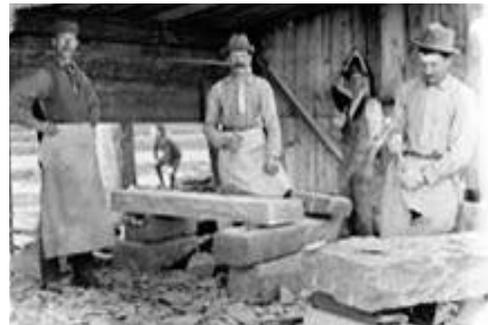
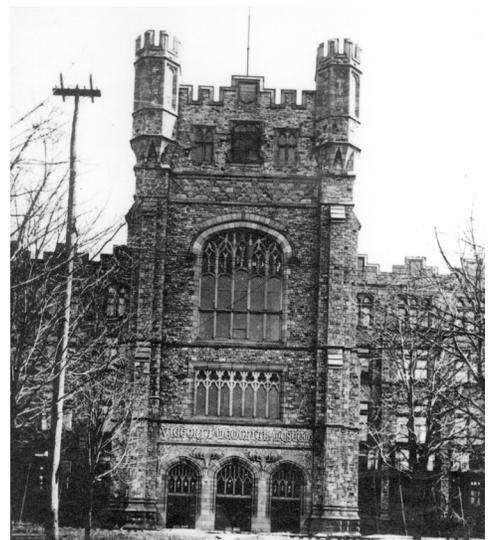
Top to bottom: 300mm cracks;
ground floor differential settlements;
Spectral analysis of the site

The VMMB is a heavy, stone-masonry structure resting on a 30-metre-deep deposit of Leda clay, a silty marine material. Since construction, the exterior walls have settled more than 500 mm into the underlying deposit of Leda clay, causing extensive cracking. When the original entrance tower failed, pulling away from the main building, cracks up to 300 mm wide occurred. In addition, the ground floor underwent significant differential settlements with corresponding distress.

Due to the VMMB's heritage status, sensitive geotechnical site conditions, and the importance of the museum's collections, we conducted extensive, detailed analysis to determine the site-specific seismic loads to be used in the retrofit design. We performed a spectral analysis of the site and incorporated dynamic modelling based on a site-specific response spectrum into our design. Recognizing the importance of this heritage building and the value of the museum collection, the design team planned an upgrade of the seismic resistance to 150% of the code, exceeding the minimum life safety requirements. Although we carried out the work in 2002, we referenced the seismic provisions of the 2005 NBCC in anticipation of significant planned changes.

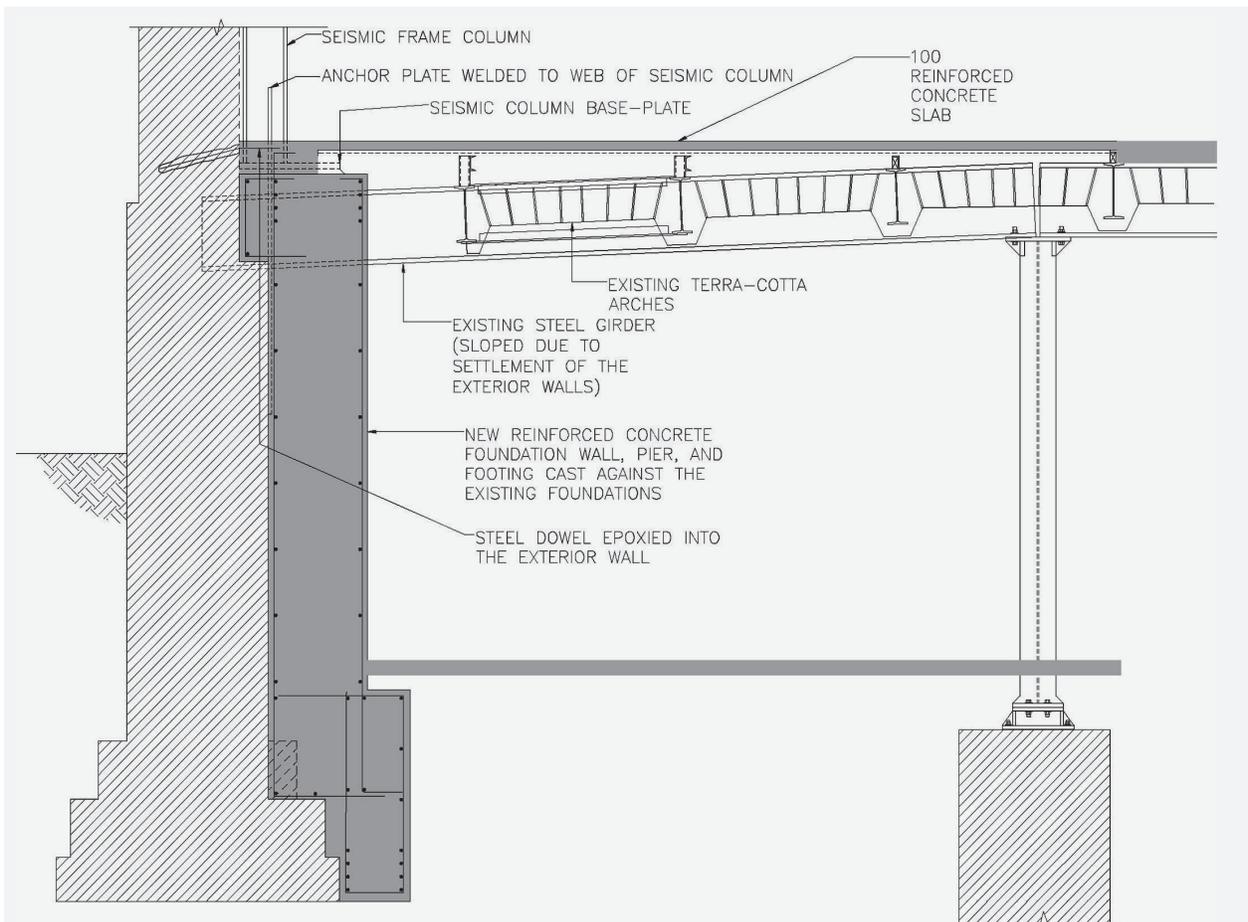
Drawing of new foundation with steel beams, and lightweight steel level floor.

The floor construction generally consists of steel beams and girders supporting terra-cotta flat arches. We constructed new level floors using lightweight toppings on top of the

terra-cotta arches. Where the original ground floor structure was significantly deformed, we designed a light weight steel substructure above the original deformed structure.

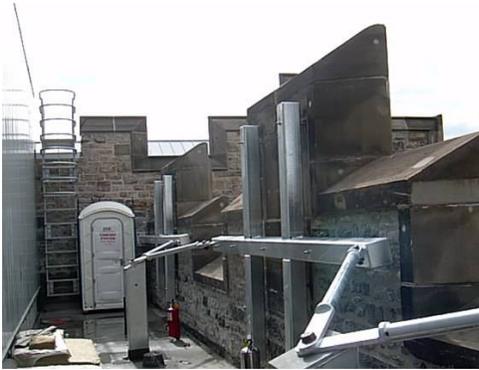
Detail Aerial view of parapet restraints.

The VMMB features high stone masonry parapets and other projecting elements above the roof. We identified these as a particular seismic risk and designed a discrete steel back up bracing system to ensure that in the event of an earthquake the parapets would not tumble down.

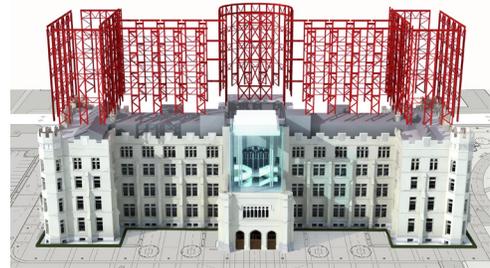
Top to bottom: Drawing of seismic endoskeleton; details of seismic endoskeleton; wire mesh catcher system; gallery with suspended artifact.

Our final retrofit strategy incorporated numerous innovations. First, we built a seismic endoskeleton consisting of a steel truss frame that extends around the entire building against the inside of the exterior stone masonry walls. We configured the truss and set the size of the steel sections to maximize stiffness, minimizing the differential stiffness between the skeleton and the stone masonry walls. While the skeleton added to the building's mass, we were able to offset this by removing terra-cotta walls from the building's interior.

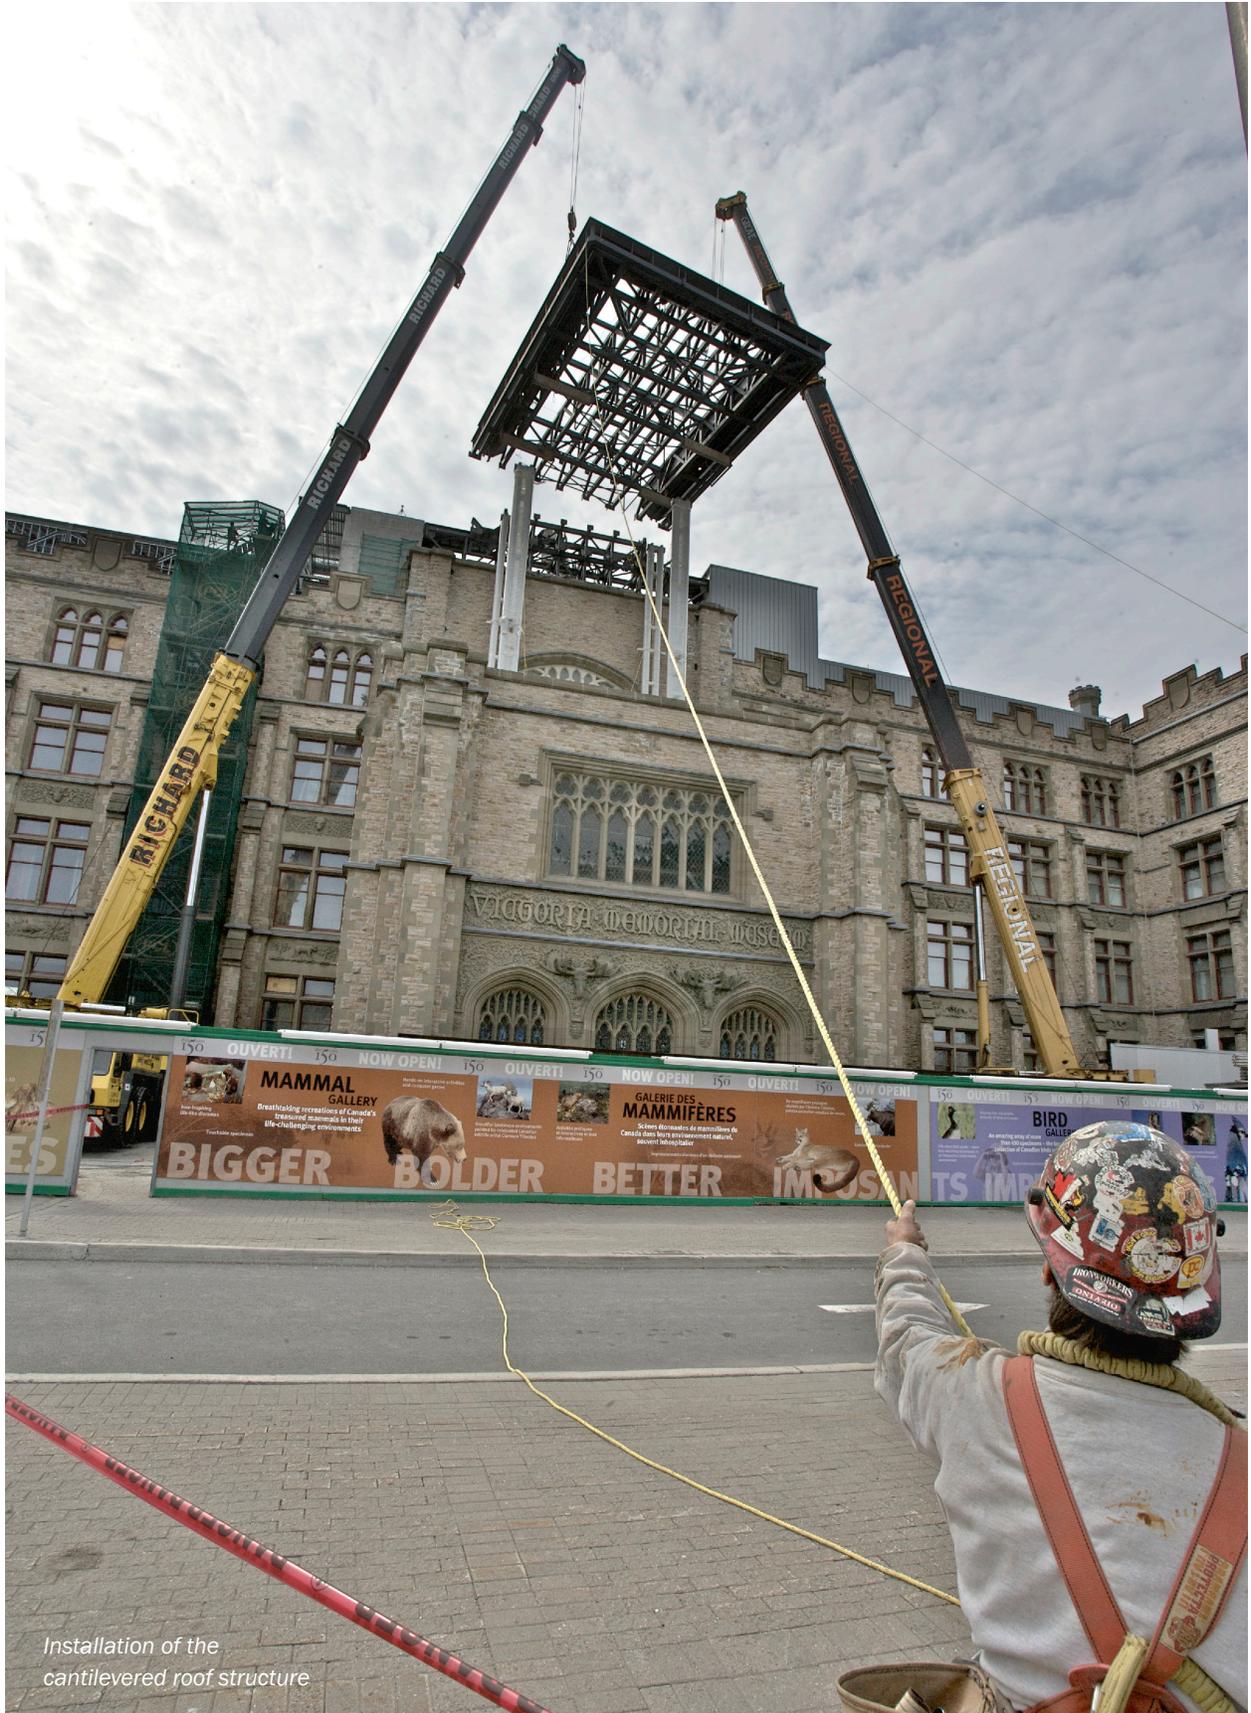
Installation of the cantilevered roof structure

The structural design included a new, cantilevered roof structure from which the glass lantern is suspended. The steel roof structure is in turn supported on new columns and elevator cores which extend down to a new raft foundation at the sub-basement level.

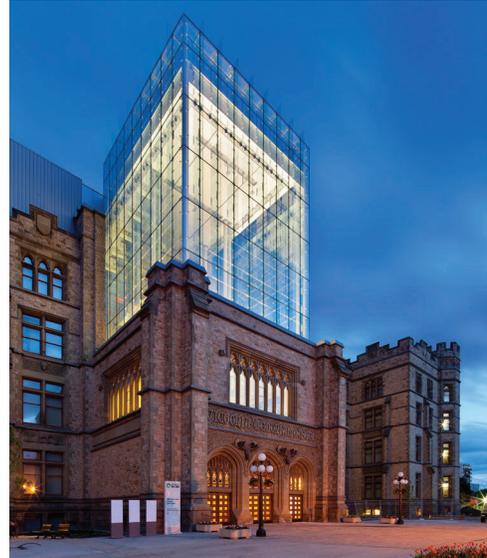
Exterior and interior views of Queen’s lantern

Named in honour of the current Queen of Canada, Elizabeth II, and her forbear, Victoria, the new Queens' Lantern entrance structure was envisioned to function as the visual signature of the museum and its renewal and to improve the circulation of visitors through the museum. The real structural challenge was that the lantern also had to be lightweight. To meet these criteria, the architects designed a striking glass box – the lantern – suspended above the foundations of the original tower.

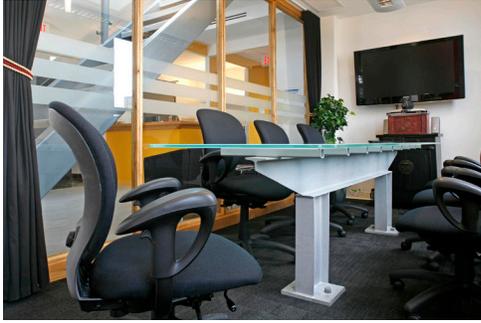
Top to bottom: Halsall boardroom table using surplus steel beam; mammal gallery.
