## Seaway Tie-Up Wall Emergency Reconstruction

On January 26, 2010, a 53-m portion of the 500-m long Lower Lock 2 tie-up wall collapsed. Recognizing Hatch's expertise, familiarity with the walls, and the proximity of experts in its Niagara Falls office, the St. Lawrence Seaway Management Corporation (SLSMC) immediately commissioned Hatch to design a replacement structure, including site supervision, on a fast-track, emergency basis. The contractor, Rankin Construction/Decew Construction (Rankin), was retained by SLSMC on a time and materials basis to complete the repair.

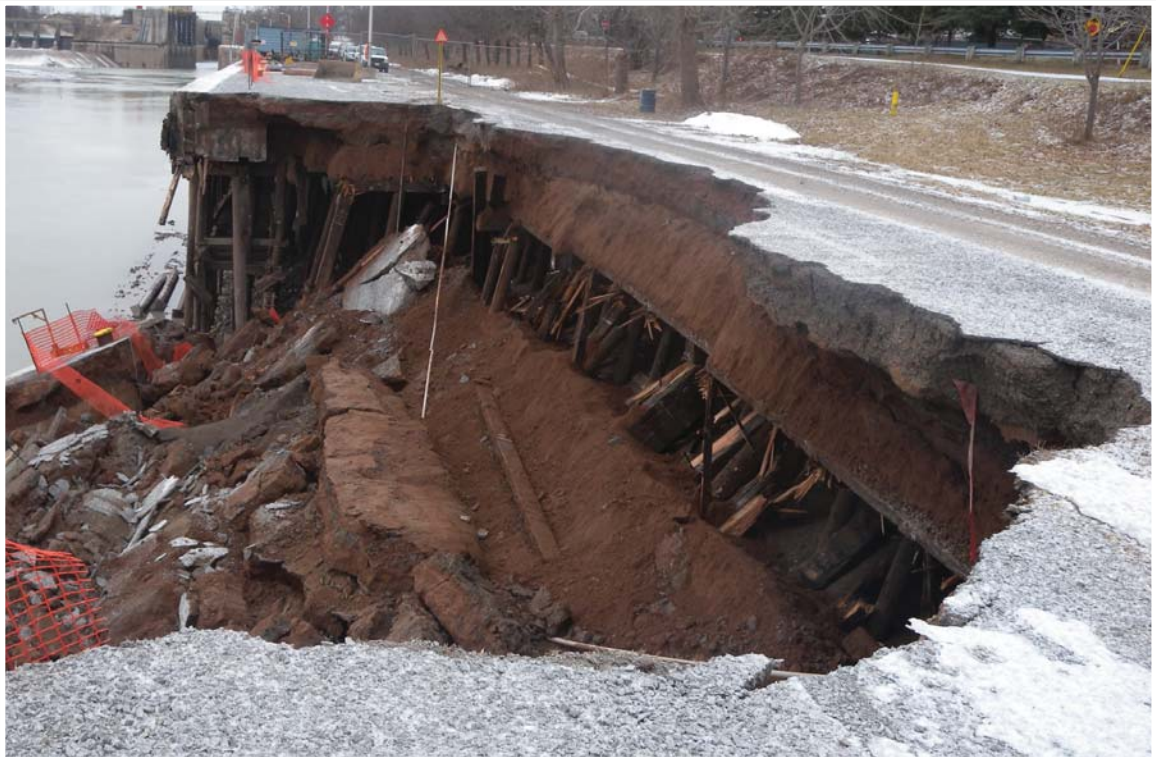
Photo 2 • View of collapsed section (January 26, 2010)

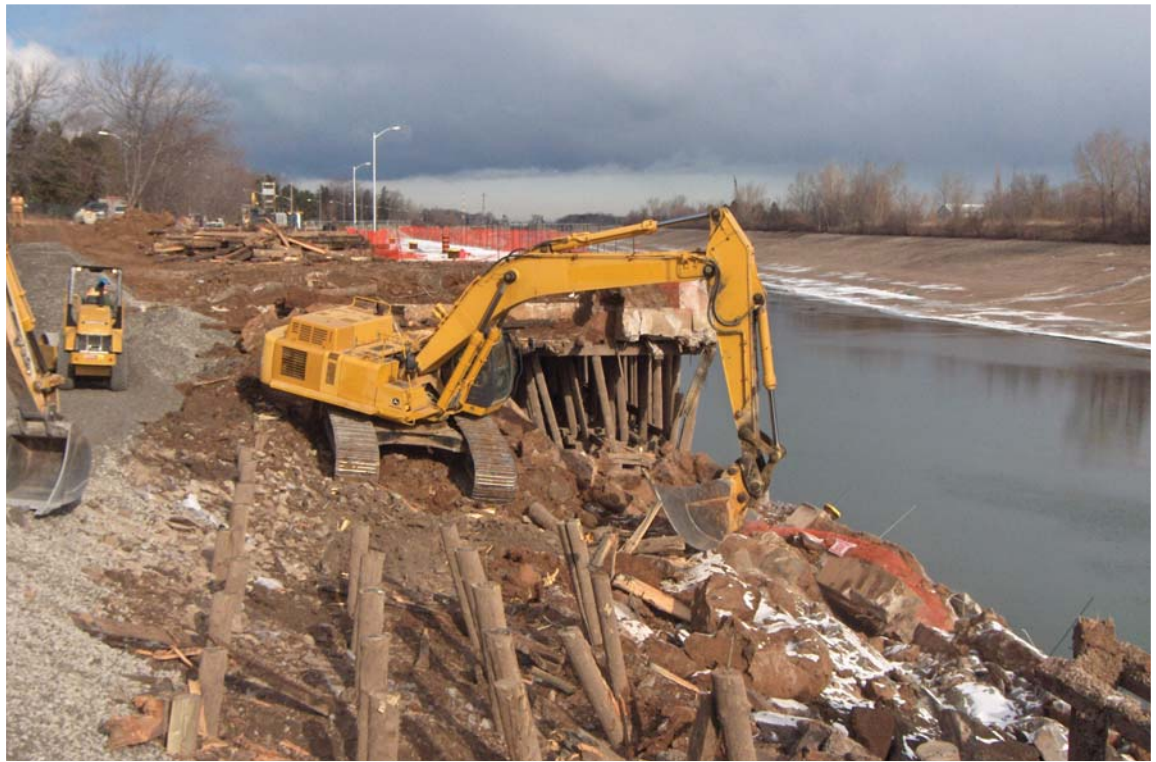
Photo 3 • Removal of debris

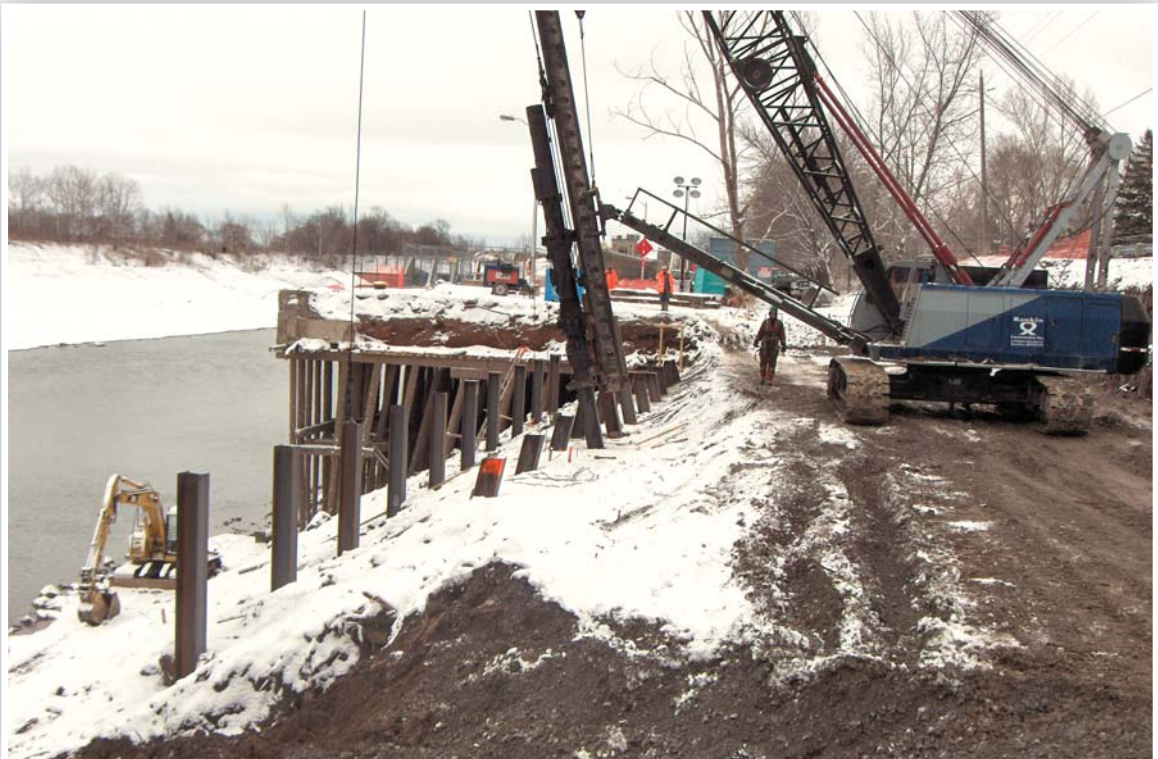
Photo 4 • Steel H pile installation

- Construction methods were reviewed at brainstorming sessions including Rankin to quickly focus on a solution which featured a simple design using readily available steel H piles supporting a structural steel deck of readily available sections. After a few days of design work, material lists were issued to order materials.

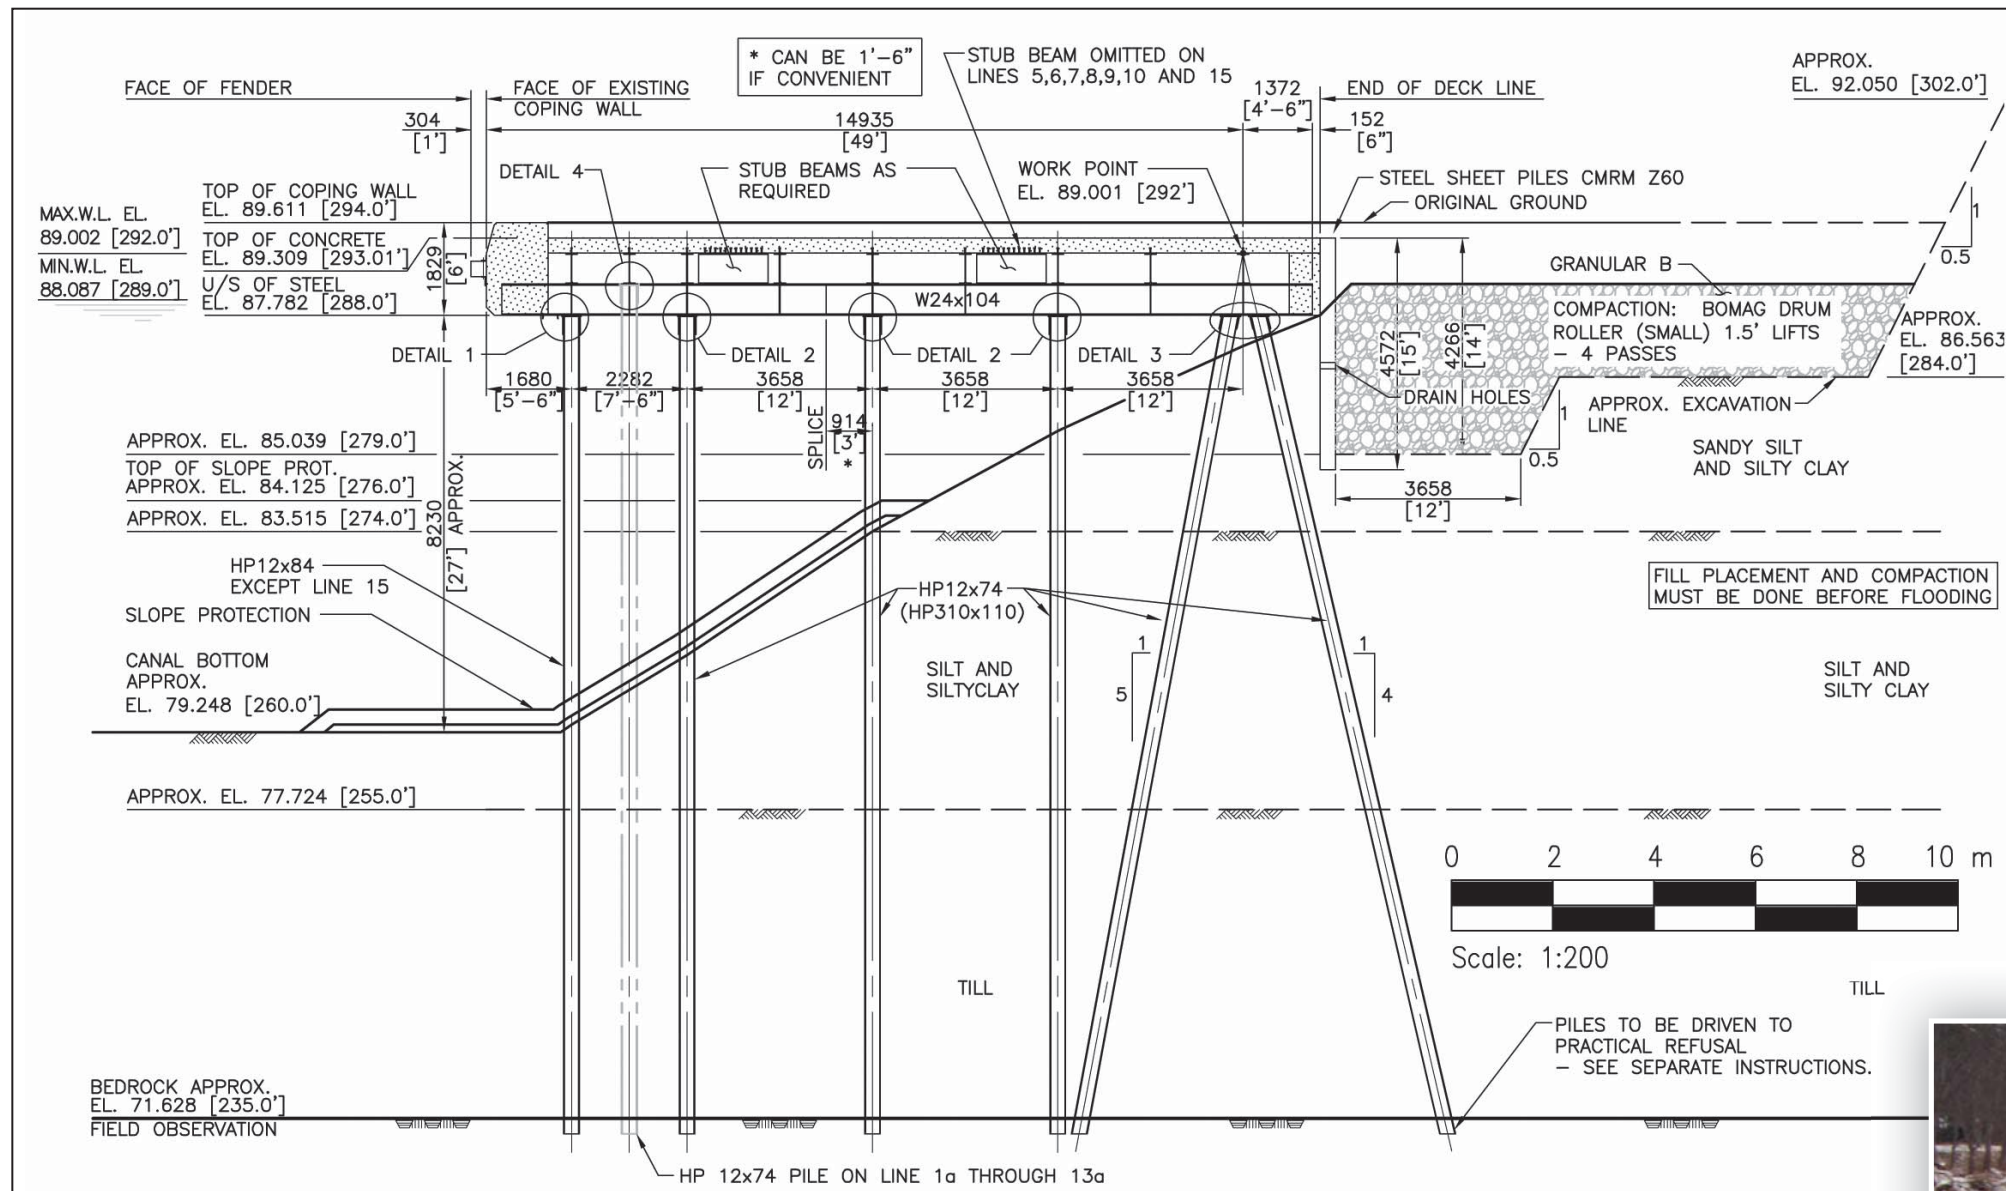
Typical section through new deck

- The deck elevation was set as high as possible so that, if necessary, work such as backfilling and pouring of the concrete deck could be completed with the canal flooded.

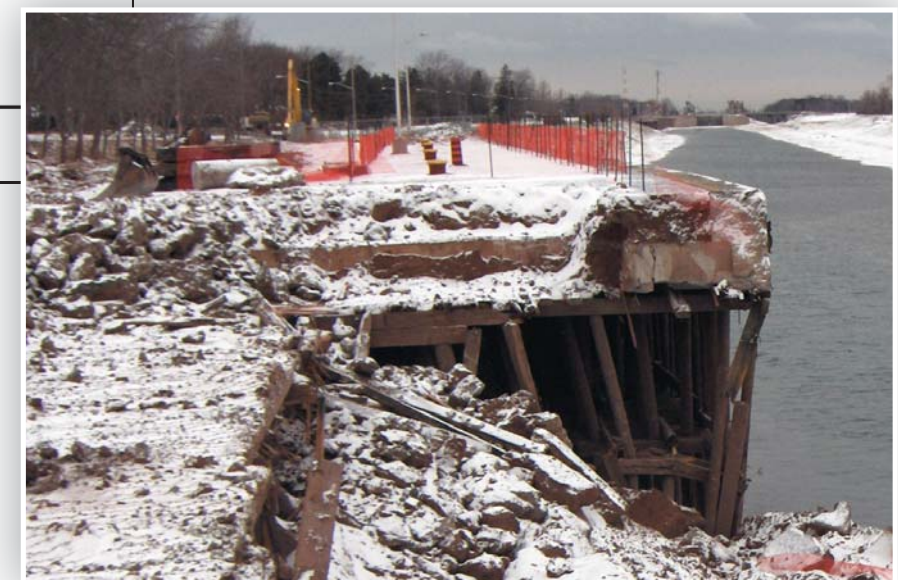
Photo 5 • View of collapsed deck

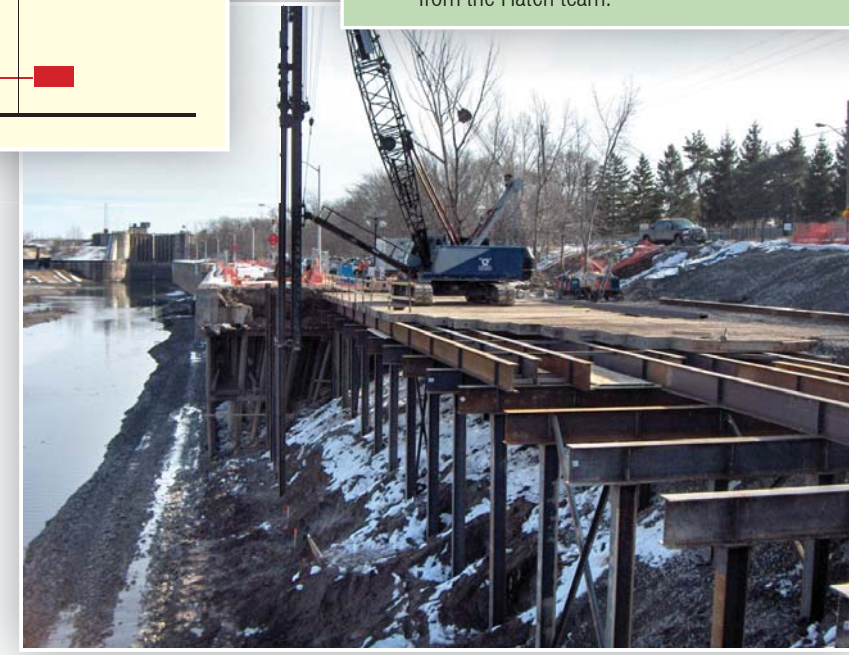
Photo 6 • Pile driving (note rig on top of new deck)

- As the deck was assembled from the land side, timber mats were placed to allow the 100-tonne pile driving rig to reach the water side pile locations. After the timber mats were no longer required, metal deck and concrete were placed.

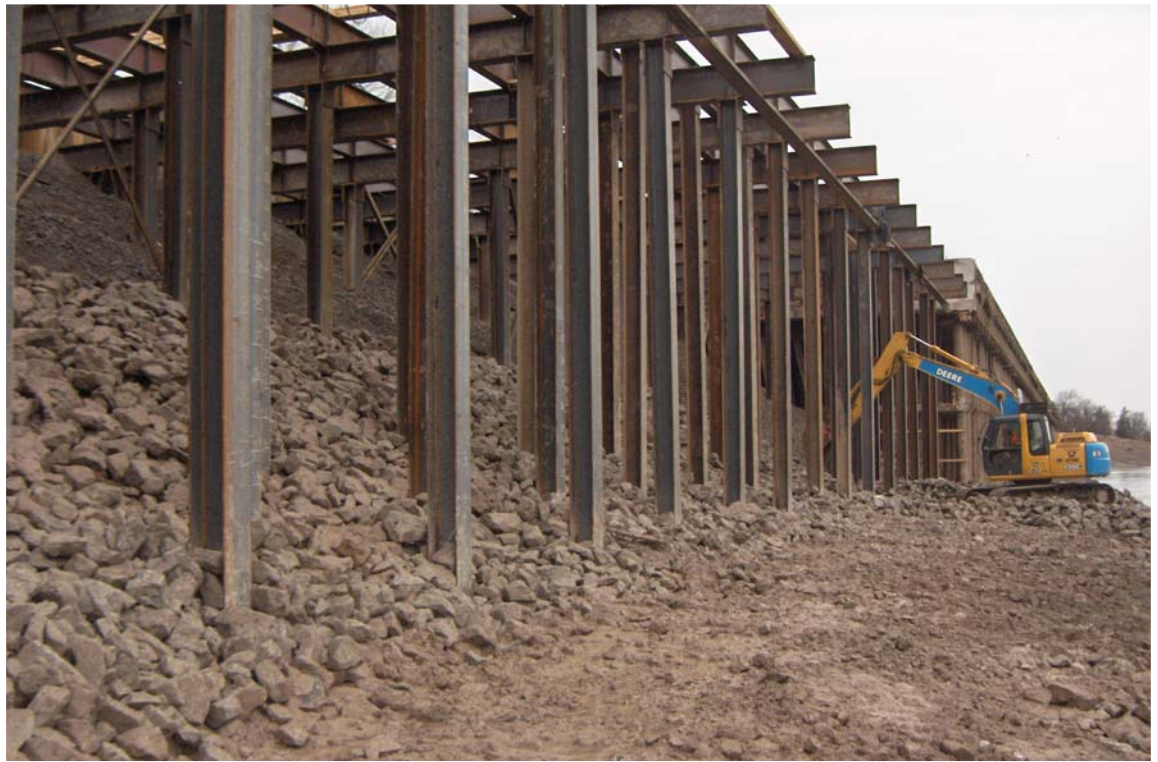
Photo 7 • Canal view of new H piles, beams, girders and placement of slope protection material

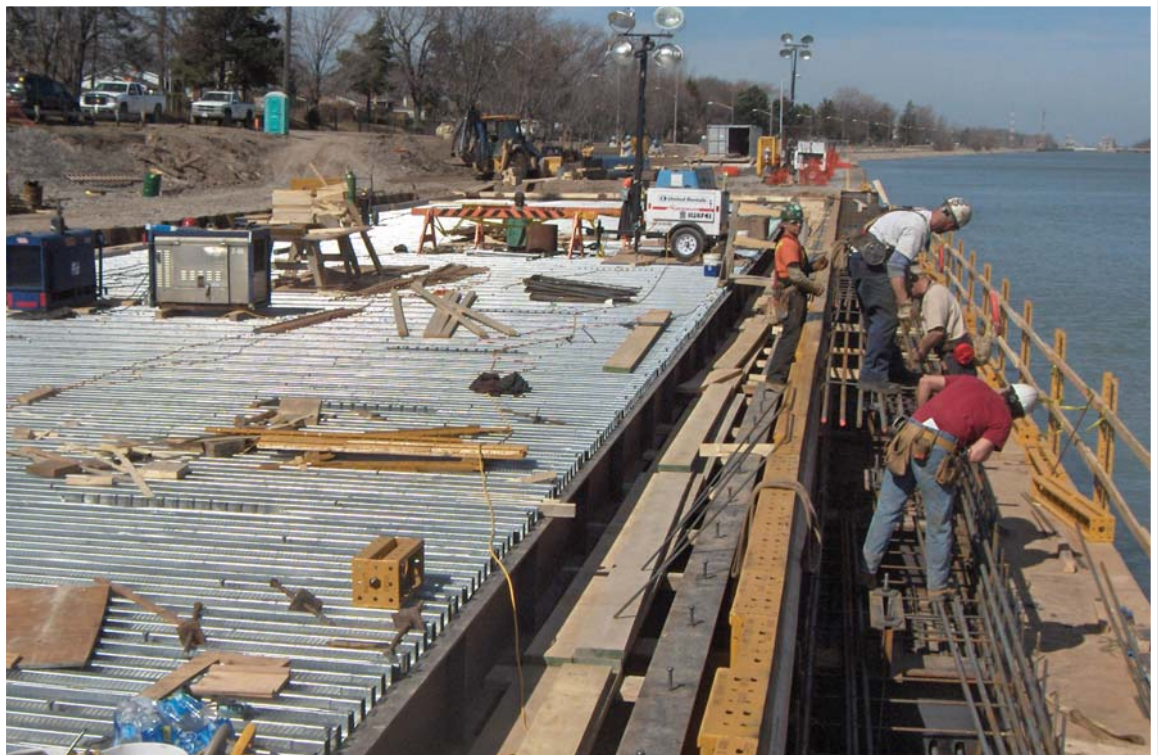
Photo 8 • Deck nearing completion

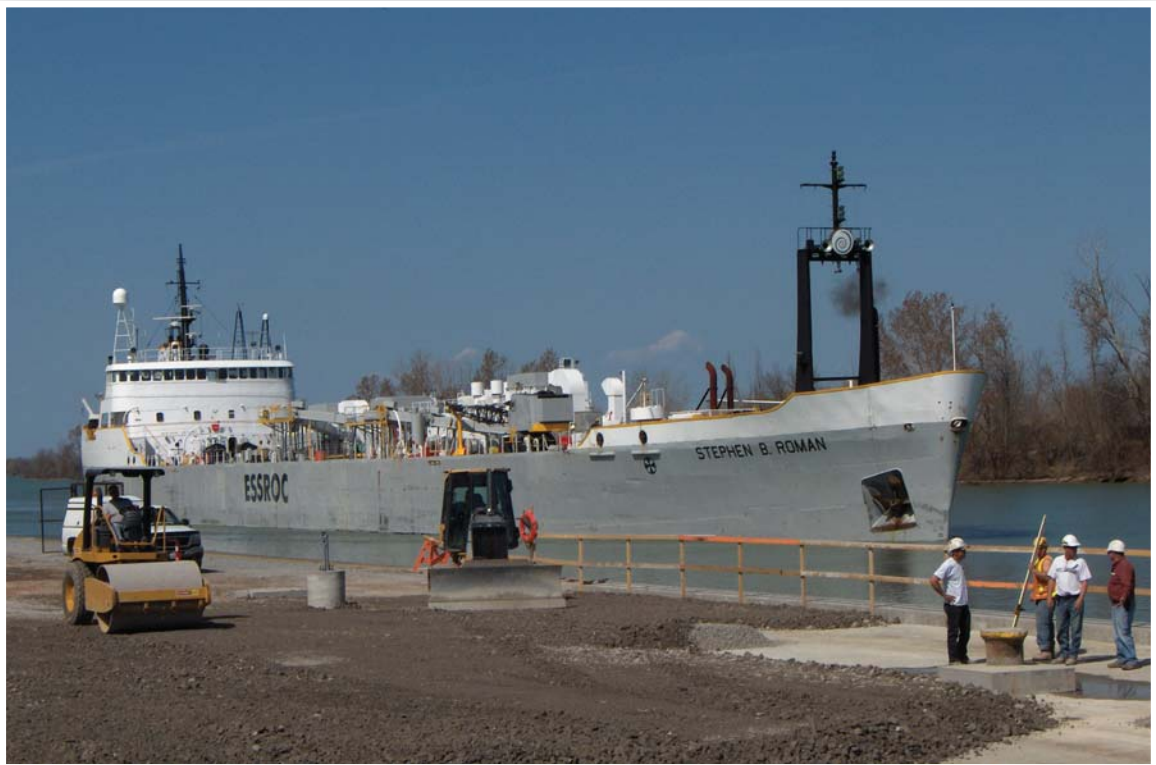
Photo 9 • Granular fill placement on reconstructed tie-up wall as ship passes through canal
