Canadian Consulting Engineering Awards 2016- Water Resources Lisgar District Basement Water Infiltration Investigation

Project Description

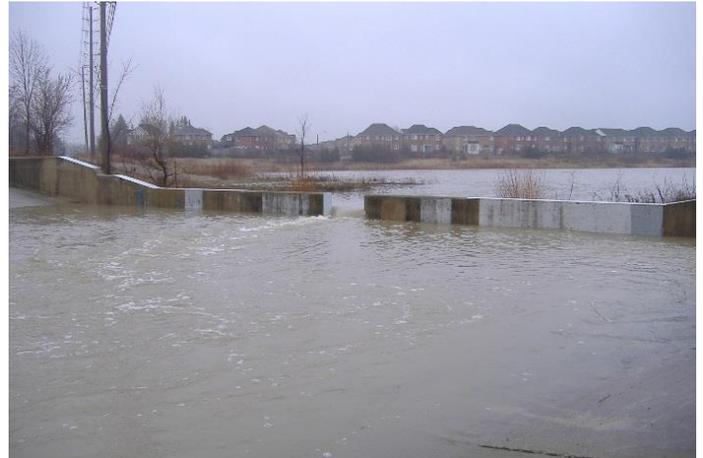
Figure 1 Osprey March/Lisgar District SWM Facility during Storm Event of April 12, 2013

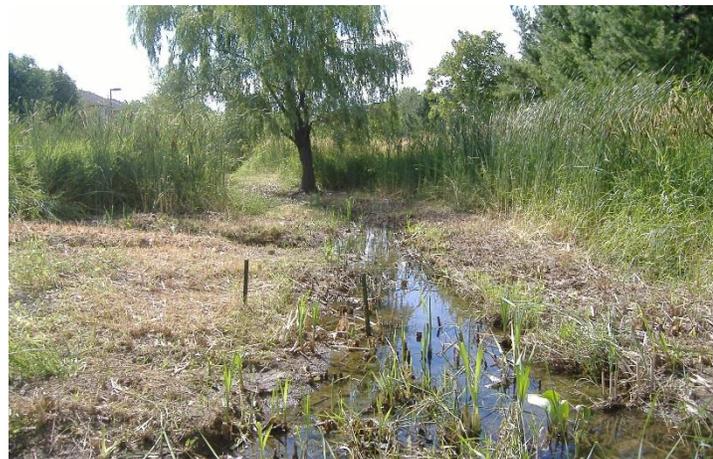
Figure 2 Tributary of Sixteen Mile Creek through Lisgar District showing Vegetation Clean-Out by City Staff

After becoming aware of the scale of this issue, the City undertook a number of actions, including inspections and sealing of the FDC system, as well as various clean-outs and adjustments to surface water features. The engineering consulting firm of Amec Foster Wheeler Environment & Infrastructure was subsequently retained to undertake an engineering study to determine the cause(s) of the basement water infiltration and recommend corrective measures. Amec Foster Wheeler's Engineers and Hydrogeologists were able to explain the basement water infiltration problem by utilizing innovative monitoring and proof-of-concept testing along with cutting edge modelling/analysis to identify the source of the problem and establish integrated solutions.

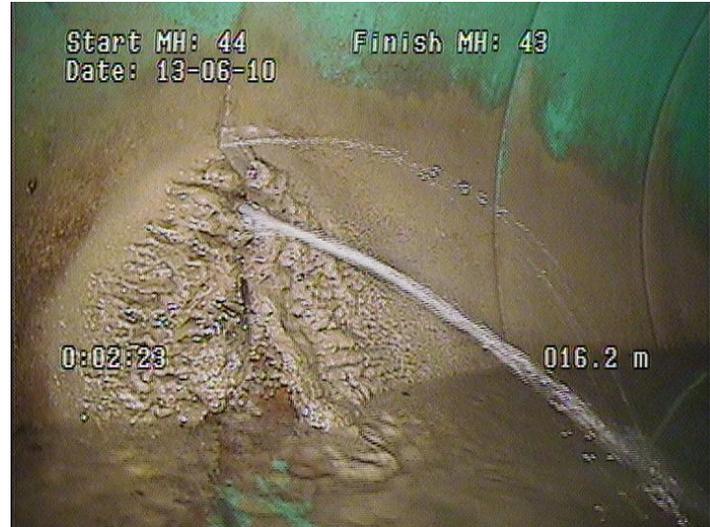
Figure 3 CCTV Inspection of the FDC System Showing Leakage/Infiltration

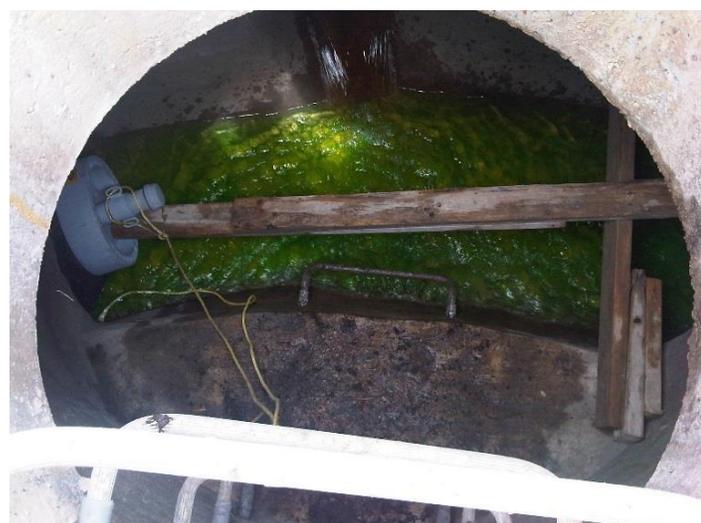
Figure 3 Storm Sewer Leakage Testing Procedure

To better understand the interactions between the various sources of water and drainage system components in the Lisgar District, and to test preliminary theories regarding causes, field testing work was also undertaken. The testing included water quality sampling (to identify the likely source of the water), impermeable collar construction and testing (to assess the potential for inflows from creeks and ponds) and storm sewer leakage testing (to definitively prove that water from leaking storm sewers would ultimately drain into the FDC system).

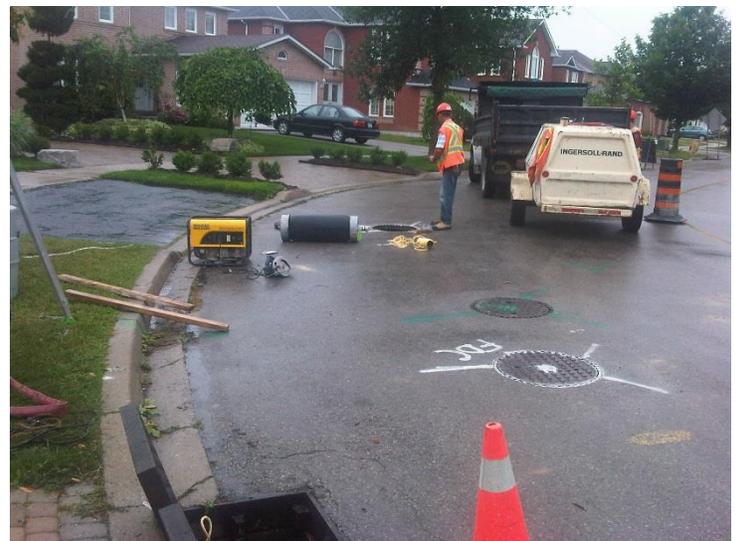
As storm sewers are not inherently built to be watertight, and due to cracks and leaks expected through normal aging, stormwater is able to leak out during storm events and migrate into the utility trench, where the bedding material, made of gravel and other granular soils, can allow water to move very quickly. Over time, water builds up in the utility trench from storm sewer leakage, as well as through other sources (other utilities, groundwater, etcetera), and is unable to drain away quickly due to the relatively impermeable nature of the native soils surrounding the trench. If the build-up of water is significant enough it can travel up the bedding material around the FDC laterals servicing the homes and into the foundation weeping tiles. This water then drains directly into the FDC pipes through the

Figure 4 Storm Sewer Leakage Testing Procedure

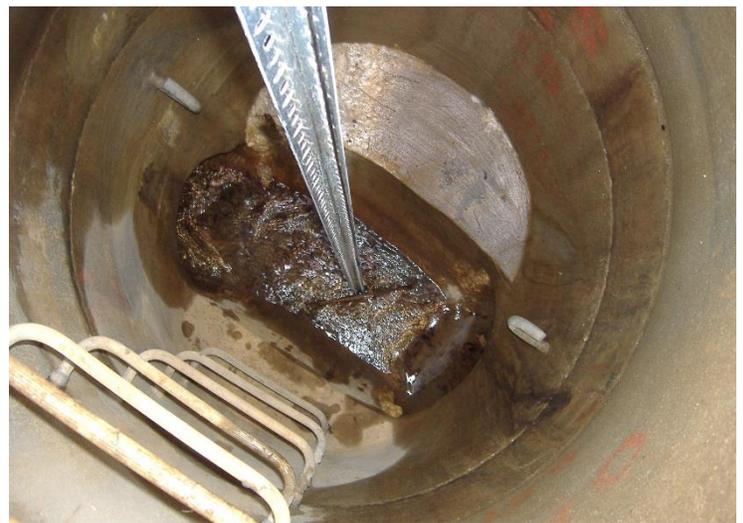
Figure 5 FDC Water Level Monitoring Gauge Installation

A comprehensive field monitoring program was undertaken over multiple years to collect data needed to help understand the surface water and groundwater interactions in the Lisgar District, and the resulting cause(s) of basement water infiltration. This included a large number of water level and temperature gauges in the FDC sewer system, storm sewer system, surface water features (Sixteen Mile Creek as well as the Osprey Marsh Stormwater Management Facility), and in monitoring wells for the groundwater system.

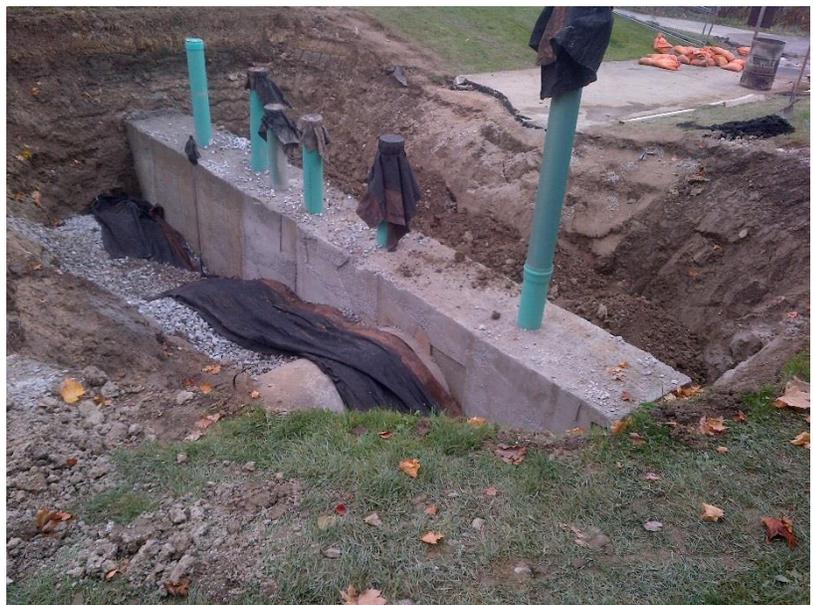
Figure 6 Utility Trench Collar under Construction

The investigation provided the opportunity for Amec Foster Wheeler to demonstrate its technical capabilities and the innovative ideas of its employees. The study required careful interpretation of a large amount of monitoring data from different sources, as well as forensic computer modelling to understand the sources of excess water. The primary cause of the basement water infiltration is also highly atypical and required innovative thinking to determine and mitigate; no such similar cause is known based on Amec Foster Wheeler's review of other municipalities with a similar residential foundation drainage system. A number of the field monitoring and testing activities advanced as part of this study are also highly innovative (i.e. have never been implemented before to the knowledge of Amec Foster Wheeler). This includes sewer monitoring gauge installations (designed to eliminate potentially dangerous personnel entries), the design and implementation of impermeable collars (to assess and eliminate water from surface sources), and storm sewer leakage

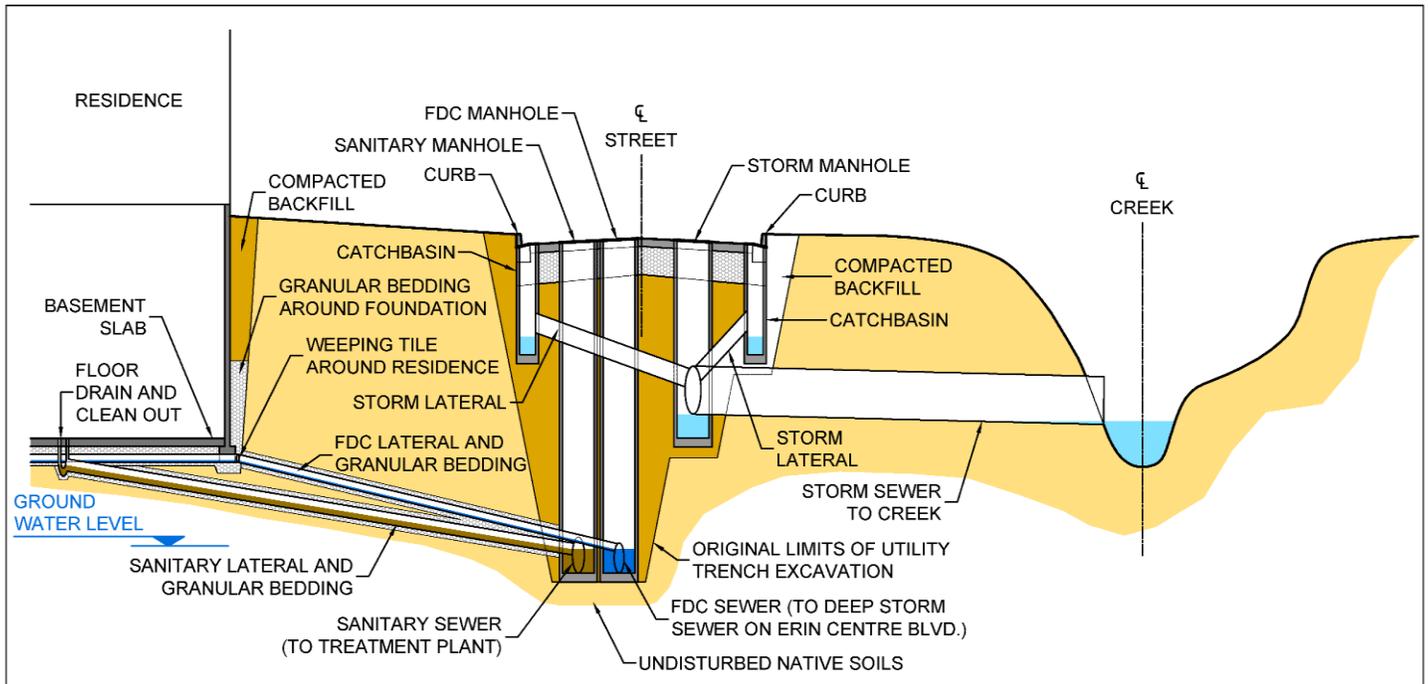
1. TYPICAL UTILITY TRENCH CROSS-SECTION

After a lengthy and comprehensive monitoring period and analysis, the study findings determined the problem to be primarily related to the build-up of water in the bedding material of the utility trenches that contain the storm, sanitary and FDC sewer systems. Amec Foster Wheeler is currently working with the City to implement and monitor solutions, which includes targeted storm sewer lining/sealing to minimize leakage, and a pilot utility trench dewatering system. Additional measures may be considered pending the outcome of these priority solutions.

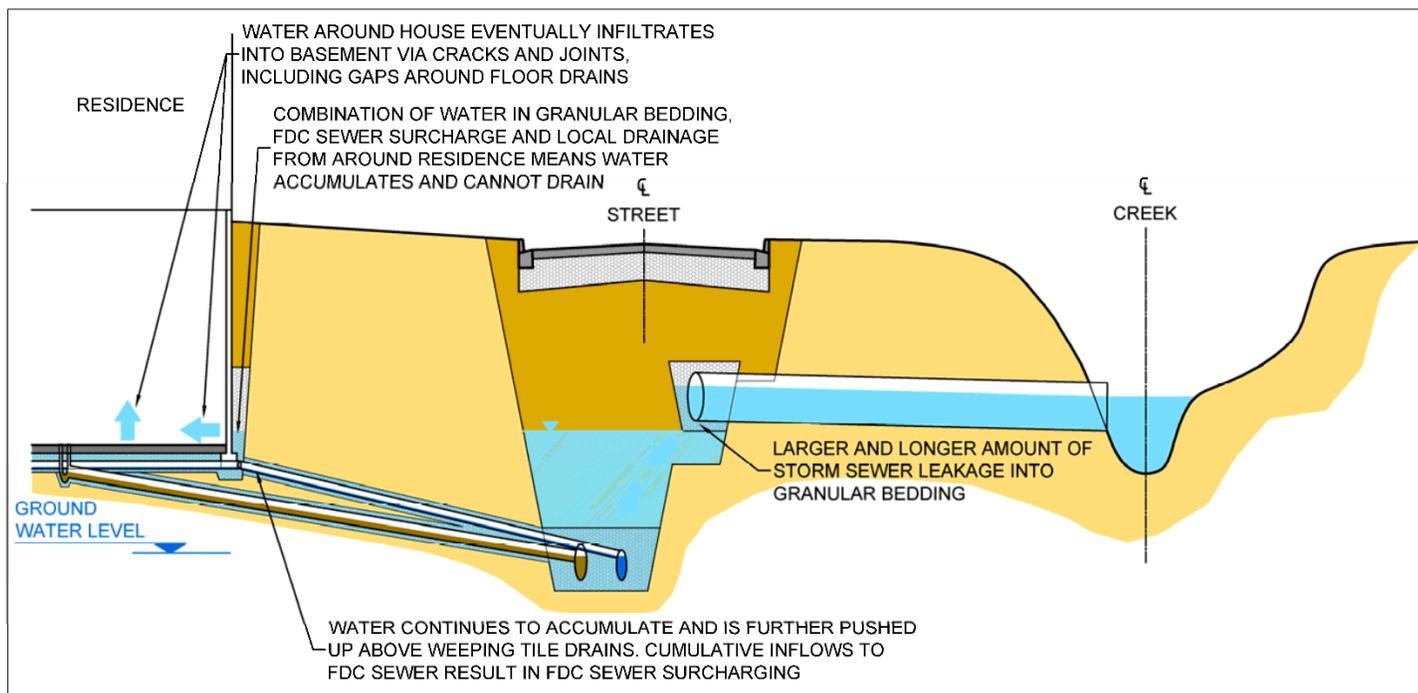
6. UTILITY TRENCH AND BEDDING - FORMATIVE STORM (2)

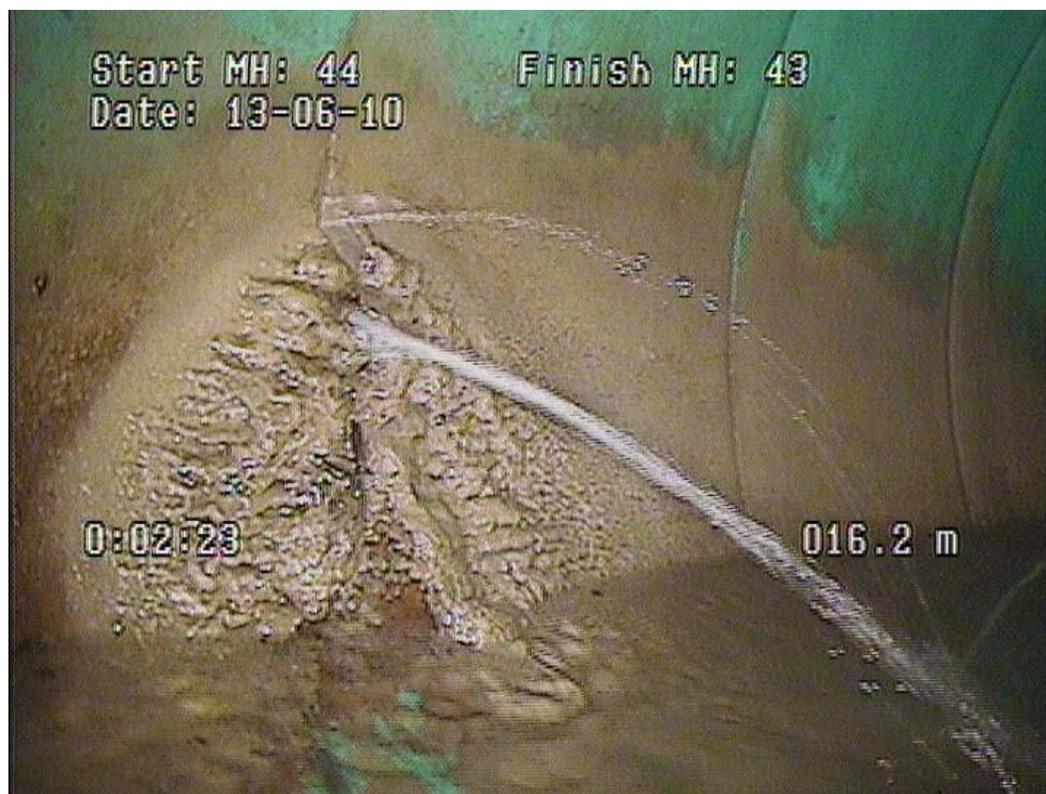
Closed Circuit Television Inspection of the FDC System Showing Leakage/Infiltration

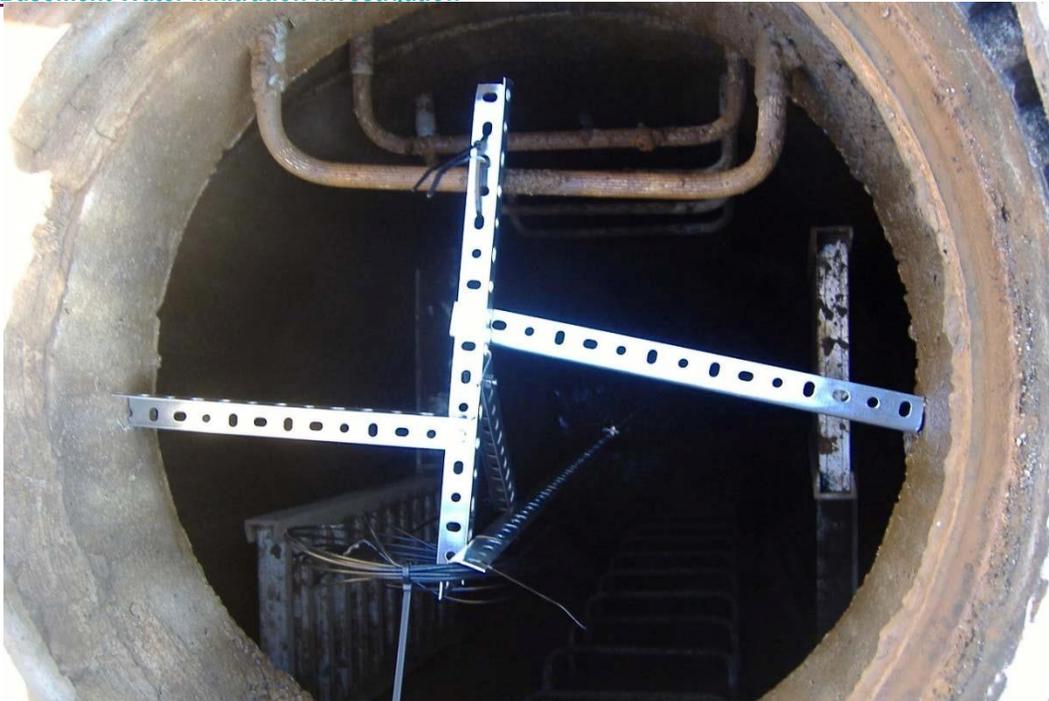
Top View of Typical FDC/Storm Sewer Maintenance Hole Gauge Installation

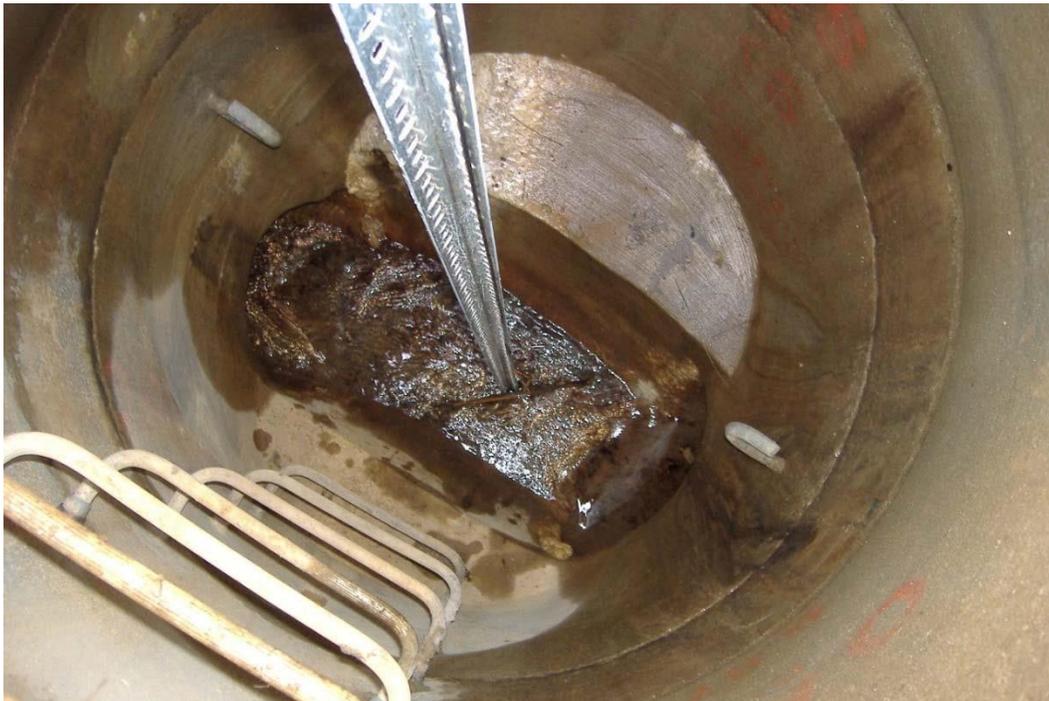
FDC Water Level Monitoring Gauge Installation

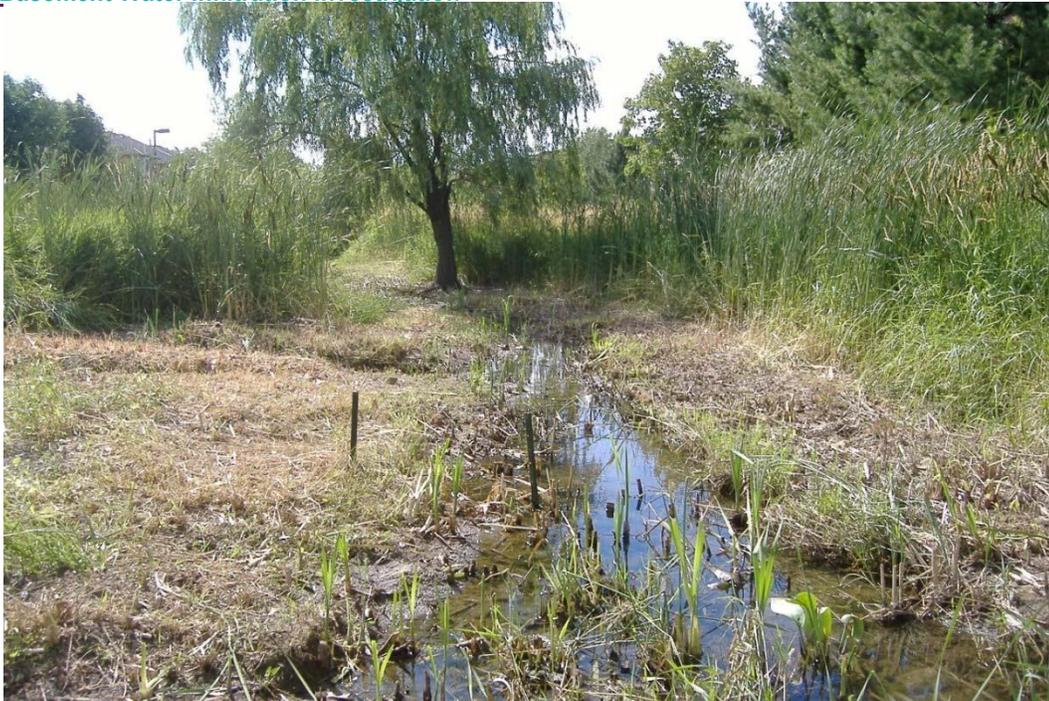
Tributary of Sixteen Mile Creek through Lisgar District showing Vegetation Clean-Out by City staff

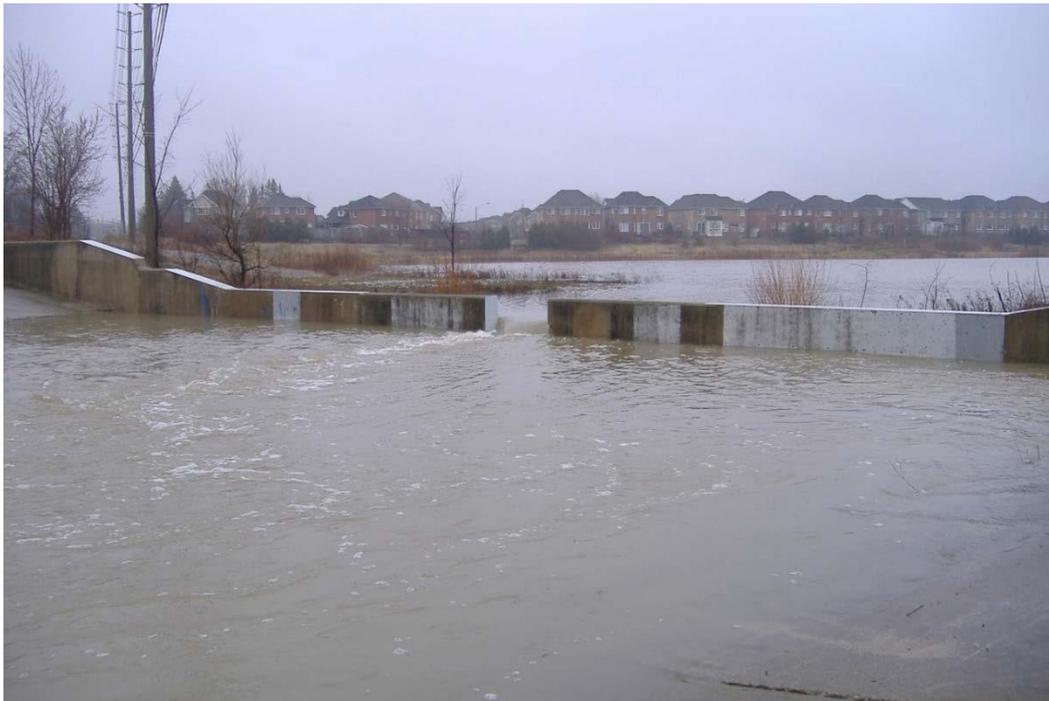
Osprey Marsh/Lisgar District SWM Facility during storm event of April 12, 2013

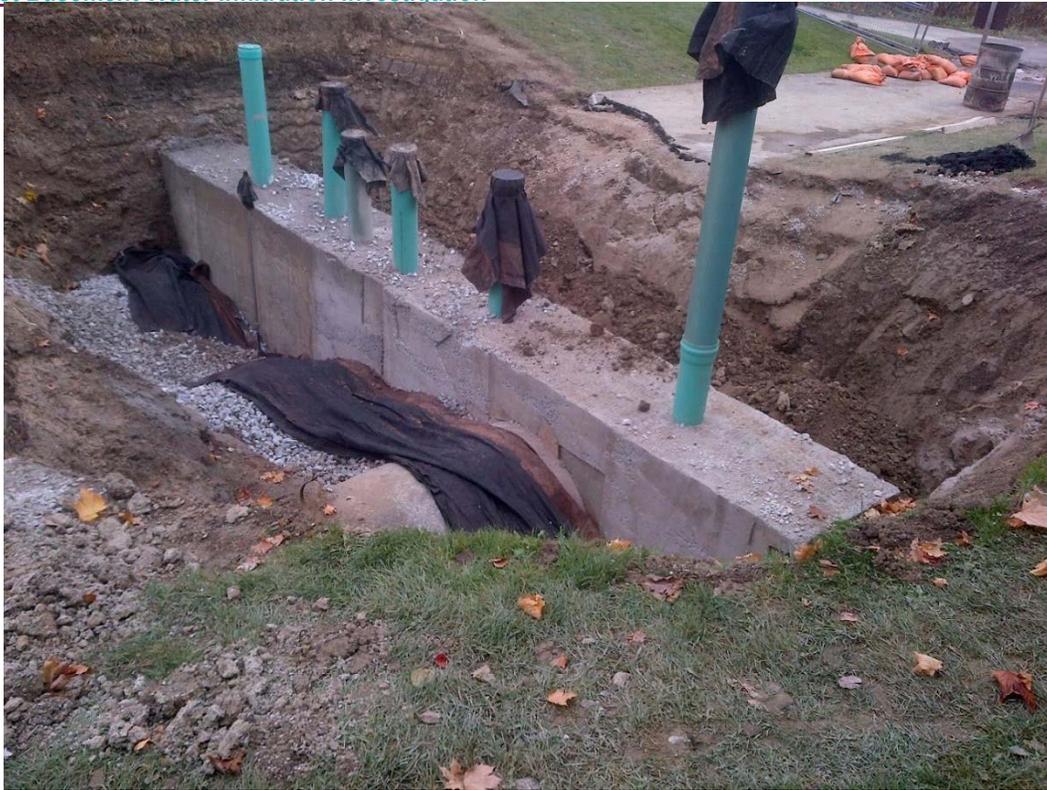
Utility trench collar under construction

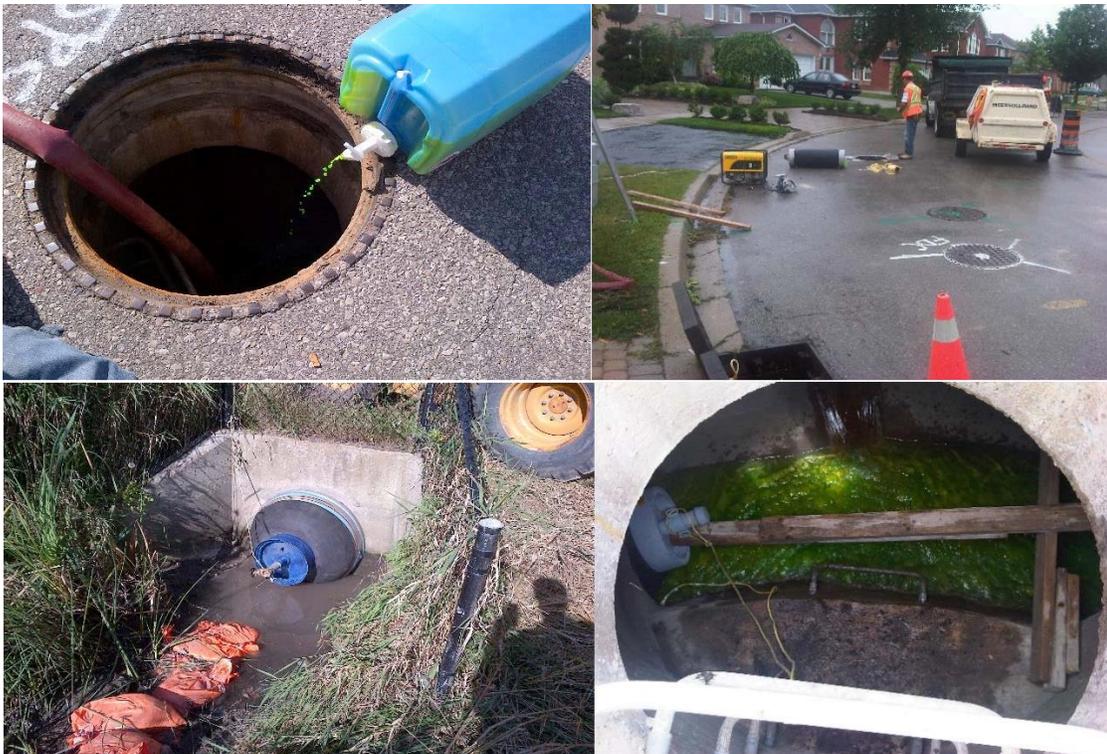
Storm sewer leakage testing procedure
