OSBORNE STREET BRIDGE REHABILITATION AND WIDENING

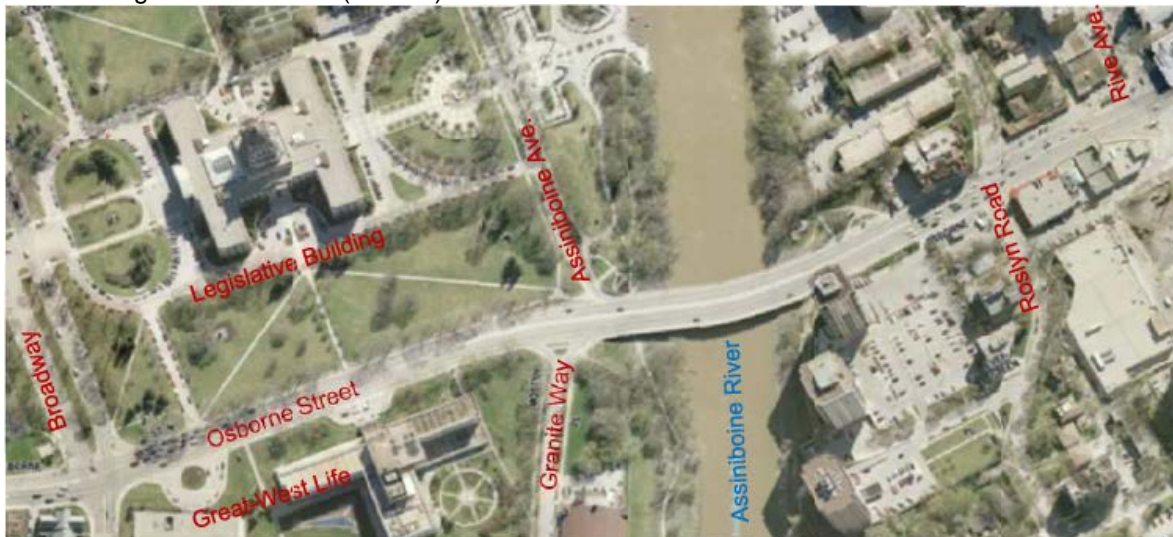
Figure 1 – Osborne Street Bridge and Associated Roadworks

Eclectic combinations of early 1900s architecture standing alongside modern high rises adorn the limits of this project. To the north of the bridge are two landmark buildings, the Manitoba Legislative (Legislative) building as well as the two Great-West Life corporate buildings. The existing twin bridges were constructed in 1976 to replace a 1912 structure. The site map of the project limits is provided in Figure 1.

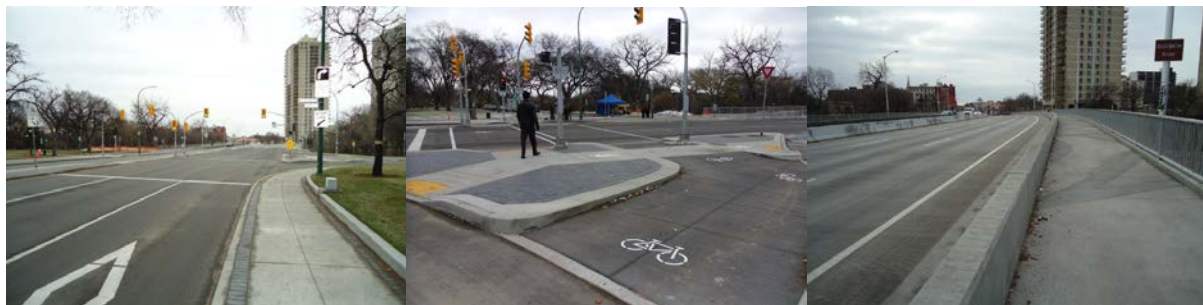
Figure 3 – Geometric Improvements for all bridge users

Vehicular Traffic Lanes: Geometric improvements were constrained due to the existing right of way. Reconfiguration of the centre median allowed for adjustments to lane widths and for provision of a 1.8 m shy distance for cyclists around the vicinity of the bridge.

Cyclists: Cycling infrastructure on the bridge was inadequate and caused many cyclists to ride on the sidewalk where they conflicted with pedestrians. Property acquisition at the bridge transitions was limited due to site constraints and costs. This limited the extension of the 1.8m shy distance only over the bridge. A pedestrian/cyclist activated signal, "the first of its kind in Winnipeg" was constructed to facilitate E-W crossing at the north end of the bridge, which also provided a suitable connection to the existing AT infrastructure. This signal was preferred over a pedestrian corridor as the signal could be timed with the adjacent signals at Broadway and Roslyn, thus maintaining progression of traffic on Osborne Street.

Pedestrians: Features such as curb ramp alignment and installation of detectable warning tiles, removal of obstacles in the accessible path of travel, and reconfiguration of sidewalk paving patterns to assist visually impaired persons were designed. High level lighting on and under the bridge and well-pruned plantings leaving clear sightlines, were other ways of addressing City of Winnipeg's Universal Design standards and crime prevention and improving safety on, around, and under the bridge for all users.

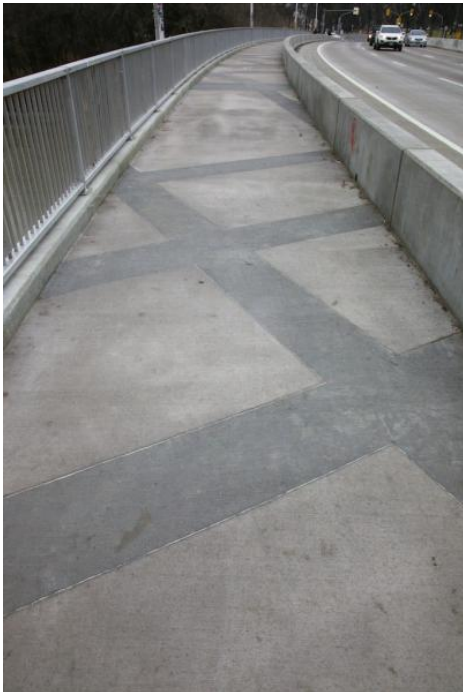
Figure 4 – Osborne Neighbourhood Map Concept on the Sidewalk

Work included placing contrasting concrete tones and stainless steel trimming in the sidewalk overlay that depicted Osborne neighbourhood’s physical map. The bridge handrails, through LED lighting and text inscribed in digitally-cut aluminium plates transformed the existing balusters (pickets). Many of the inscribed texts were inspired from surveys in which residents related anecdotes or wrote about their memories, dreams and hopes. Two illuminated gateway zones at both bridge entries displayed four important architectural moments of the neighbourhood’s history (the Legislative building, the Roslyn Apartment Building, the Granite Curling Club, and the Evergreen Towers), this was accomplished through renditions fabricated with water jet-cut aluminium plates and LED lighting. The end result is not an immense, attention-grabbing monument but rather a slow, quiet, and interactive experience that highlight the vibrancy and community spirit of the neighbourhood.

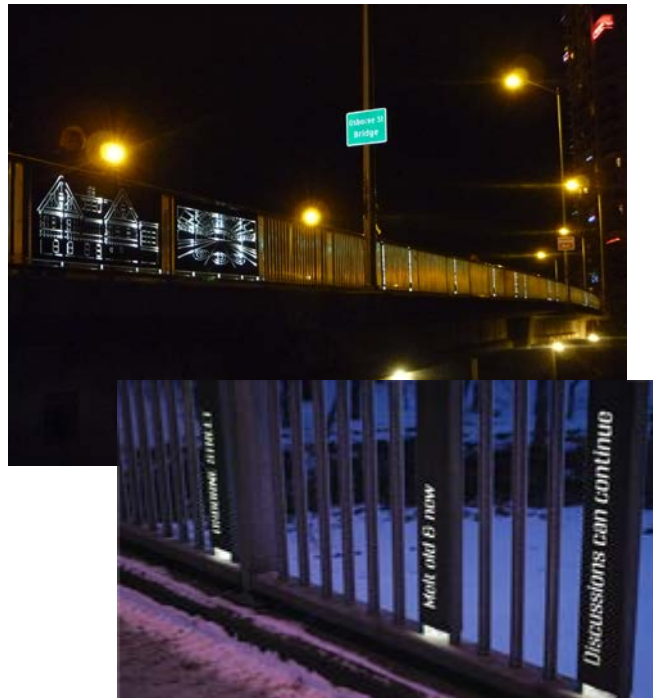
Figure 5 – Illuminated Handrail

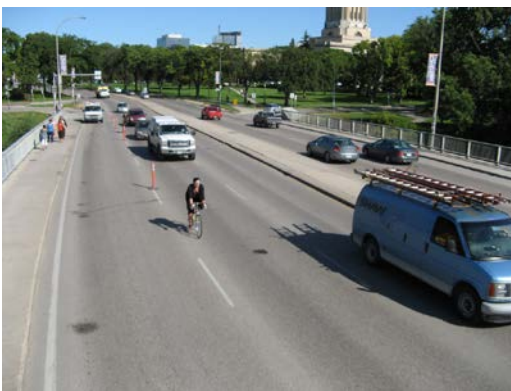
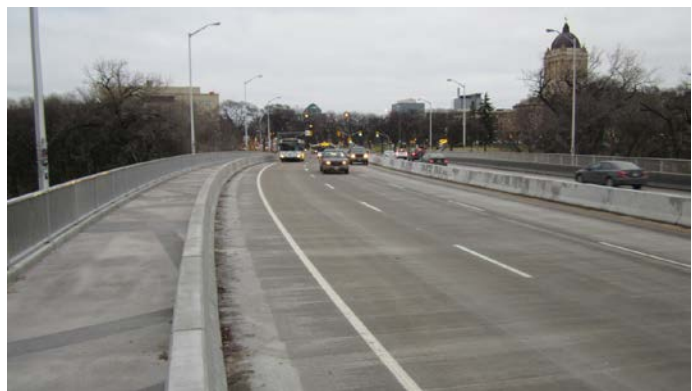
Figure 6 – Pre and Post Construction views of Osborne Street Bridge
