Canadian Consulting Engineering Awards 2013

Heron Road Bridge Rehabilitation Ottawa, Ontario

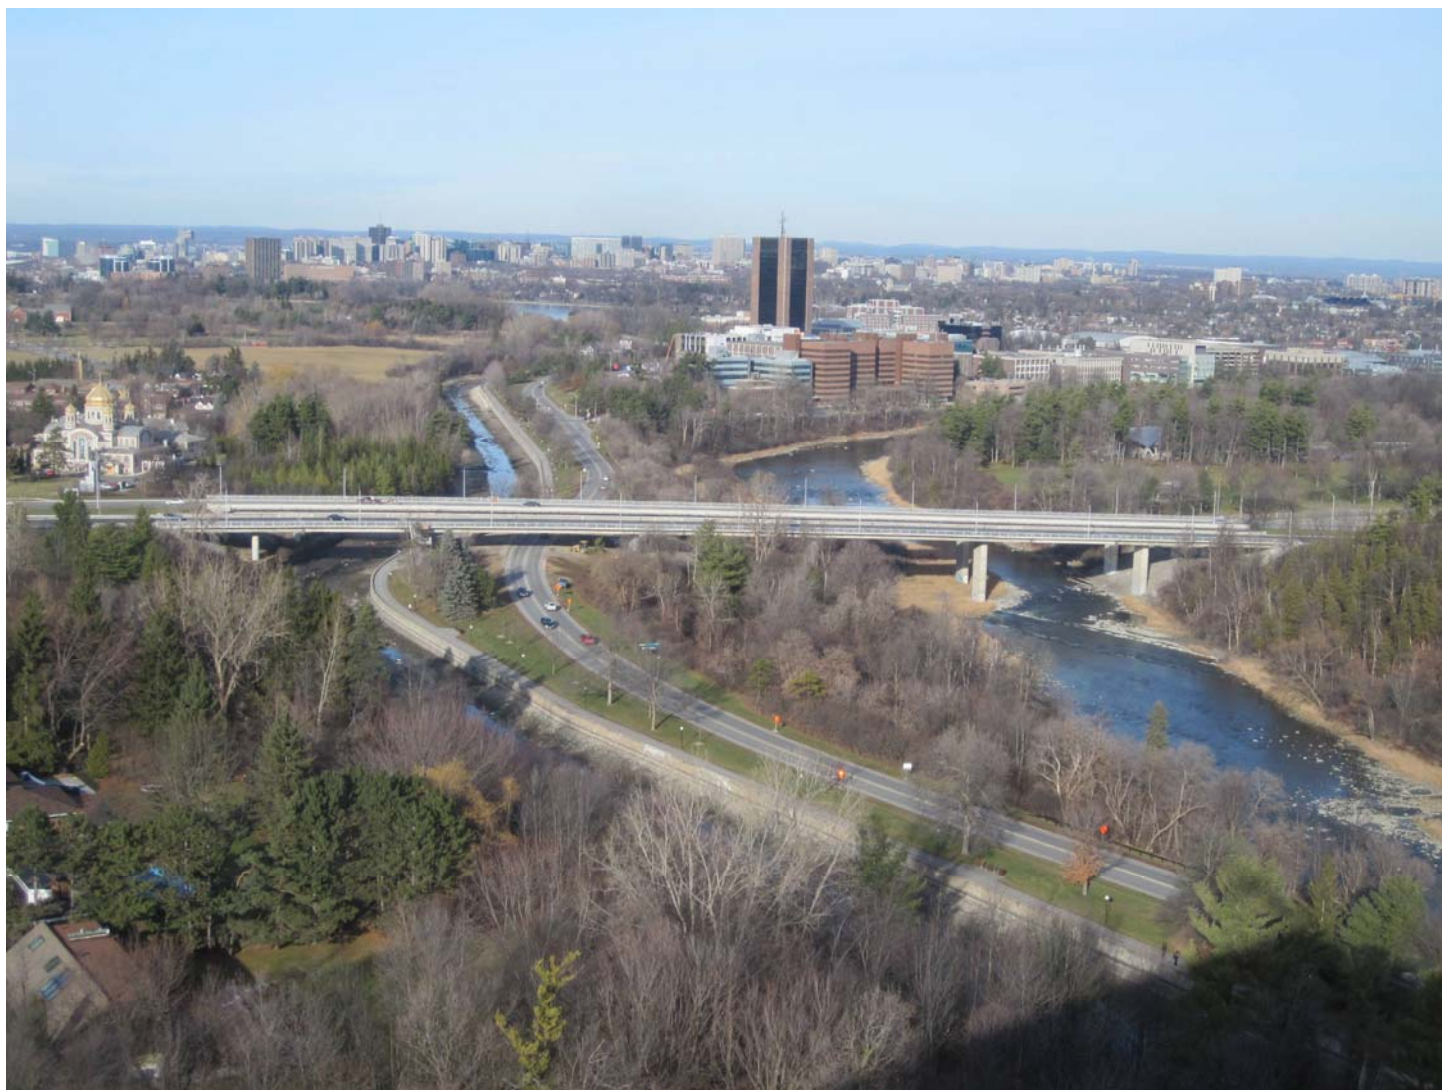
Overall view of the Heron Road Bridge

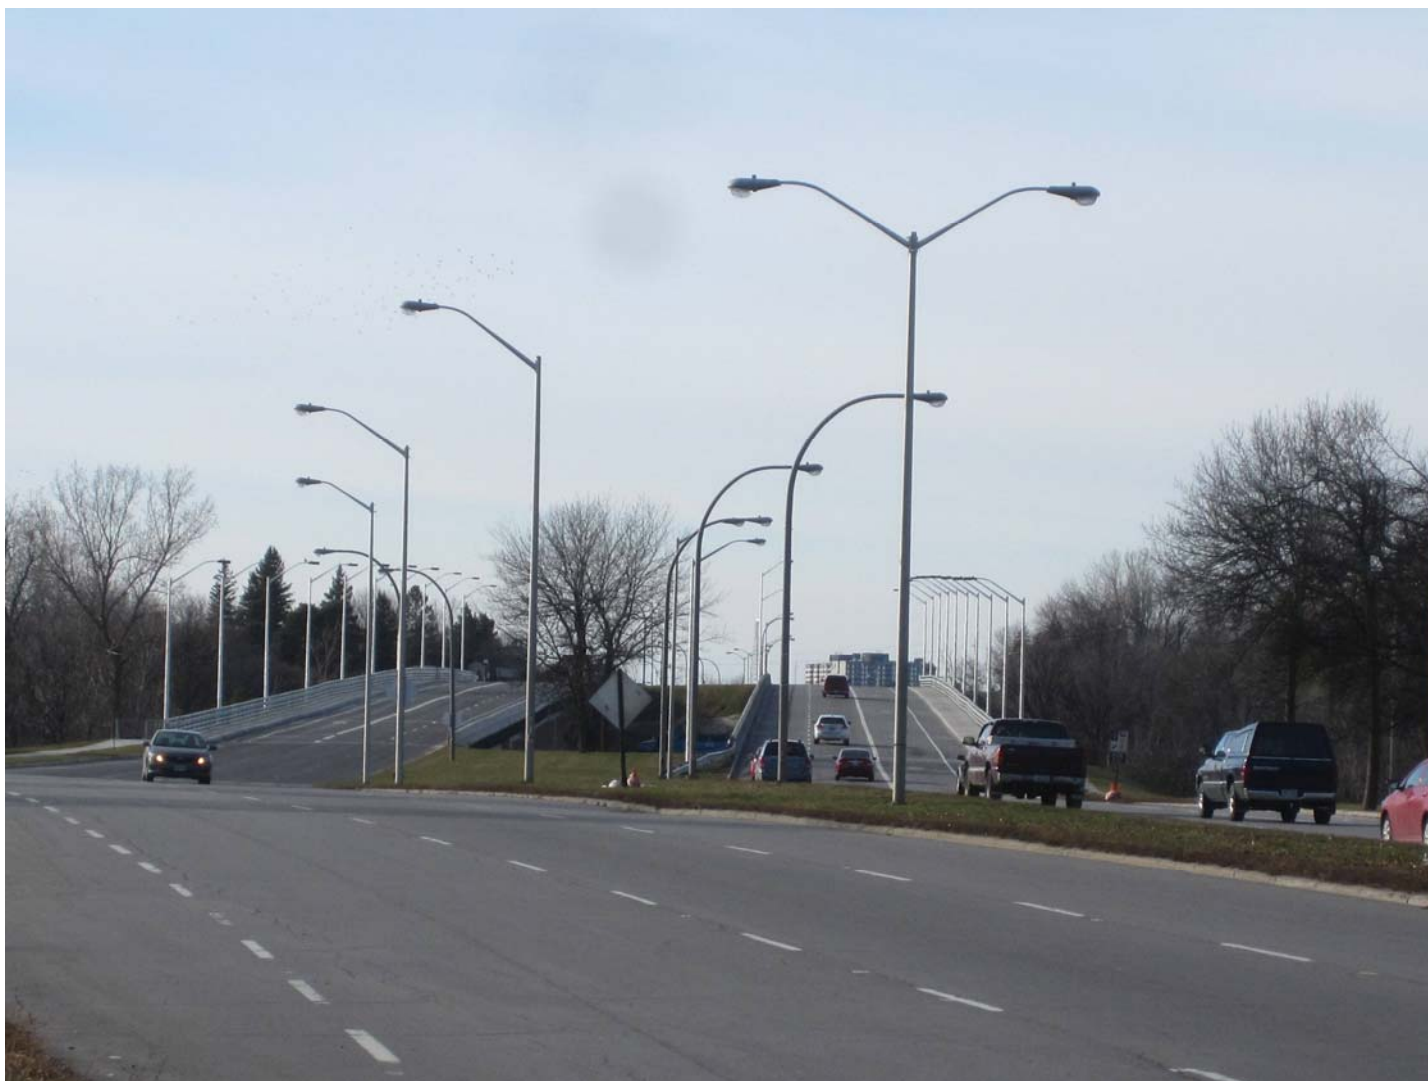
Twin structures each carrying two general purpose lanes, one bus-only lane, a bicycle lane and a sidewalk

- Changed roadway configuration from three general purpose lanes to two general purpose lanes, one reserved bus-only lane and added a cyclist lane.
- The pathway link to the adjacent Vincent Massey park was modified and relocated to meet the accessibility standards and provide a better connection to the park.
- Bicycle channels were introduced at the stairs connecting the bridge to the pathway along the Rideau Canal and Colonel By Drive to help cyclists with transporting the bicycles along the stairs.
- Cut-off lighting was used to prevent spillage into the Rideau River and Rideau Canal and thus protecting the natural environment off the structure.
- An open railing system that met the stringent crash testing requirements of the Canadian Highway Bridge Design Code while keeping the views open to the roadway users.

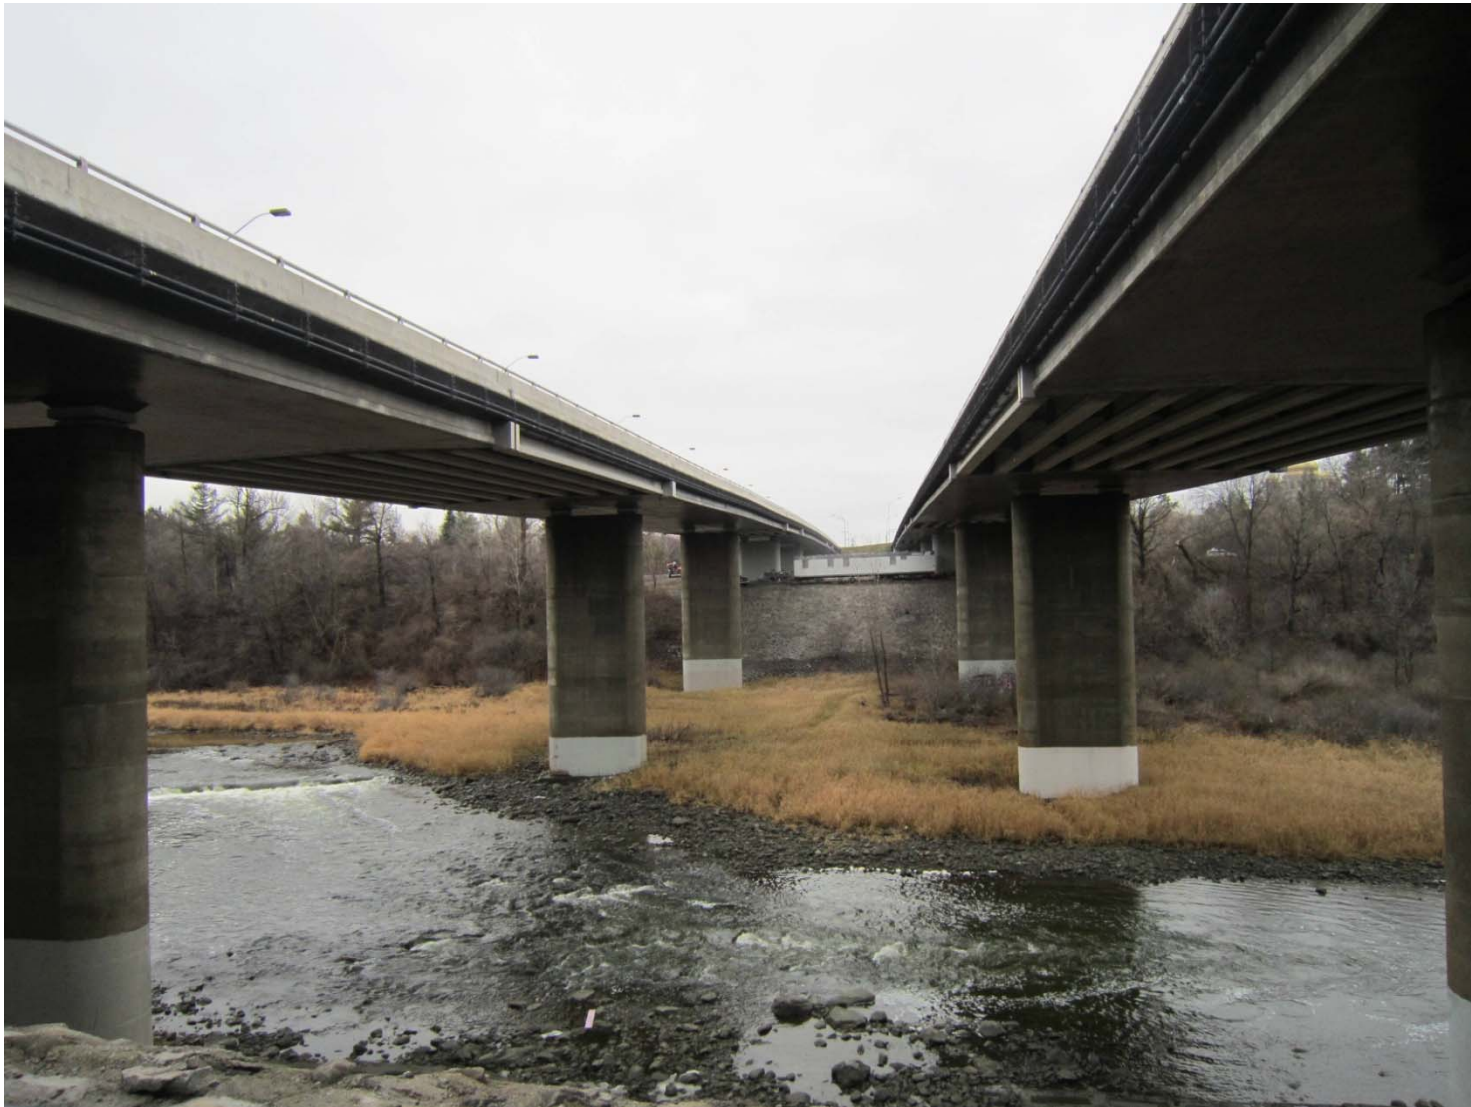
Overview of retrofitted bridge with new seismic isolation bearings and new external post-tensioning system

- Failed external post-tensioning system supporting the bearing seat of the suspended span requires replacement. This system was implemented to remedy a defect in the original design of the bridge and has previously failed at other locations before and was becoming a maintenance issue to the City of Ottawa. A new external post-tensioning system consisting of post-tensioning CFRP strips was implemented. The CFRP strips were stressed and glued with epoxy to the concrete corbel.

An external post-tensioning system was previously utilized at the end of the post-tensioned deck supporting the suspended spans. This system was installed to assist with crack control due to insufficient transverse reinforcement in the original design. However, this system failed at several locations and had already been fully replaced before. During the recent rehabilitation several replacement options were considered. Delcan made use of advancement in the CFRP technologies which included the development of an anchorage system that works with CFRP strips. The system has been used in numerous bridge rehabilitation projects in Europe but this was the first application of its kind in Canada. The design of this system was carried out in collaboration with Sika and VSL. The final product required much smaller anchorages than the existing system and the strips blend nicely with concrete surface and are hardly noticeably from a distance. The solution is therefore not only more durable, but it also significantly enhances the aesthetics of the bridge.

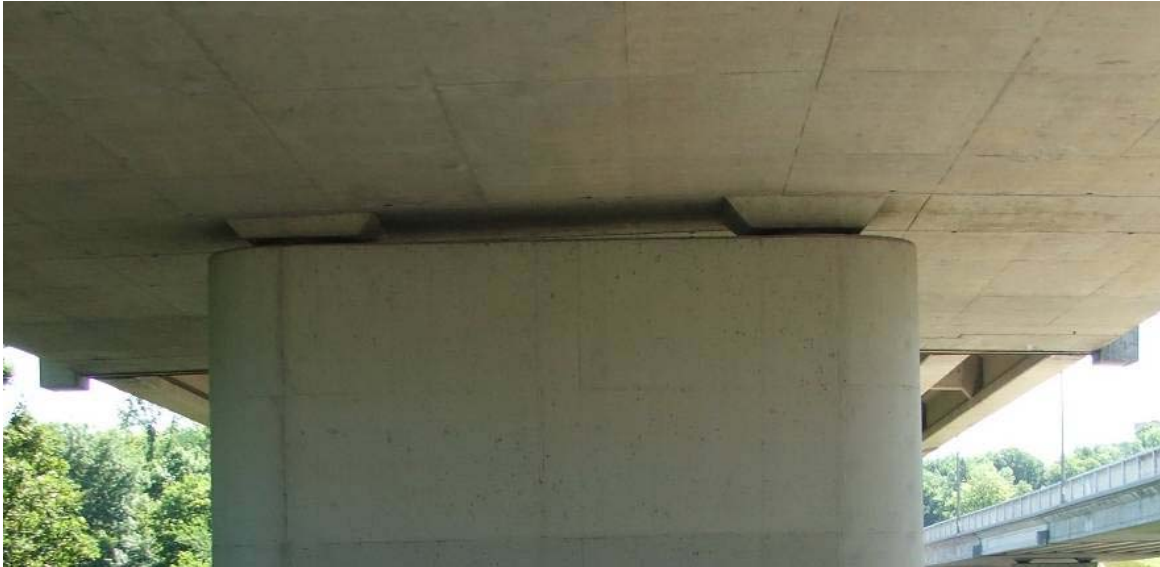
Existing bridge bearings

- Seismic evaluation revealed two major deficiencies with the structure including: inadequate piers, abutments, and associated bearings and foundations to transfer the seismic loads to the deep foundations and significant risk of unseating/collapse of the suspended spans under a seismic event. Two retrofitting schemes were considered for the piers and abutments including: brut force strengthening approach and the seismic isolation strategy. The strengthening approach involves strengthening the foundation, substructure elements and bearing replacement and would require significant in water works. The seismic isolation approach involves replacing the pier bearings with seismic isolation bearings and modifying the articulation at the abutment to accommodate the anticipated seismic movements. This retrofit scheme works by partly isolating the bridge deck from the ground motions induced by the seismic event, which would significantly reduce the loads experienced by the substructure members. The specialized isolation devices, used in such schemes, also help dampen the seismic energy, reduce seismic displacements and restore the bridge to its original location, following a seismic event. The seismic isolation approach was implemented for the Heron Road Bridge as it is the simplest and most cost effective solution.

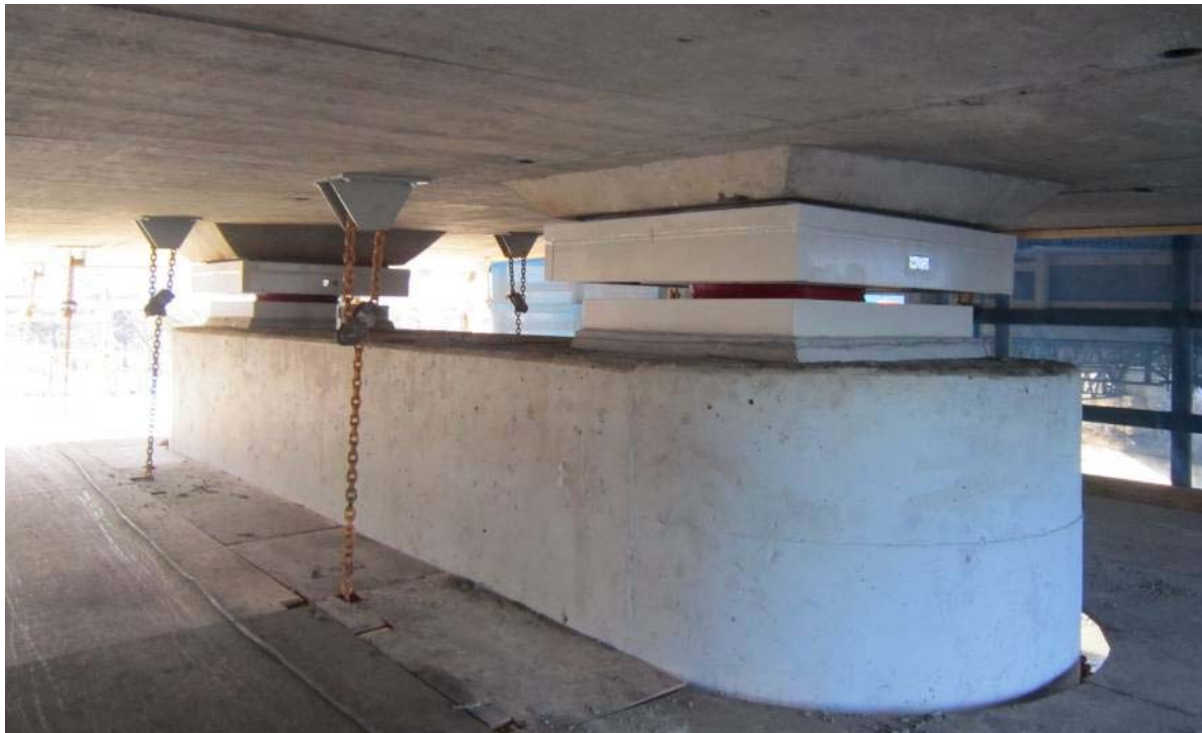
New seismic isolation bearings

- Modifications to the abutment articulation to accommodate the longitudinal and transverse seismic movements which are in the range of 80mm as well as uplift forces which could be experienced under certain live load patterns.
- Installation of the seismic isolation bearings required the jacking of the entire structure by about 250mm. This involved jacking the 8200 tonnes bridge at the piers and abutments by increments of 25mm from one end of the bridge to the other.
- The design of bumper restrainers which can accommodate the thermal movements of the structure and prevent the unseating of the suspended span during a seismic event.
