ENTRY SUBMISSION CHARLOTTETOWN **RUNWAY 10-28**

REHABILITATION APRIL 2013

Executive Summary

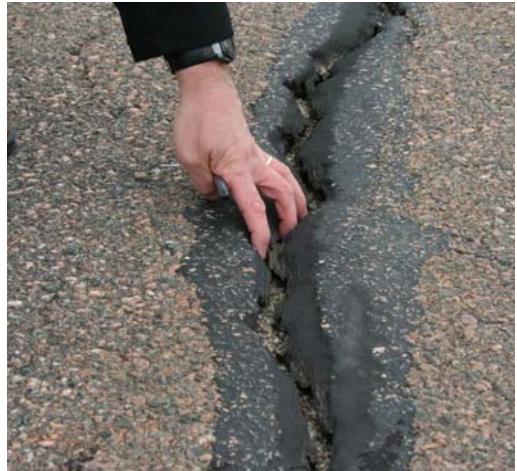
Transverse Cracking had occurred on the existing runway in several locations. It appeared that the runway had deteriorated over time due to thermal loading.

Runway 10-28, a 1524-m long and 60-m wide cross-wind runway had not received a major rehabilitation in its 27-year lifespan. The runway had deteriorated over time due to thermal loading. There were no signs of distortion, rutting or structural failure except at the intersection of the two runways which was in poor condition. It was also felt by some key stakeholders including Nav Canada that if Runway 10-28 was extended to 1829 m there could potentially be a shift of 40-50% in air traffic using the runway. However, the priority of the Charlottetown Airport Authority was to rehabilitate the existing runway and the budget was not available to extend it.

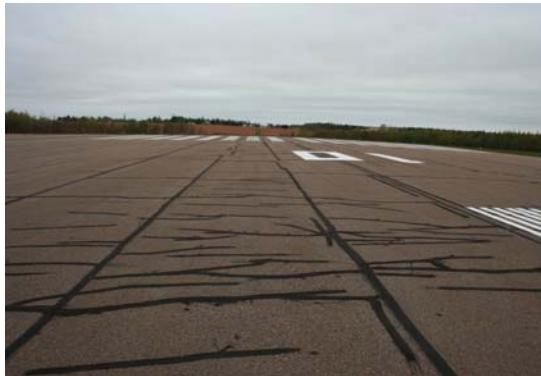
Longitudinal, transverse and joint cracking were prevalent on the pre-existing runway

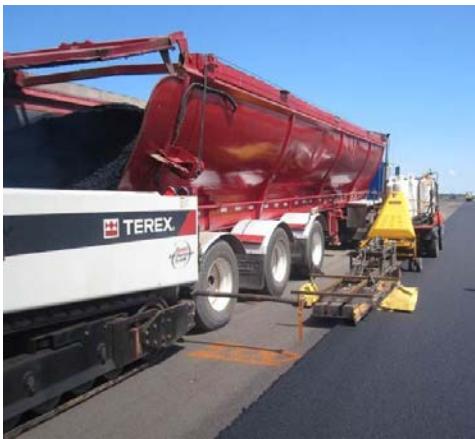
Paving was completed using asphalt joint heater. The paving schedule was in jeopardy when rain occurred during confined window for construction. A portable heater borrowed from a nearby ice arena helped to dry materials so paving could proceed as planned.

Paving at the intersection of the two runways that service the airport was coordinated with airport management to minimize interference with air traffic. Work was completed at specific time periods around the clock over three days. No large planes could land during this period, meaning that an extension of this period would result in air traffic scheduling issues and revenue loss to the Airport. The final paving of the intersection was to take place between midnight and 7:00am on September 6, 2012. Rain during this paving event threatened to cause delays in completing the asphalt seal coat due to wet conditions. To prevent delay and Airport revenue losses, a portable heater was borrowed from a nearby ice arena and used to dry the base asphalt surface, thus allowing paving to continue as scheduled.

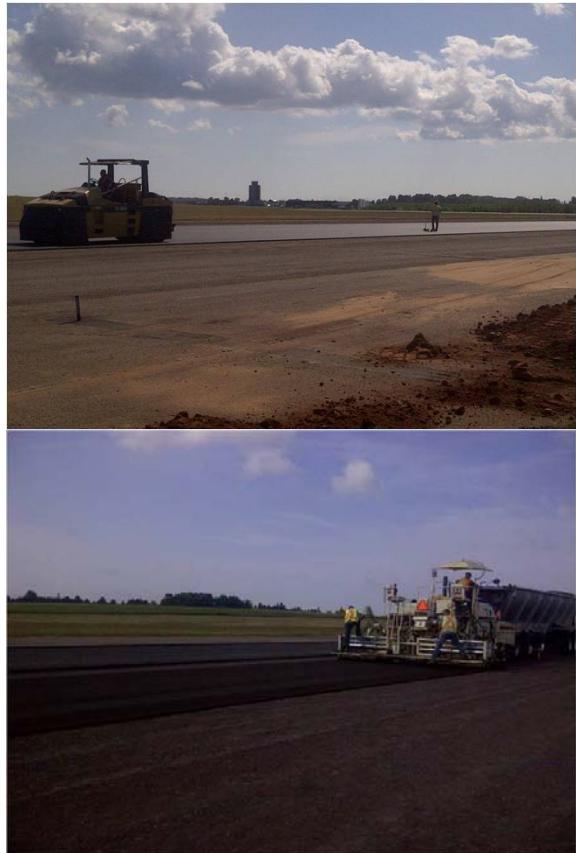
The recycled asphalt millings were spread onto the pre-compacted rough aggregate base. The millings were then compacted onto the aggregate base following application

Due to uneven thickness of the asphalt on the existing runway in the center 30-m wide section, portions of the base gravel surface were disturbed during milling. As a result of this issue, and in combination with larger than expected and surficial aggregate separation, the exposed granular material was not suitable for direct application of the planned asphalt base. To prevent the need to remove and replace the base aggregate HMM devices a plan to reuse the asphalt millings to prepare the surface for asphalt placement, which minimized delays and controlled project costs. It is estimated that if this alternate method had not been applied,

the project would have been delayed two weeks and project costs would have increased by approximately \$300,000.

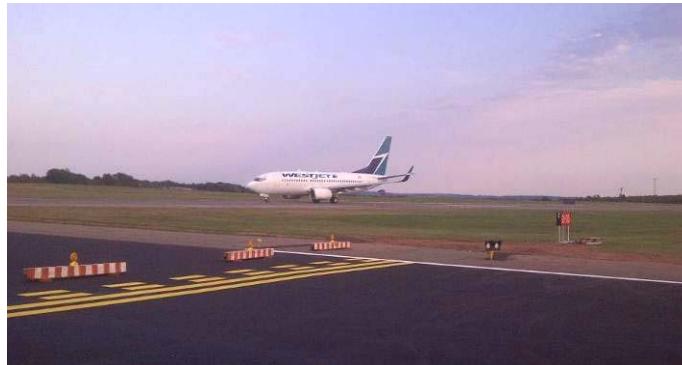
Construction on Runway 10-28 was not allowed to impact air traffic operations on the primary runway except during the work at the intersection of runways, during which air traffic was limited to smaller aircraft.

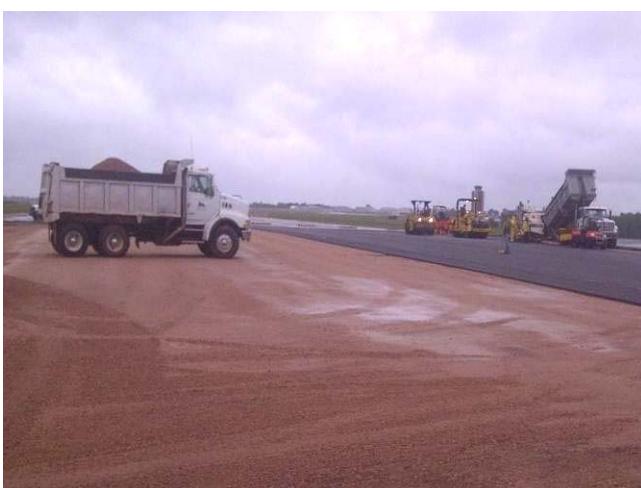
Multiple crews and equipment from the local contractor were working at any given time in order to keep the tight construction schedule.

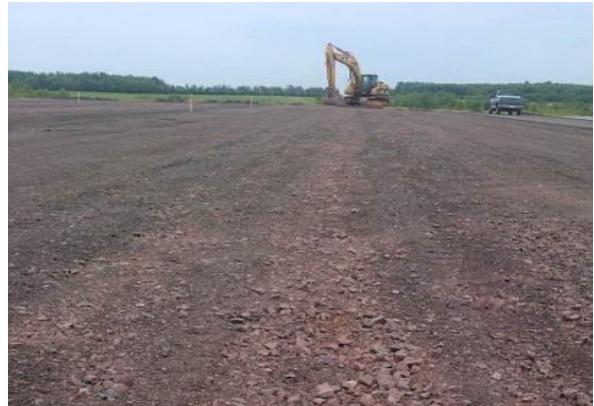
The base aggregate following the milling of the existing asphalt surface. Innovation to handle the poor gradation and surficial aggregation saved not only budget and schedule but the carbon emissions that would be caused from additional hauling and equipment operations.

The use of recycled asphalt millings instead of additional work of removing and replacing granular material not only saved time and budget but also reduced the overall carbon footprint of the project. It is estimated this innovation saved approximately two weeks of construction activity and the associated carbon emissions associated with the additional construction activity. Since the granular material required would need to be brought in from off the island, the impact of hauling the needed material would be greater and would have also involved barges.

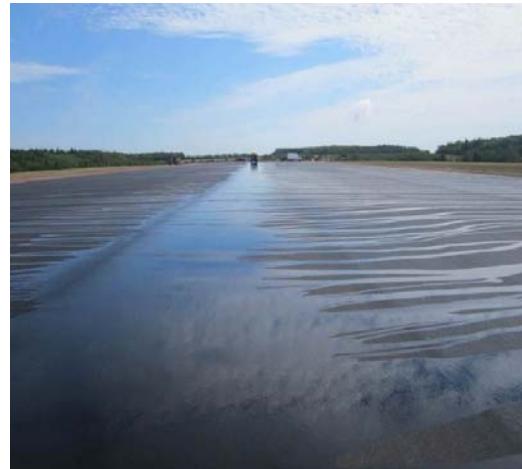
At the end of the project, flood tests were conducted to identify any ponding areas. The project went very smoothly and was completed on budget and on schedule.
