CANADIAN CONSULTING ENGINEERING AWARDS

COLOMAC MINE REMEDIATION

ENVIRONMENT

APRIL 2013

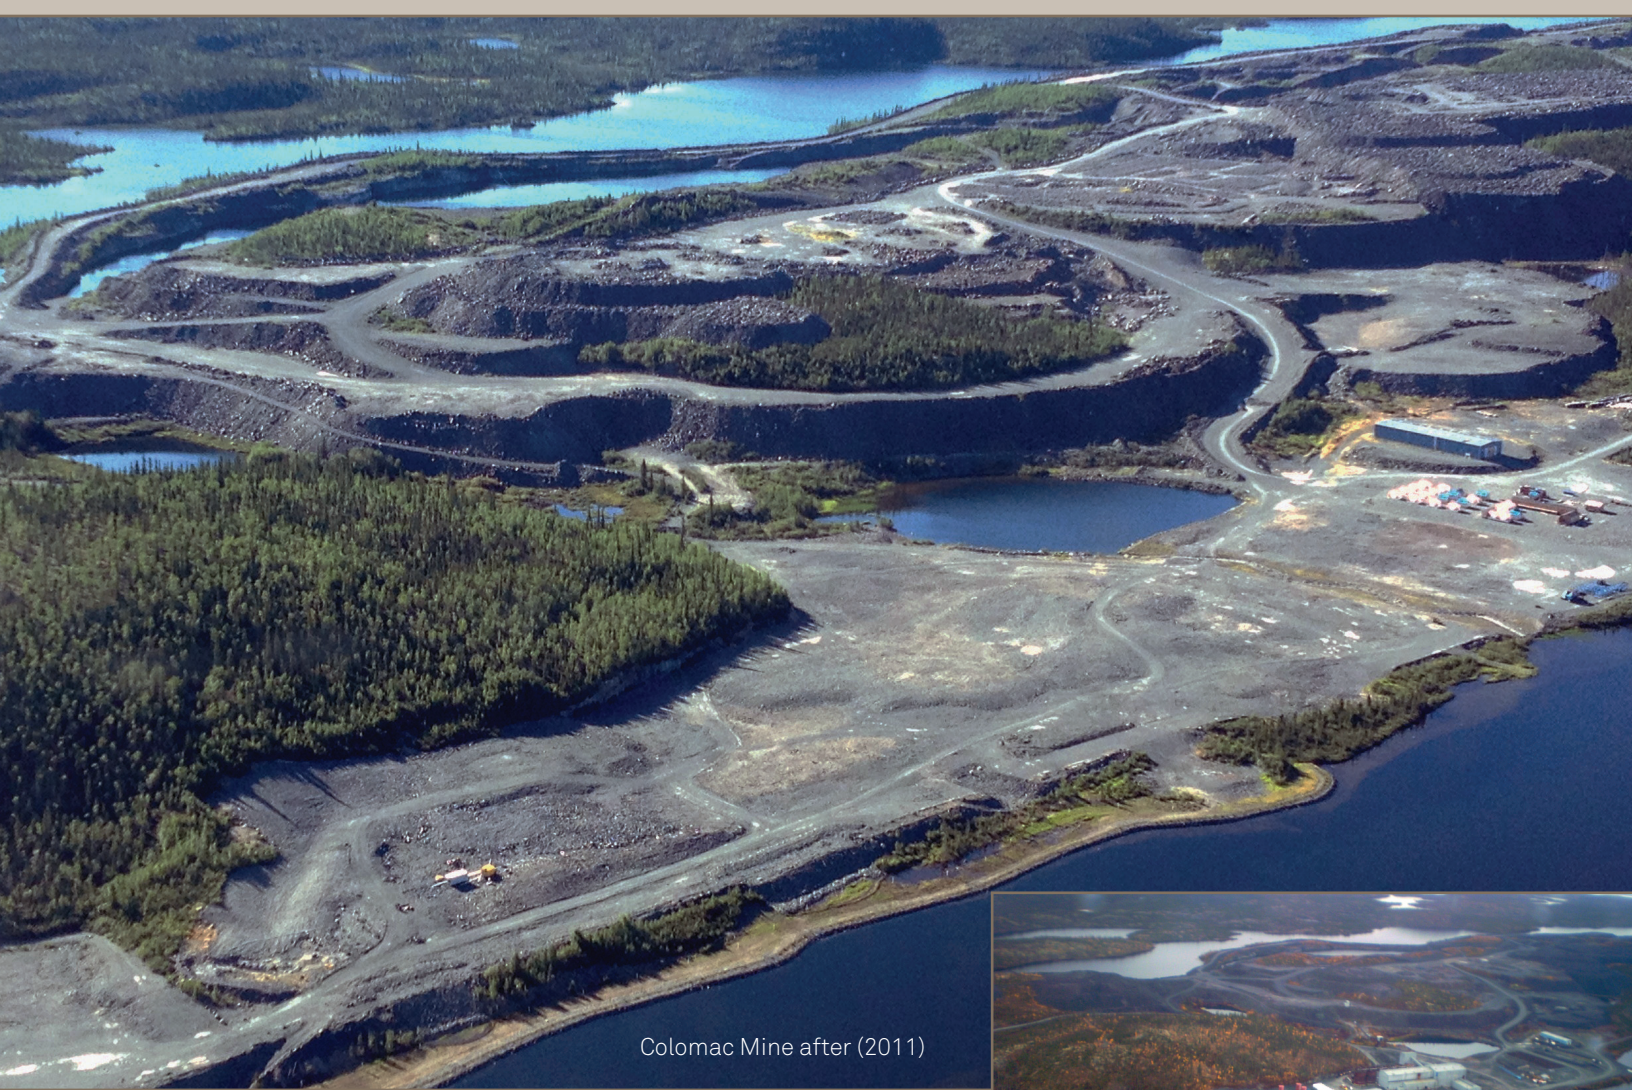
Colomac Mine after (2011)

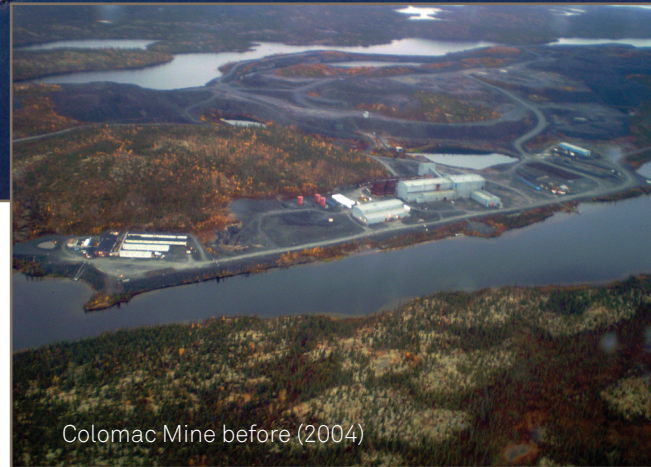
Colomac Mine before (2004)

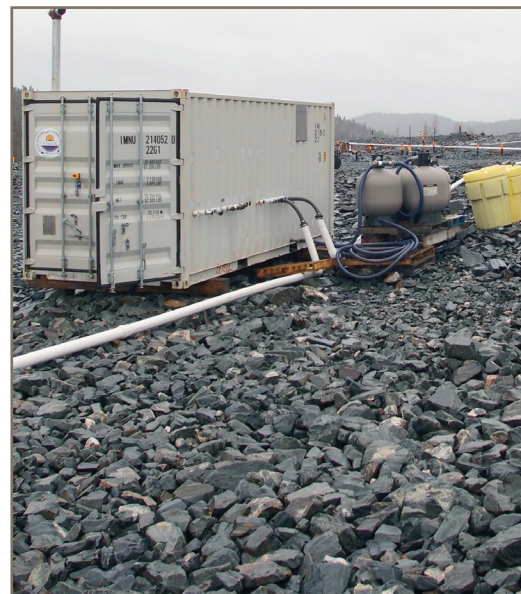
Multi-Phase Extraction System

Over 17,000 m³ of soil and overburden contaminated with petroleum hydrocarbons was excavated and treated in a landfarm on site. Free product within the fractured bedrock was extracted via monitoring/recovery wells using a Multi-Phase Extraction (MPE) system. Free product migrating out of the bedrock fractures at known seep areas on the shoreline of Steeves Lake was captured in two constructed seepage collection systems. A trench filled with peat was created along the shoreline to trap and attenuate free product and impacted water not controlled by the seepage collection systems.

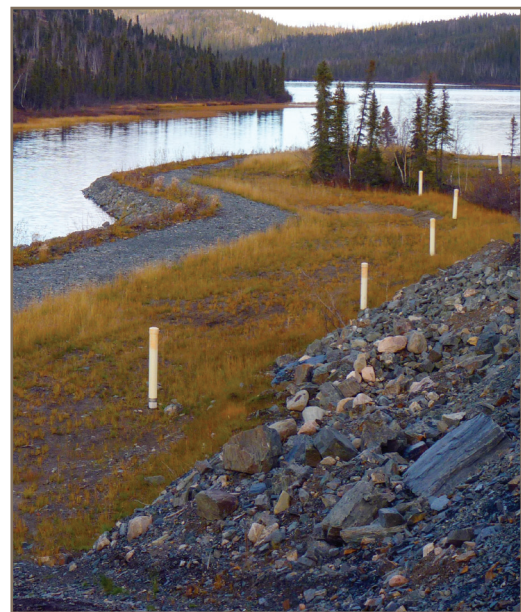
Steeves Lake Sediment Cap

Building upon a challenging remedial concept, AECOM designed an innovative 750 m long cap for hydrocarbon contaminated lake sediments using only on-site materials and requiring no dewatering of the laterally extensive and deep water work area. Coarse-grained waste rock was used to build the new erosion resistant shoreline, serve as a causeway during construction, provide filtration to finer grained capping material deposited on the inshore side, and provide shade and shelter for fish. Contaminated sediments were capped with a mix of native low-permeability silt till and peat to provide adsorption and increased attenuation. A trench was cut into the perimeter berm, filled with peat and silt till, and planted with locally sourced willow stakes and alder seeds to create natural erosion control and improve the new shoreline for fish habitat. The cap was finished with the placement of a surface layer of peat and seeded with natural grasses and alder seeds. In total, the construction of the sediment cap required 6,700 m³ of natural silty till, 3,500 m³ of natural peat, 22,000m³ of rock fill and over 6,500 m³ of geotextile.

“In total, the construction of the sediment cap required 6,700 m³ of natural silty till, 3,500 m³ of natural peat, 22,000m³ of rock fill and over 6,500 m³ of geotextile.”

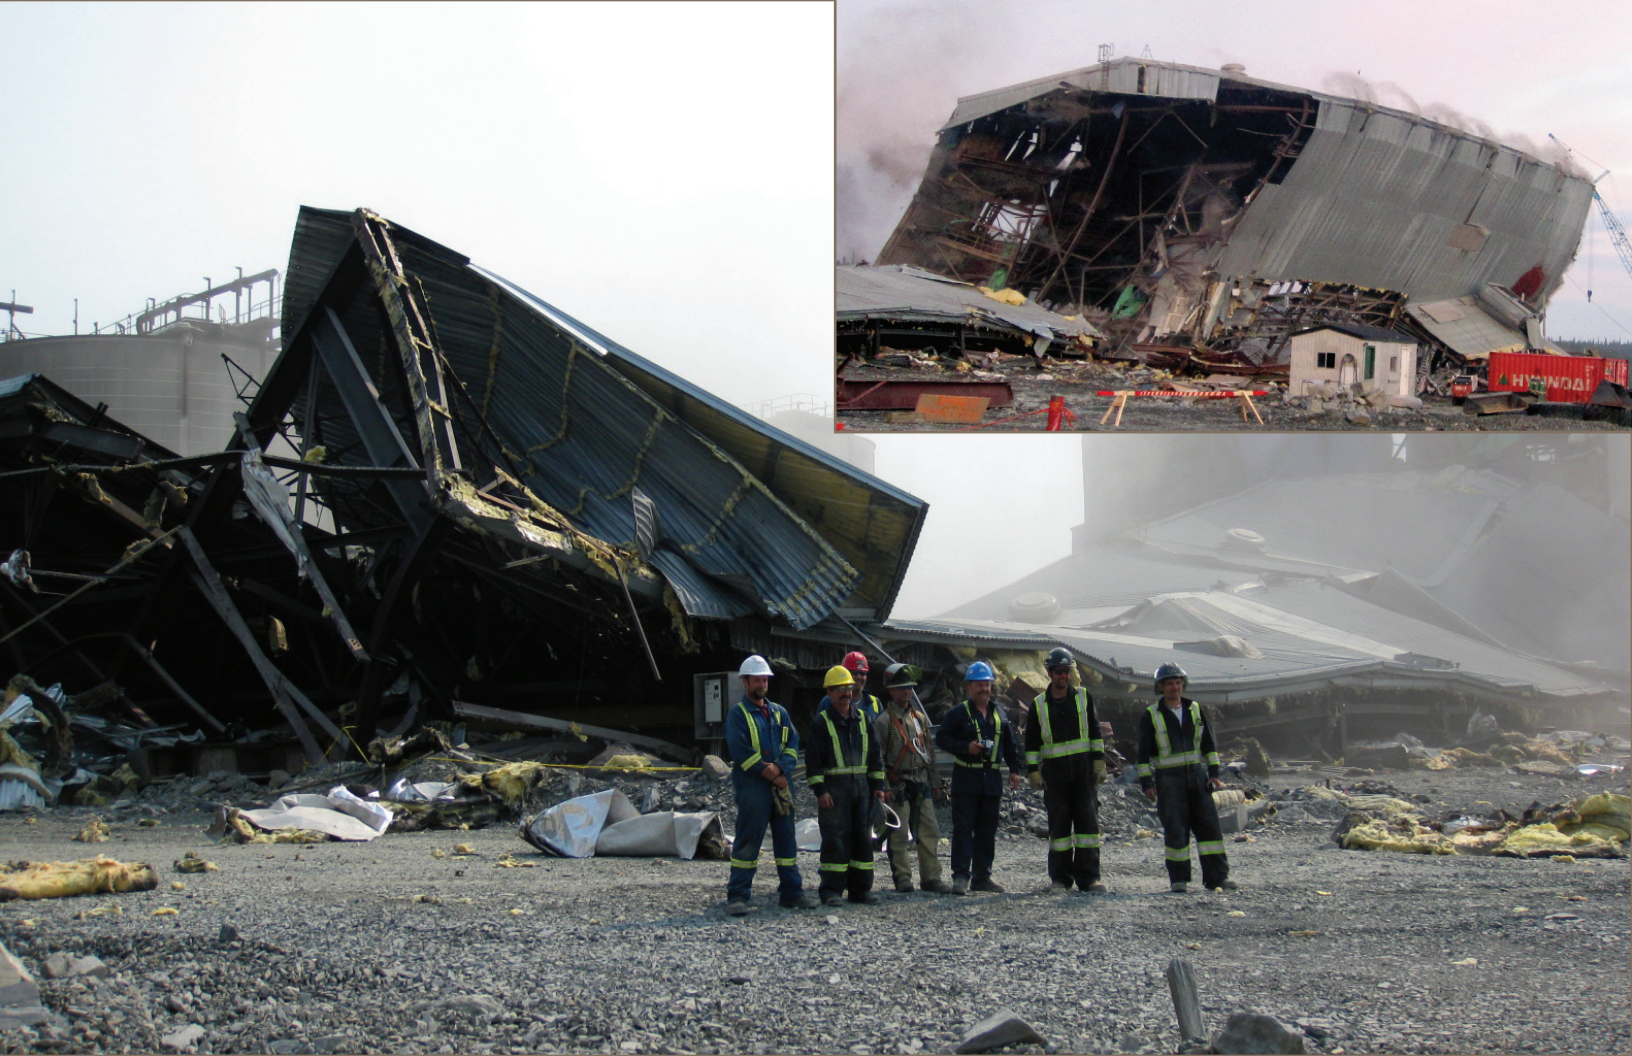
Demolition Team (main)
Demolition of Main Mine Complex (inset)

In total, four large buildings, a camp complex, five above ground conveyors, two underground conveyors, 21 large tanks and all related infrastructure was demolished. Prior to demolition, each building was assessed for hazardous materials and then decontaminated. Cyanide contaminated dust was prevalent in many of the on-site buildings and extensive decontamination work was completed to eliminate the hazard to site workers and to the environment. Removal of the cyanide contaminated dust had to be completed without allowing the dust to come into contact with water, as cyanide gas would have been created. The dust was removed by large vacuums with HEPA filters.

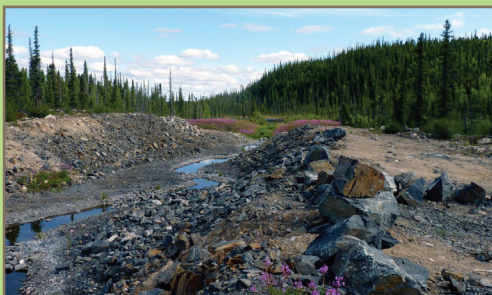
Tailings Lake Discharge Channel

The discharge channel, a wide flat channel, was previously completed to allow passive drainage from Tailings Lake to L-Shaped Lake but was not amenable to fish passage. The channel was improved by adding a terraced section to the channel base to create a small meandering stream suitable for fish passage and lowering grades in areas of hydraulic drops.

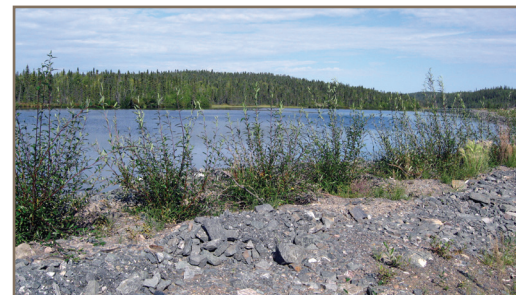
Successful growth of willow stakes

Re-vegetation was completed along shorelines and channel banks to create riparian zones to enhance fish habitat by providing shade cover and temperature control for the near-shore water, and by reducing surface runoff and erosion. Sedge plugs, willow cuttings and alder seeds harvested from the site with a commercially produced grass seed mix containing species native to the area, were used for the re-vegetation.

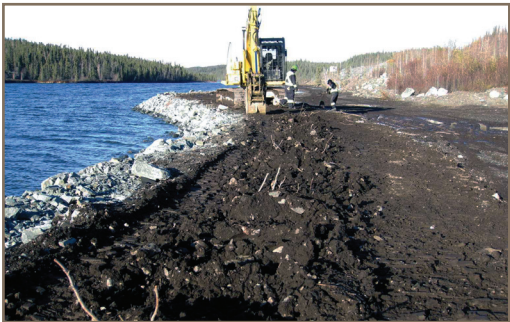
Newly planted willow stakes along Steeves Lake new shore

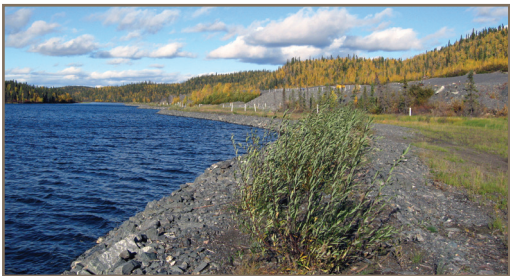
Successful growth of willow stakes

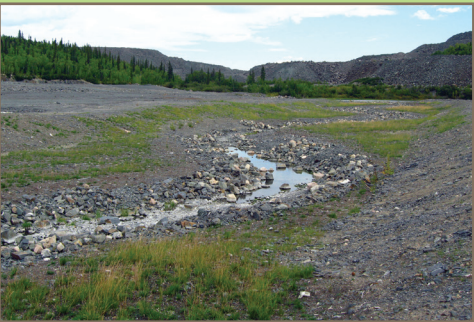
Truck Lake to Steeves Lake Channel

The channel, completed to restore drainage and fish passage between Truck Lake and Steeves Lake, consisted of a seasonally flooded wetland on the shore of Truck Lake that fed into a constructed shallow meandering stream cut into a wide channel. The stream section was designed to allow for fish passage during times of high water.

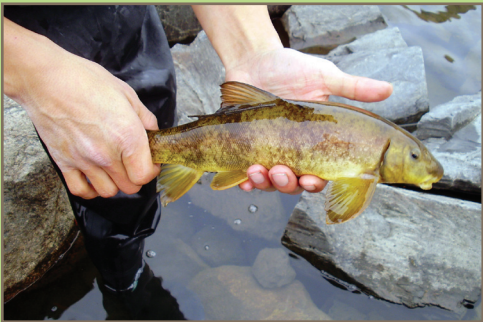
Whitefish relocated from active work area

Following the installation of the silt curtains in several water bodies, an AECOM Fisheries Biologist was brought to site to develop and implement fish salvage procedures to remove fish from areas of in-water works. Due to the unique size and location of each isolated area, various salvage techniques were used. Techniques included angling, electrofishing, use of seine, drag and fyke (hoop) nets and use of a minnow trap. In addition, the biologist developed a plan for on-going water quality monitoring of the work areas. The biologist trained Tlichio employees to complete the water quality monitoring and to provide assistance during salvage activities.

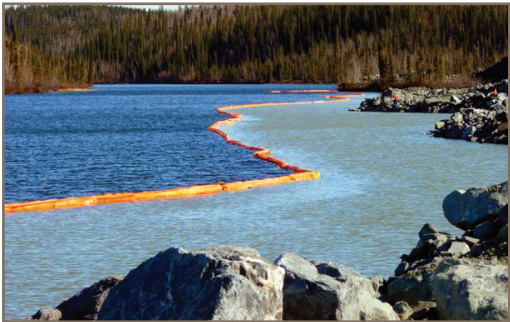
Effective containment of turbidity caused by construction activities

During the completion of the drainage restoration works and the installation of the Steeves Lake sediment cap, measures were put in place to protect the water quality and aquatic habitat in and near the work areas. Completion of the drainage channels and the cap involved both the excavation and placement of granular material which resulted in increased turbidity and sedimentation in the water. To mitigate the risk to aquatic life and habitat, erosion and sedimentation control measures were implemented such as silt fences, sediment traps and impermeable silt curtains.

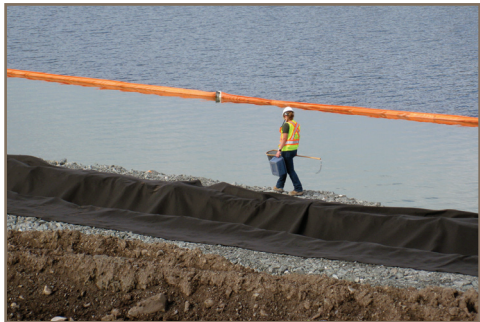
Daily monitoring of Steeves Lake

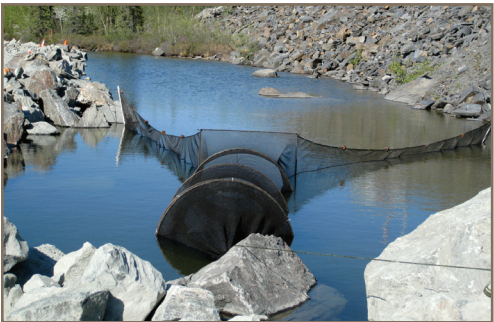
Use of hoop nets in Steeves Lake

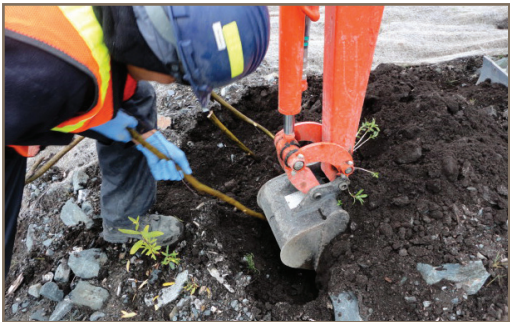
Planting of live willow stakes

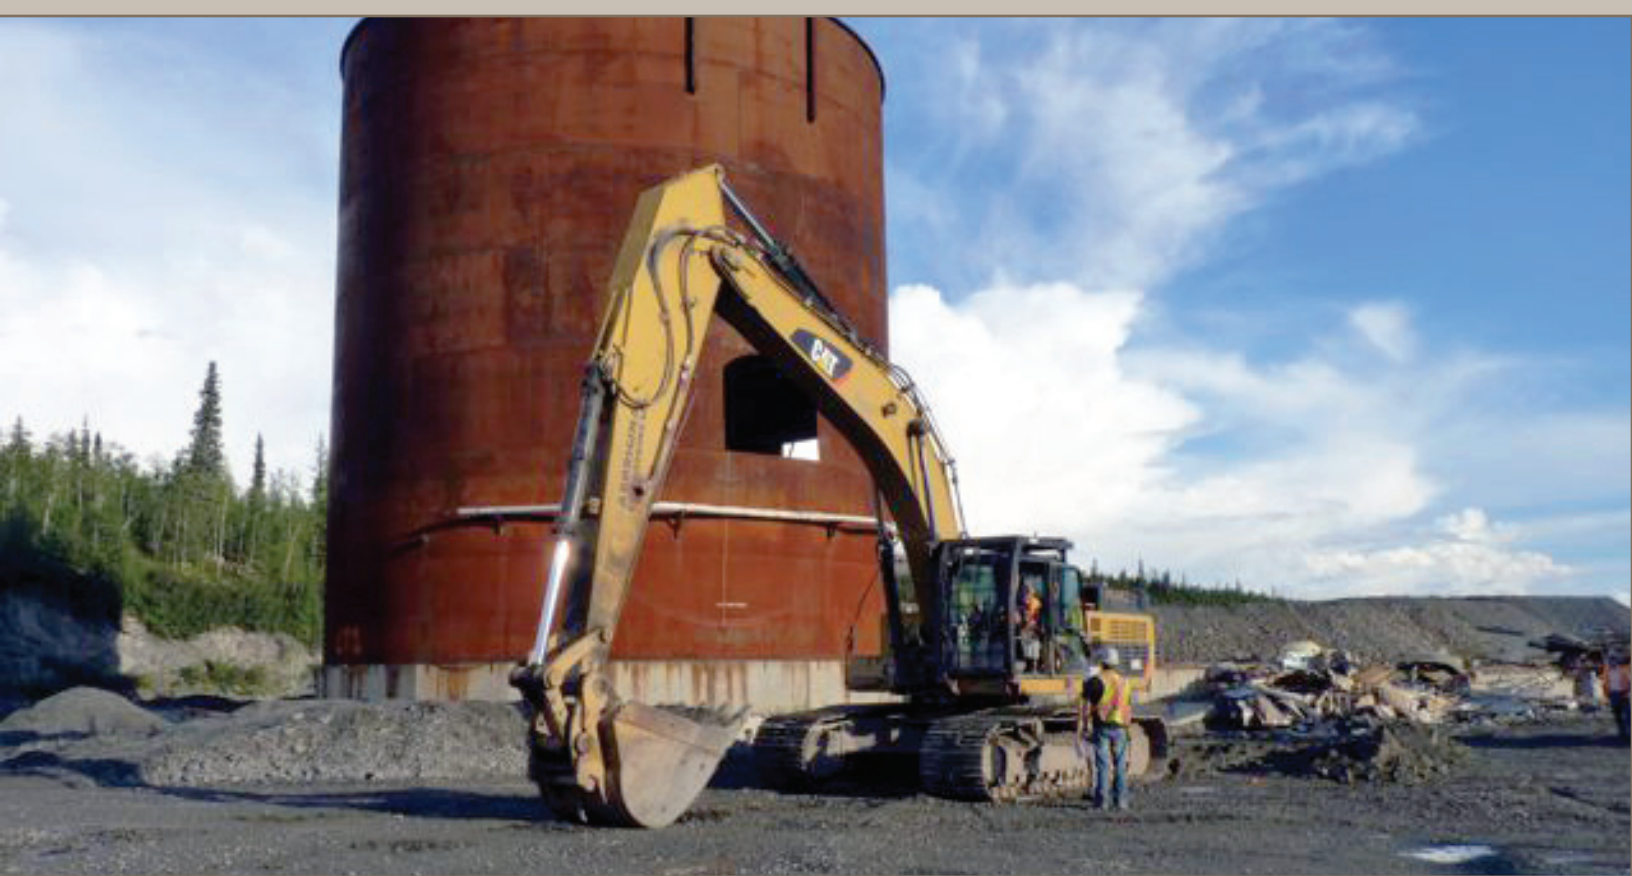
One of twelve leach tanks requiring decontamination

Twelve leach tanks were located outside the mill as part of the cyanide leaching process and each tank contained solid tailings and ice to be removed as part of the decontamination process prior to demolition. The contents of each tank were to be removed in a solid state and disposed of in a disposal cell for tailings contaminated waste. At the start of the remediation it was identified that the liquid within the leach tanks was not frozen and would have to be removed. The liquids were sampled and based on the analytical results, detailed contaminant loading mass balance calculations were completed for Zone 2.0 Pit, a large water-filled pit created by the ore mining process. It was determined that the release of water into the pit would not be detrimental, and 7,750,000 litres of water was released into the pit via a bed of corrugated steel pipe, salvaged from a demolished building, to provide aeration, slow the water velocity and remove suspended sediments. The leach tank liquids were successfully pumped into the pit with very little disturbance to the receiving water and the solid contents of the tanks were able to be removed and hauled with trucks to the disposal cell.

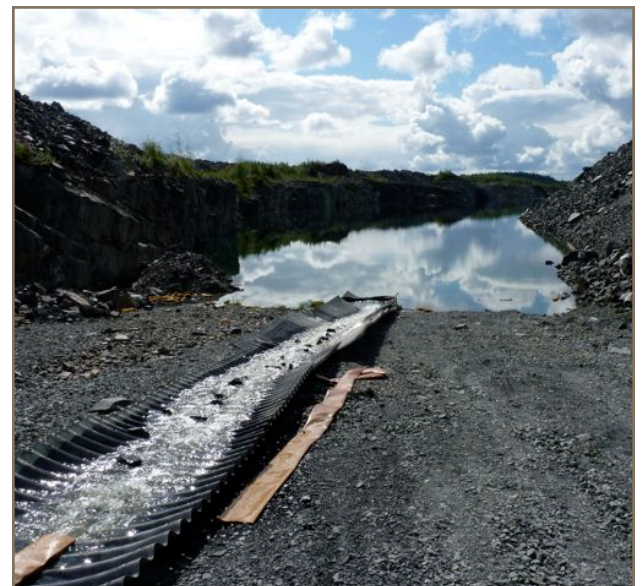
Corrugated steel pipe used to aerate discharging water in zone 2.0 pit

“The leach tank liquids were successfully pumped into the pit with very little disturbance to the receiving water...”

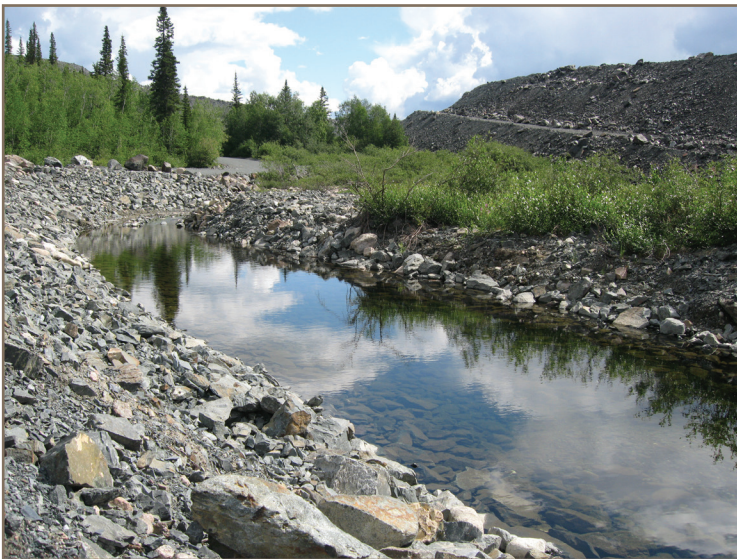
Extension of Spot Pond

Natural drainage conditions between Spot Pond and Truck Lake were severely altered during mine operations by placement of a mine access road over an existing creek that connected two water bodies. The existing creek was identified for completion of a drainage restoration consisting of an extension of the Spot Pond to enhance the connection to the channel, removal of the road base and reduction of the overall grade of the creek to facilitate fish passage. During excavation of the Spot Pond extension and road removal, a significant amount of subsurface flow was noted through the side walls of the excavation. The subsurface flow caused significant erosion and a substantial reduction in the water levels in Spot Pond. Following completion of the road removal, it was clear that the hydraulic grades that existed prior to the mine development could no longer be maintained with an open channel. An AECOM hydrotechnical engineer was brought to site to assess the drainage channel and develop a long term control for the channel discharge. A plug-like dam, to be placed in the location of the former road bed, was designed and constructed from granular material salvaged from the interior of the concrete footings in the mill and polypropylene geomembrane liner left over from other site activities. Following installation of the plug, the water levels in Spot Pond rose to pre-construction levels and erosion was no longer observed along the walls of the Spot Pond extension.

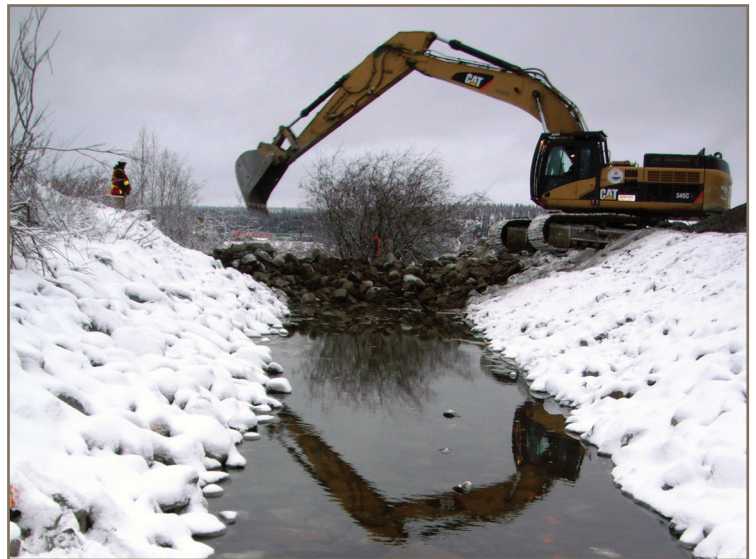
Installation of the dam in the Spot Pond to Truck Lake Drainage Channel

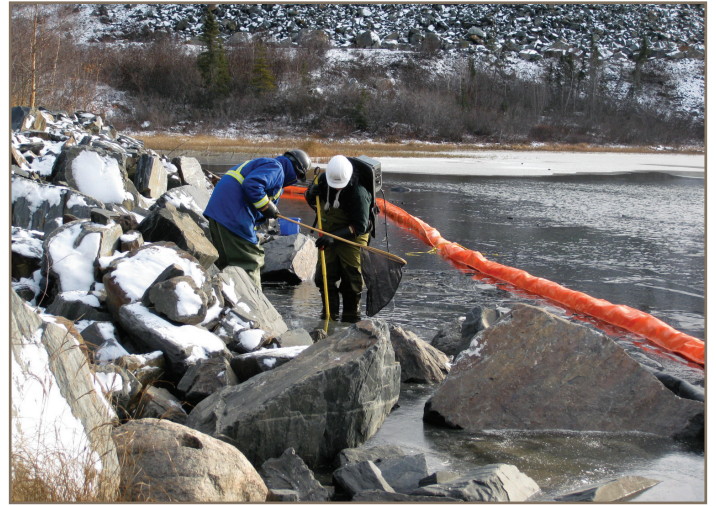
Fish salvage in winter conditions
