The 2013 Canadian Consulting Engineering Award Nomination of:

# THE CHARLOTTETOWN CONVENTION CENTRE FOUNDATION AND SEAWALL

By: Eastpoint Engineering Limited

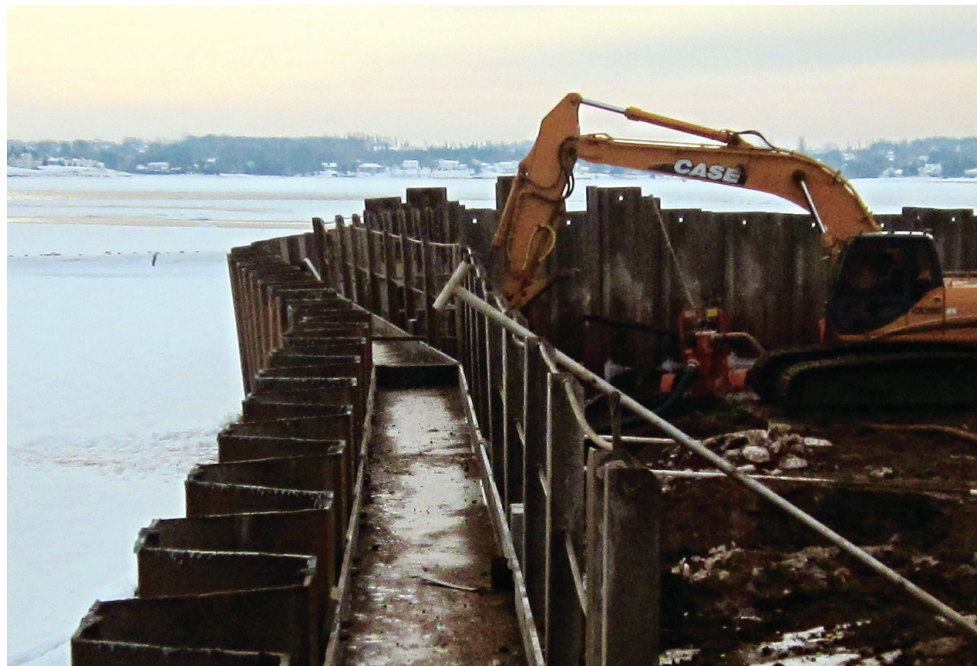
With the remediated site soils providing a platform from which to work the second phase of the project began, the straightening of the SSP seawall. While the toe of the SSP seawall remained in its original position the seawall failure consisted of a “fanning” of the top of the SSP wall, leaning outward into the harbour. Straightening of the SSP seawall was viewed as an option which was more cost effective and could be more rapidly executed, rather than the removal and re-driving or replacement of the seawall.

Charlottetown Convention Centre Site : Seawall Fanning

Since the SSP wall had experienced a “fan” like distortion, it was necessary for a straightening process to exert a uniformly distributed load along the face of the wall in order to cause the wall to return to its original vertical position without kinking. A number of options were considered to accomplish this, involving the pulling of the wall from the landward side into a straight line. Because of the difficulties involved on the site in achieving both uniform load and sufficient pressure to return the wall to its original constructed position, a unique and novel approach was selected. This approach involved using the hydrostatic pressure exerted on the wall during tidal cycles.

On a rising tide the excavation behind the SSP seawall was carried out using an excavator working from the stabilized soils. The material immediately behind the wall was removed to the required depth and back far enough from the “fanned” position so, when the tide rose, the hydrostatic forces exerted a uniform load on the wall and returned it to a vertical position. At this stage the wall was anchored in the new position and this length of SSP seawall was secured with tie rods and anchor blocks.

Using nature’s tidal force, the “fanned” section of seawall was returned to its original position and anchored to a newly constructed tie back mechanism consisting of a series of concrete anchors installed across the site and buried in the backfill. This remedial work placed the seawall in a position from which completion of the structural infill could be undertaken.

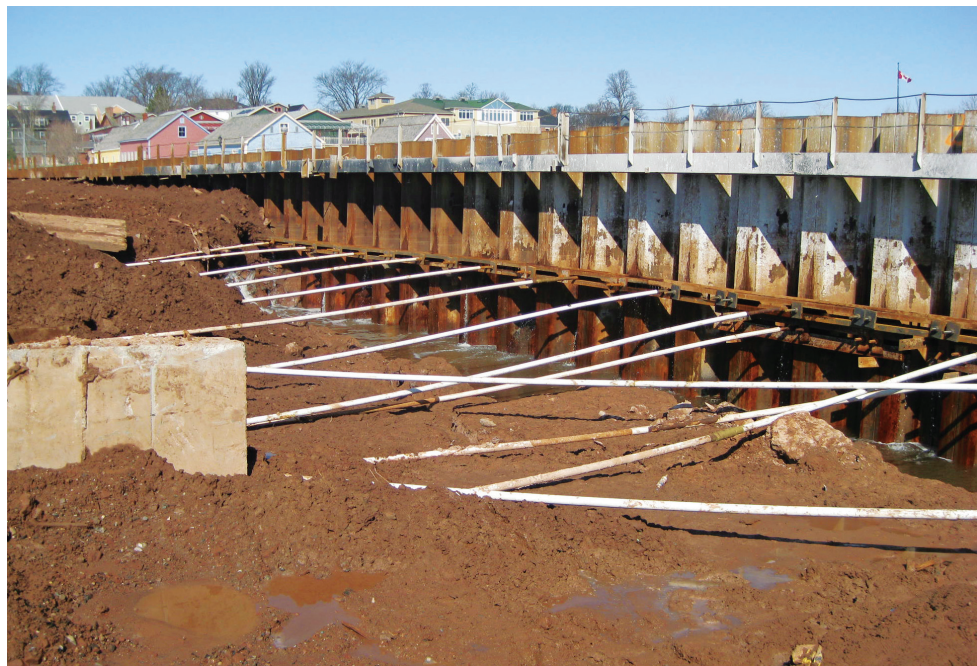
Prior to the wall straightening the areas of wall that were not affected by the failure were anchored so they would not be affected by the straightening process. This anchoring consisted of the installation of tie rods and concrete anchor blocks. This step ensured that the unaffected areas of the SSP seawall remained vertically plumb during the straightening efforts.

Charlottetown Convention Centre Site : Steel Sheet Pile and Seawall Tiebacks
