# COMPOSITE BARRIER WALL ROCKSHED STRUCTURE MILE 109, CN ASHCROFT SUBDIVISION, BC

#### EMIL ANDERSON CONSTRUCTION INC.

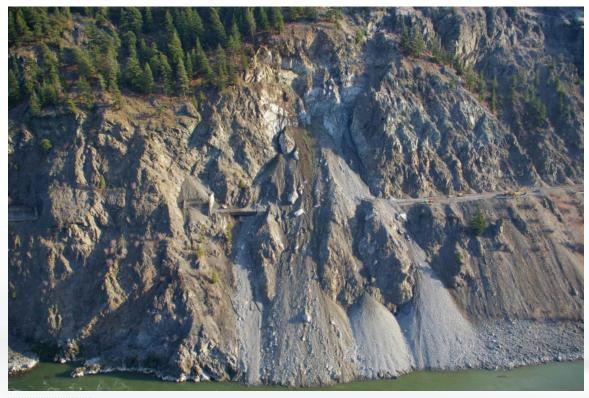
LANDSLIDE 53,000 m<sup>3</sup> rock landslide on November 25<sup>th</sup>, 2012

On November 25<sup>th</sup>, 2012 a 53,000 m<sup>3</sup> rock landslide occurred along the Canadian National Railway (CN) track, at Mile 109.43, between Lytton and Boston Bar, British Columbia. The slide debris covered 70 m of track with debris up to 10 m deep and destroyed a 21 m long concrete rock shed, causing a 4-day service disruption.

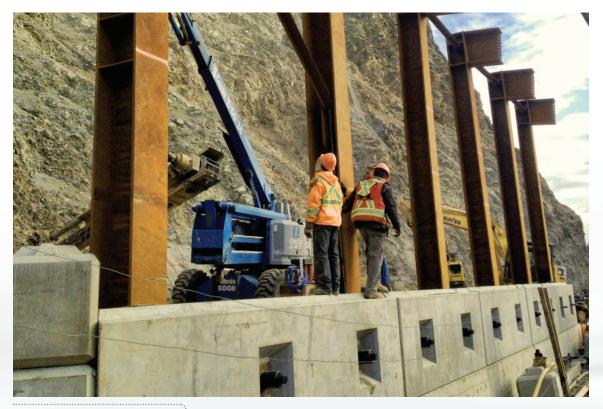
MODULAR CONCRETE COMPONENTS

First row of modular pre-cast concrete panels tied back to the bedrock with rock anchors

One of the challenges of the construction of this composite structure along the operating railway was to deal with the ongoing train traffic. KCB's innovative design solution was to use modular components, including the retaining wall, rock shed concrete roof panels and rock shed footings, which could be pre-cast and transported to the site. The structure consists of pre-cast concrete footings, steel frames and concrete roof panels. On the down-slope side of the structure the concrete footings were attached to micropiles which extended down through the talus and heavily fractured bedrock. The retaining wall and shed components are independent; rockslide impact forces on the wall are not transferred to the shed. This design methodology for landslide protection structures is transferrable to other sites.

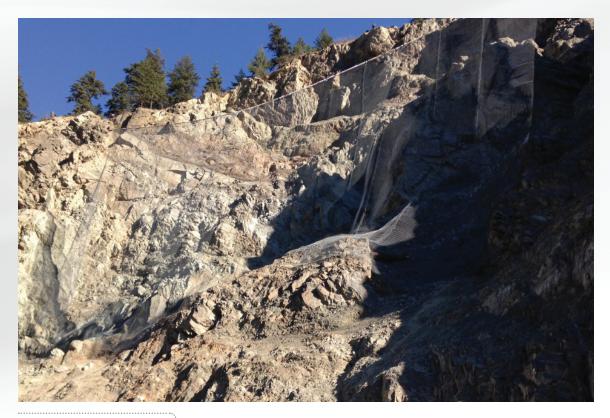
MESH ATTENUATION CURTAIN

View of the mesh attenuation curtain across the rockslide area

The MAC design consists of a Geobrugg TECCO high tensile steel mesh connected to a 25 mm support cable with hooks. The support cable is anchored to rock at either end in safe areas. Based on measurements of block sizes at the site and dynamic rock fall analyses, a design impact load on the system of 250 kN was estimated. The support cable is attached to anchor systems on either side composed of two and three anchors at the east and west ends respectively. The support cable is connected to the anchor systems by a cable arrangement that allows even distribution of the load to each anchor. Pulleys are installed at locations where the support cable changes direction.

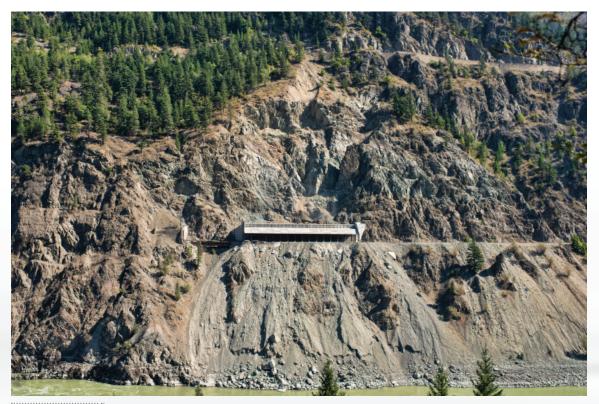
ROCK SHED Completed rock shed

The composite structure comprises a barrier wall with backfill to absorb the impact of normal and drag forces and a sloped rock shed to guide the debris flow over the track and down to the talus slope below. Modular components of both the "wall" and "shed" are tied back to the rock slope with rock anchors. The wall and shed components are not connected, but are designed to act independently. In this way, landslide impact load-induced strains in the barrier wall are not transferred to the rock shed structure.

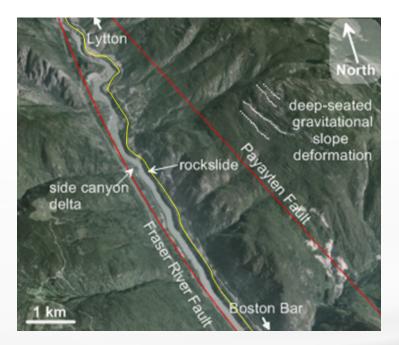
#### ANALYSIS

Numerical analysis was carried out using DAN-W software to derive impact loads for design of the new track protection structure.

These volumes were incorporated in the software DAN-W for run-out simulations of the rock avalanche. The dynamic run-out analysis was used to derive impact loads for design of the new protection structure. The model was calibrated by finding best-fit frictional rheology for back-analysis of the 2012 rockslide. A modified version of the pseudo-three-dimensional runout analysis software DAN-W was used, allowing output of normal and shear stresses at the base of a sliding frictional mass. This was the first use of DAN-W for such a purpose.
