CCE AWARD SUBMISSION

GIANT MINE REMEDIATION PROJECT MINE SUPPORT SERVICES, PHASE 1

PROJECT OUTLINE

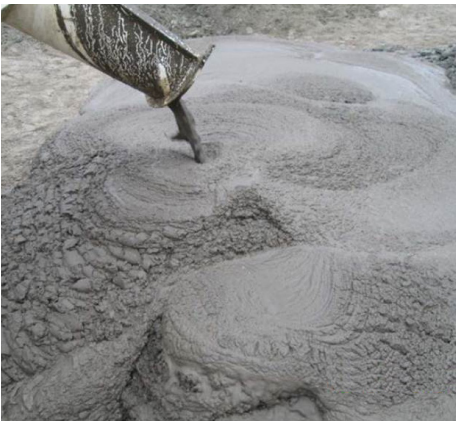
Photo 4 - Cemented Paste Produced

Process design studies and laboratory testing were completed to assess the suitability of the on-site tailings to be used as a possible economic backfill feed material. Multiple paste mixes were developed including bulk void fill, remote barricade fill, and fill suitable for plugging leaks (Photo 4).

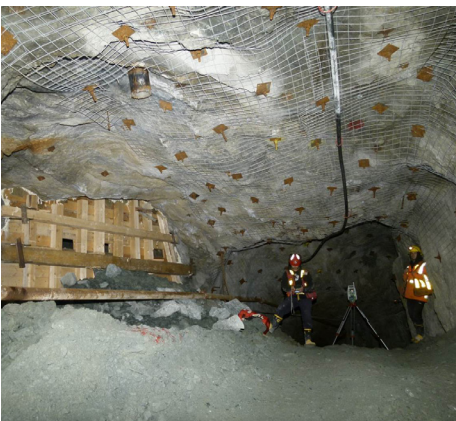
Photo 6 - Underground Backfill Barricade

Development of detailed step-by-step work plans to deal with the complex underground mine geometry (Photo 5), regulatory commitments and the extreme cold involved unprecedented and unique flexibility and innovation. Construction of conventional and remotely-placed fill barricades (via boreholes drilled from the surface (Photo 6)), accurately-drilled paste delivery boreholes (Photo 7), and the installation of an infra-red camera system allowed for management and monitoring of the backfilling progress.

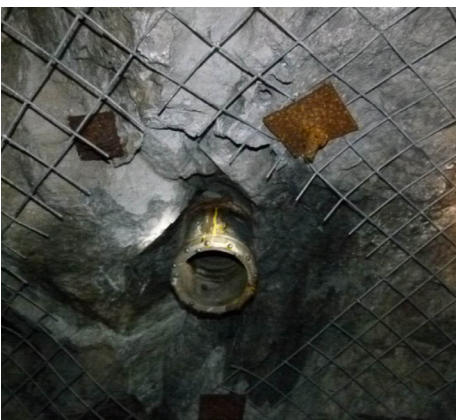
Photo 7 - Underground Breakthrough of 50 m Long Borehole With Steel Casing From Surface

The team developed underground mitigation approaches which involved borehole drilling, bulkhead construction and backfilling the stopes with cemented paste tailings. Investigative boreholes were successfully completed under a tight schedule that intersected openings as narrow as two metres in width and 140 metres in depth. Remote placement techniques and state of the art laser cavity scanning were used to gather inaccessible underground information to create 3D models (Photo 3) and two-dimensional level plans. This allowed the team to develop mitigation plans based on optimal positions for backfill delivery and containment barricades.

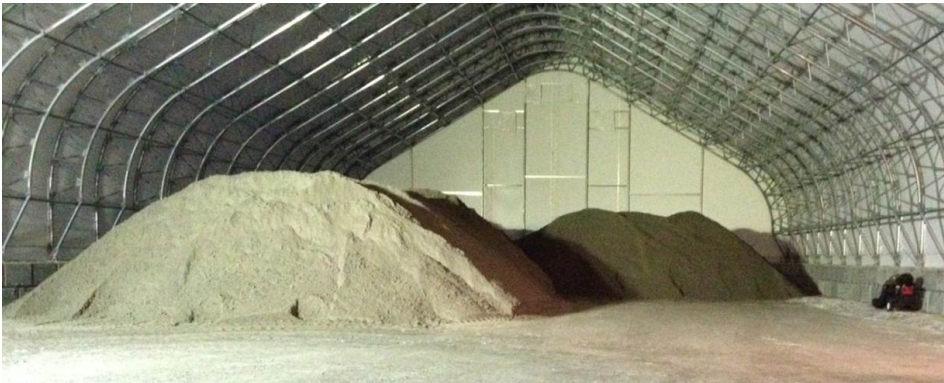
Photo 9 - Storage of Processed Tailings In Temporary Storage Building

Producing paste backfill with an outdoor mobile system using highly variable frozen arsenic-laden tailings (Photo 8) at extremely cold temperatures had never been done before. Mine utilities were limited; the team adapted by implementing artificial lighting, heating water and equipment, erecting tents for monitoring and slump testing, and erecting indoor tailings storage facilities to raise tailings temperatures (Photo 9).

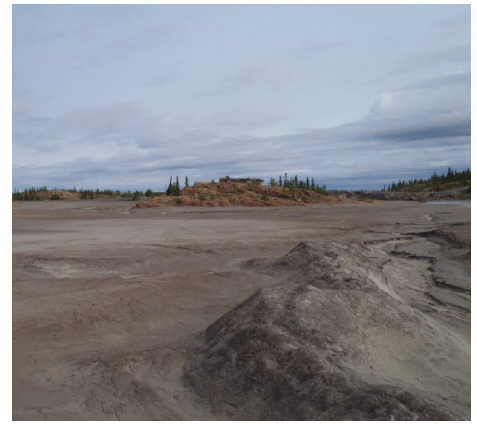
Photo 8 - Existing Tailings Pond At Giant Mine

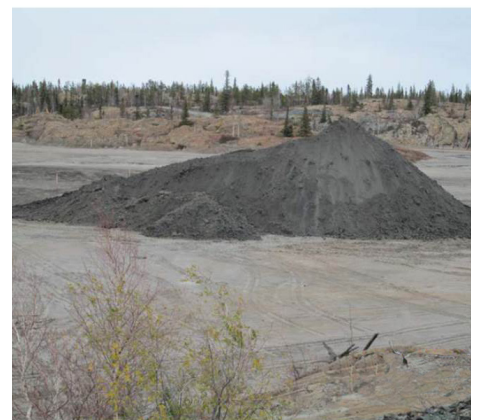
Photo 11 - Stockpile of Processed Tailings for Paste Production

Proving that local tailings material (Photo 11) present at the site can be used to stabilize underground openings that pose a risk to safety, and to current remediation plans, represents a large cost savings to the project. The lessons learned on this project will help reduce the \$903 million liability attributed to the overall Giant Mine Remediation Project in the public accounts of the federal government.

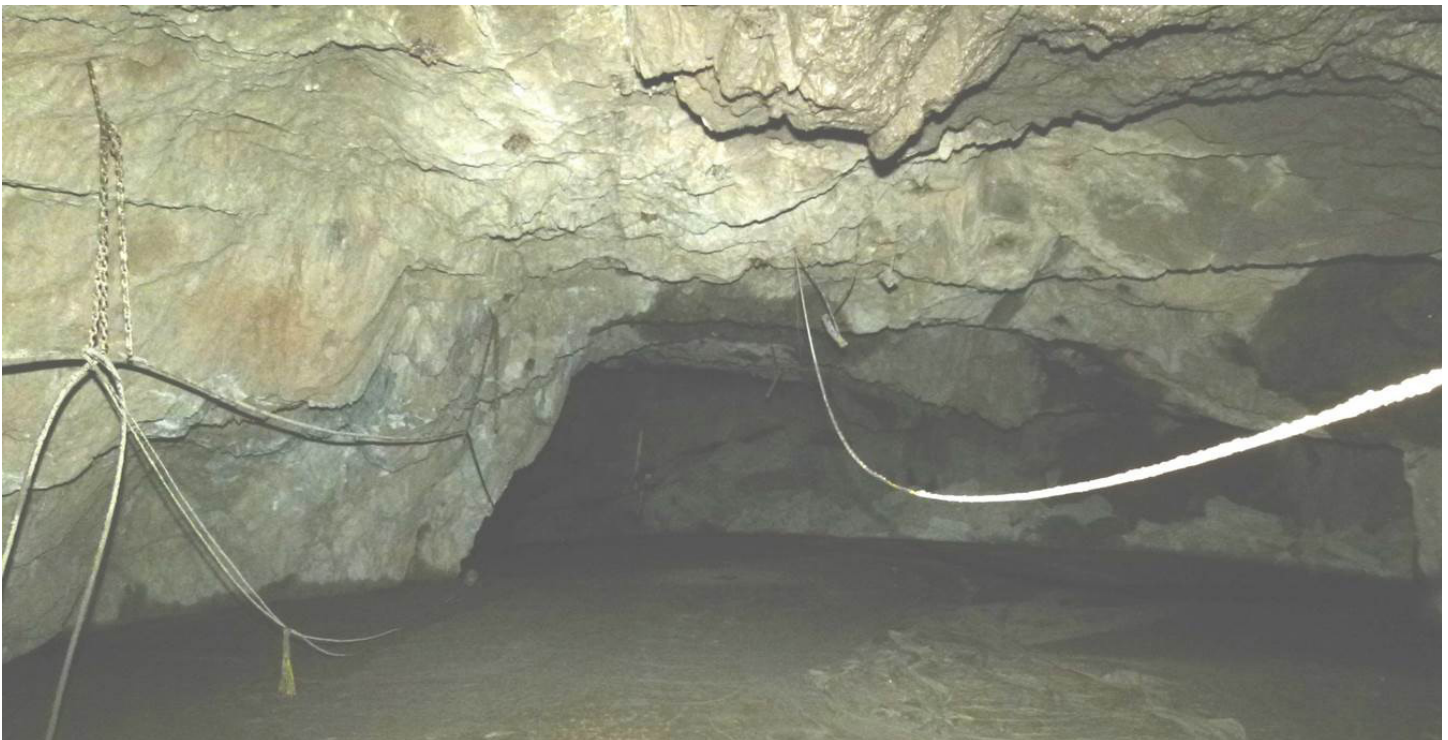
Photo 12 - Partially Backfilled Stope Void Under Baker Creek

One particular stope complex (Photo 12) required immediate attention to reduce the potential for surface water to enter the mine and eventually contaminate Great Slave Lake (Photo 13) which would jeopardize the overall remediation plan.
