Minto Bridges East & Centre Rehabilitation

Ottawa, Ontario Canada

Minto Bridges East and Centre Rehabilitation

PROJECT OUTLINE

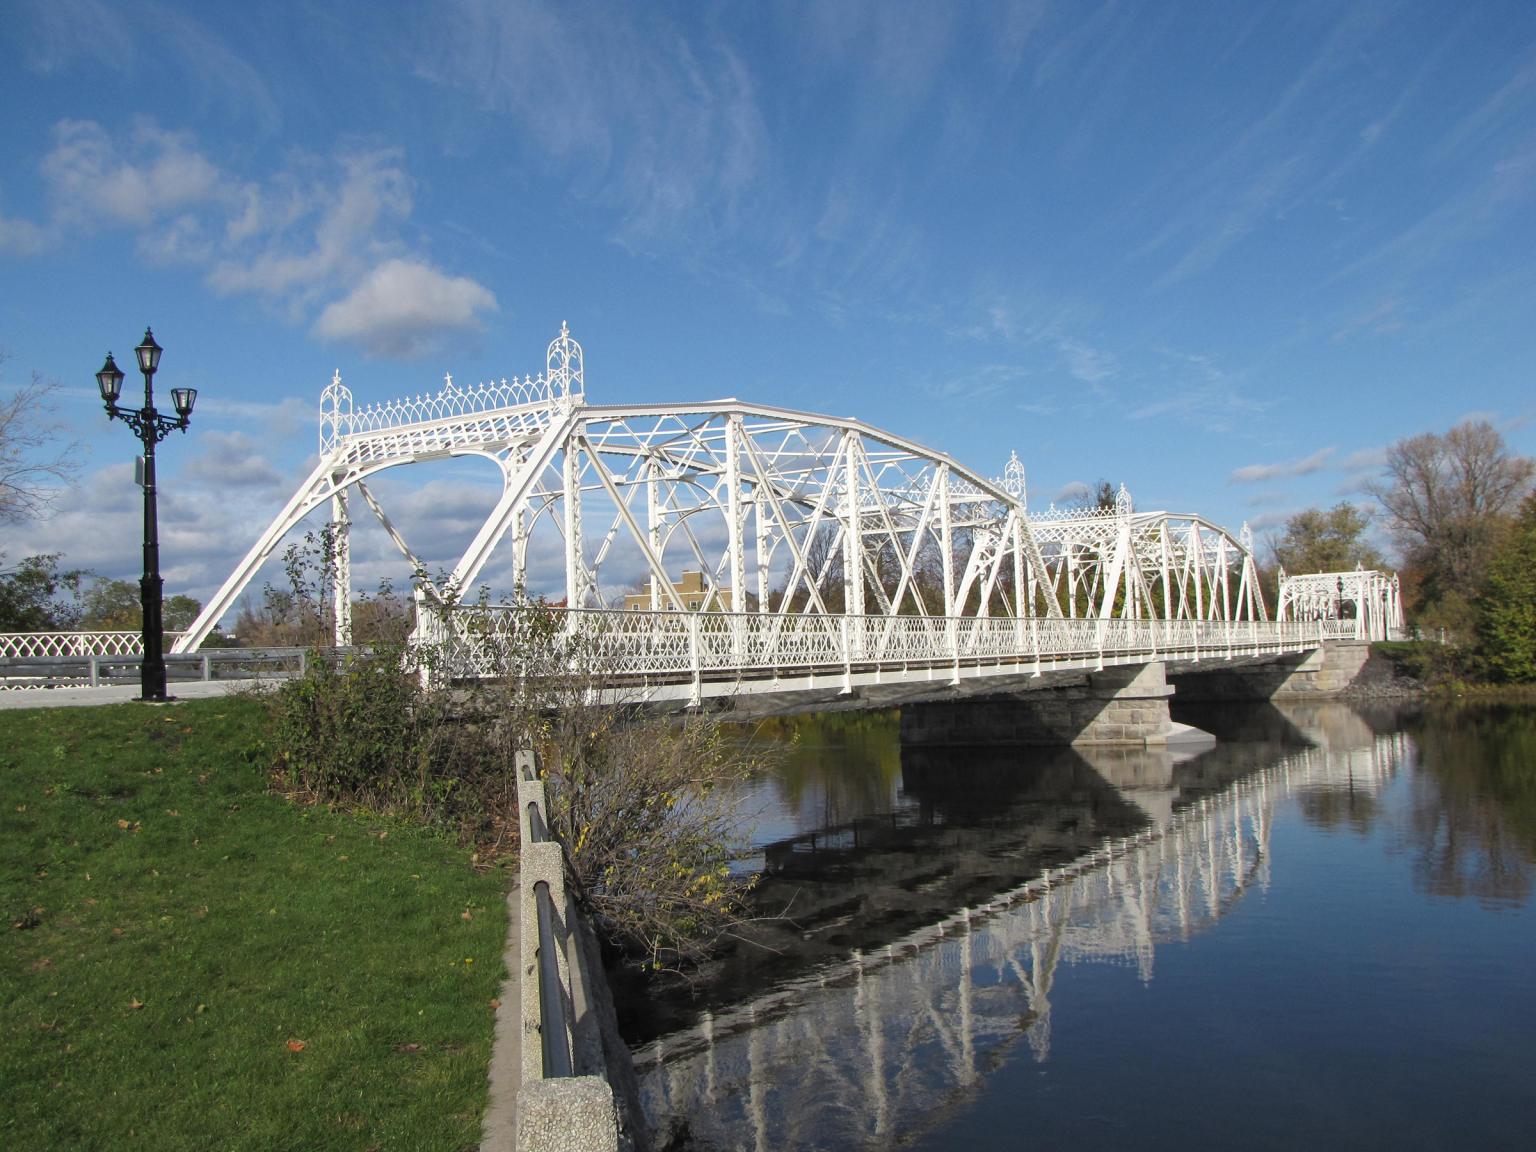
Photo name	Caption/Description
"Hero" Photo – best overall project photo - To be used on cover/later per request	Used on the cover
Photo 1	Located in Ottawa's urban core, Minto Bridges East and Centre span the North Branch of the Rideau River along Union following the former processional route from the Governor General's residence to Parliament Hill, now linking recreational pathways.
Photo 2	South elevation of rehabilitated Minto Bridge Centre (foreground) and Minto Bridge East (background right); light and open ornamental truss bridges harmonize well with the surrounding environment
Photo 3	Extensively deteriorated structural steel on deck underside due to road salt exposure; note deteriorated coating and very severe corrosion with perforations in roadway stringers below open deck grating; bridges had been closed to vehicular traffic since November 2013
Photo 4	Post-rehabilitation pre-fabricated FRP deck panels and wearing surface on Minto Bridge Centre; initial deck panel erection completed in only a few days

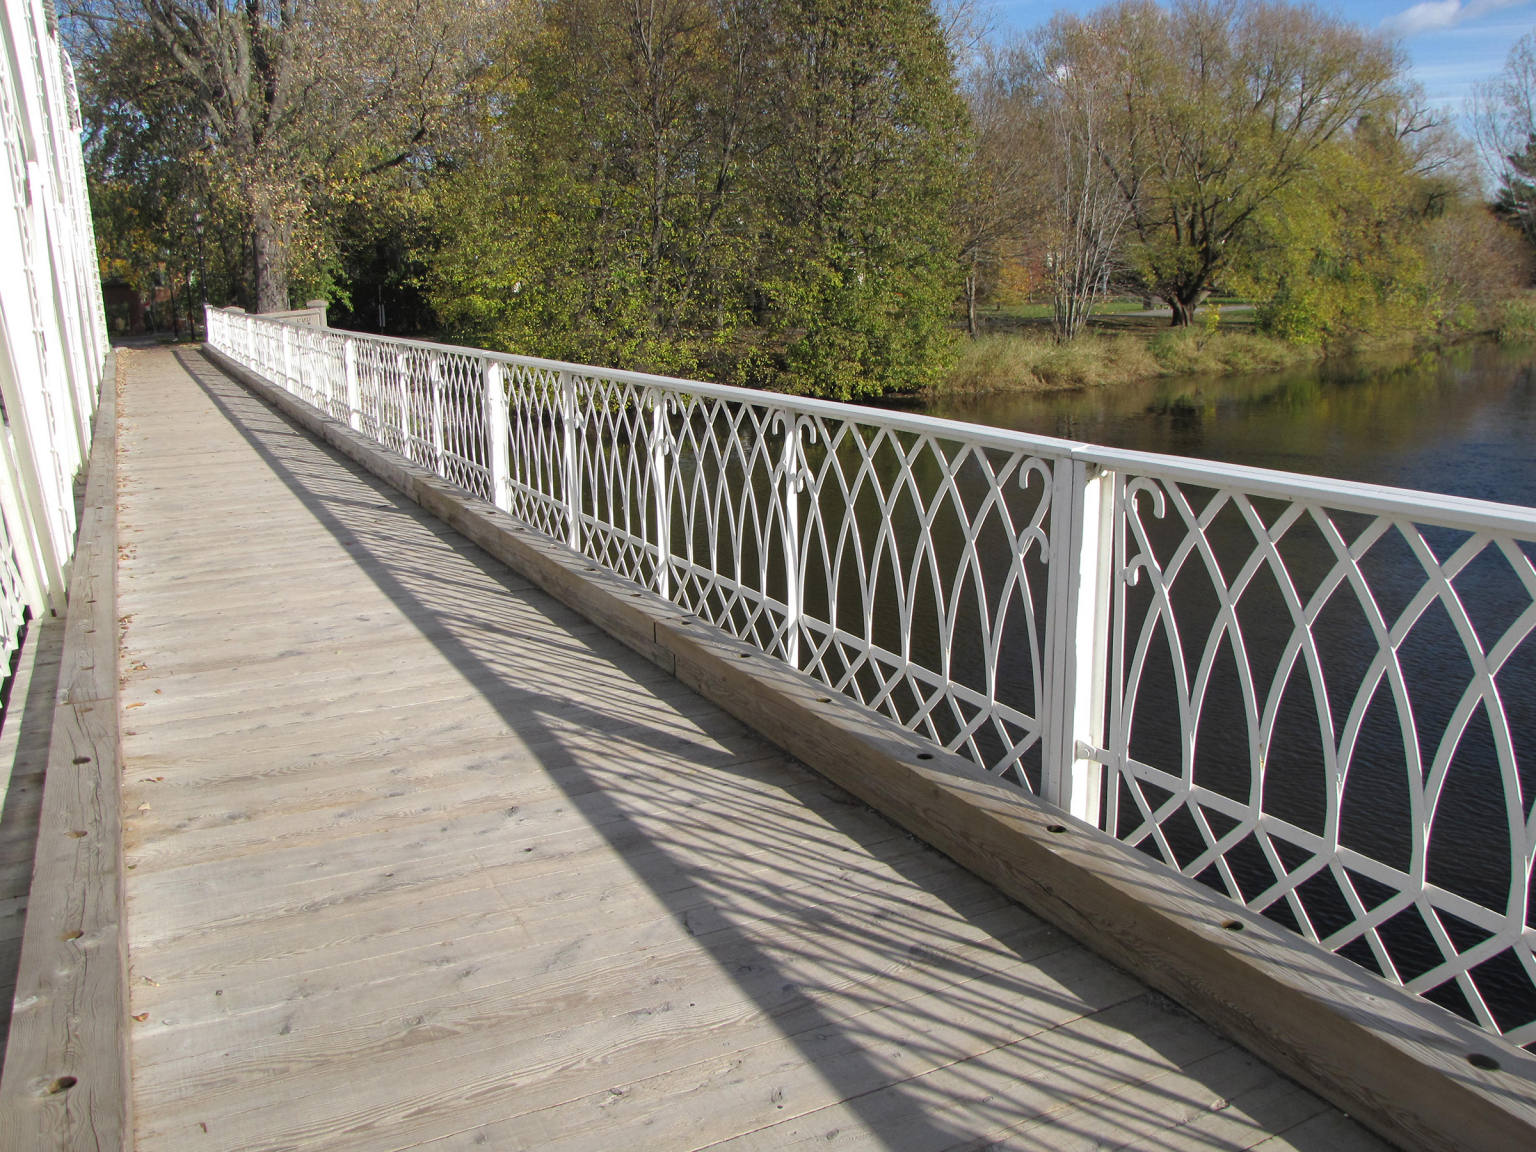
Photo 5	Reconstructed timber plank sidewalk and rehabilitated ornamental pedestrian railing on Minto Bridge East preserving heritage components of structures
Photo 6	Bridges re-opened to vehicles, pedestrians and cyclists in December 2016, three years after bridges closed; important pedestrian and cycling link between both shores of the Rideau River

The restoration of existing components, such as the stone masonry substructures and decorative steel railings, and the reuse of similar construction materials for reconstructed elements, such as the timber plank sidewalks, preserved the cultural heritage features of these bridges. (243)
