**CANADIAN
CONSULTING
ENGINEERING
AWARDS**

**TUNDRA MINE
REMEDICATION**

1 Project Summary

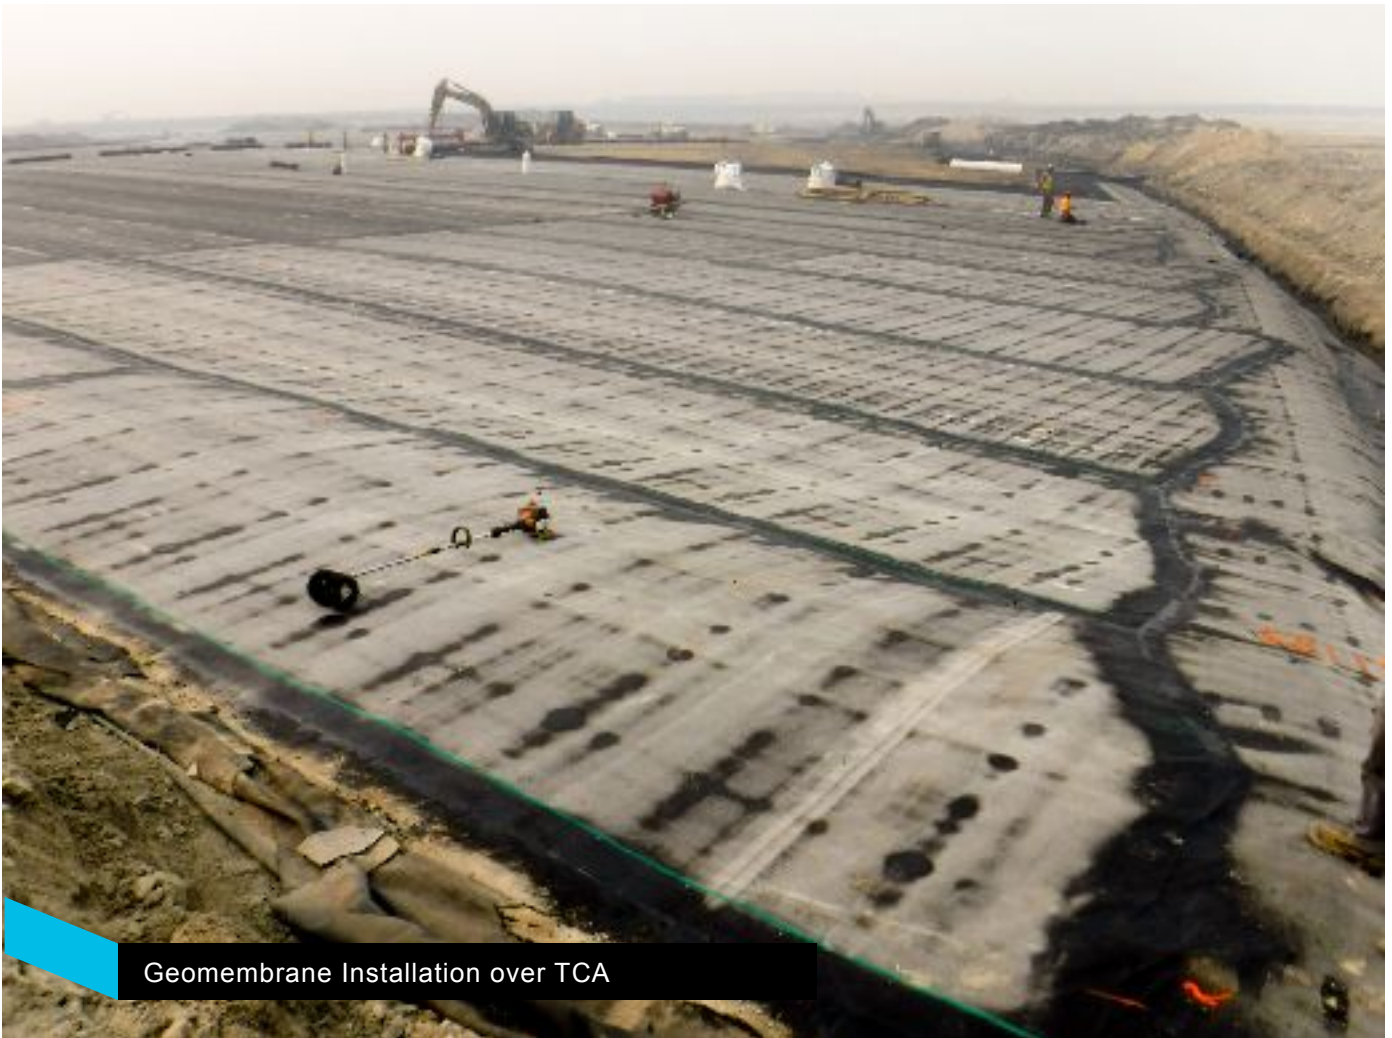
Geomembrane Installation over TCA

For the arsenic impacted tailings, the design included relocating tailings from two large areas and consolidating into one Tailings Containment Area (TCA). Waste rock and debris were also placed into the TCA. The cover design included a bituminous geomembrane (BGM) liner, cushion non-woven geotextiles, and granular covers for physical protection and erosion control. The consolidated TCA covered an area of approximately 250,000 m² which added complexity to the design and the shipping, handling and installation of the geosynthetic materials. Borrow material was produced on site for the TCA granular cover and for other areas on site.

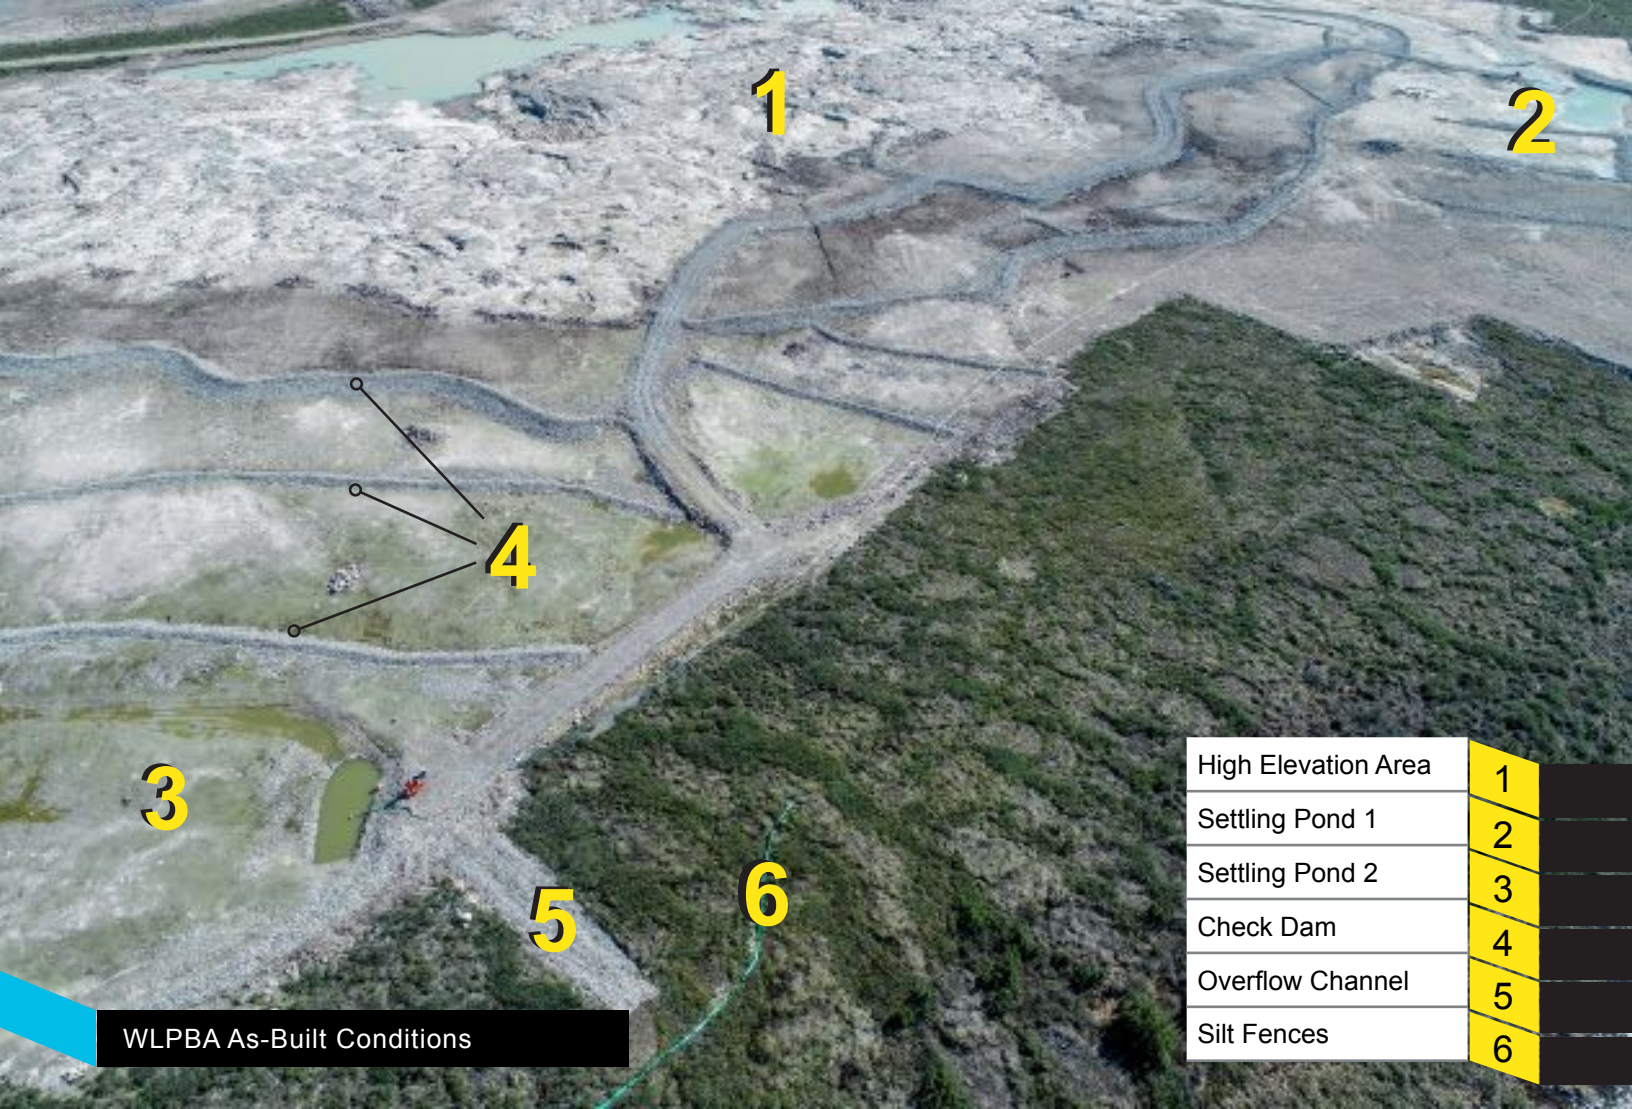
High Elevation Area	1
Settling Pond 1	2
Settling Pond 2	3
Check Dam	4
Overflow Channel	5
Silt Fences	6

- An unfavourable result of quarrying in the WLPBA was exposing highly silty borrow material, creating a situation likely to generate runoff with unacceptably high suspended sediments. AECOM and OKC completed a stabilization study and design which resulted in reshaping the borrow surface material to reduce the runoff velocity of surface water and constructing riprap check dams at regular intervals to promote sediment settlement, thereby mitigating the potential for erosion. AECOM worked closely with the remediation contractor during construction and in many areas directed where the check dams and regrading work should be completed.
