Hawkesbury Lagoon Site Remediation

2019 ACEC CCE Engineering Excellence Awards | Category D | Environmental Remediation

Innovative modeling remediates lagoon

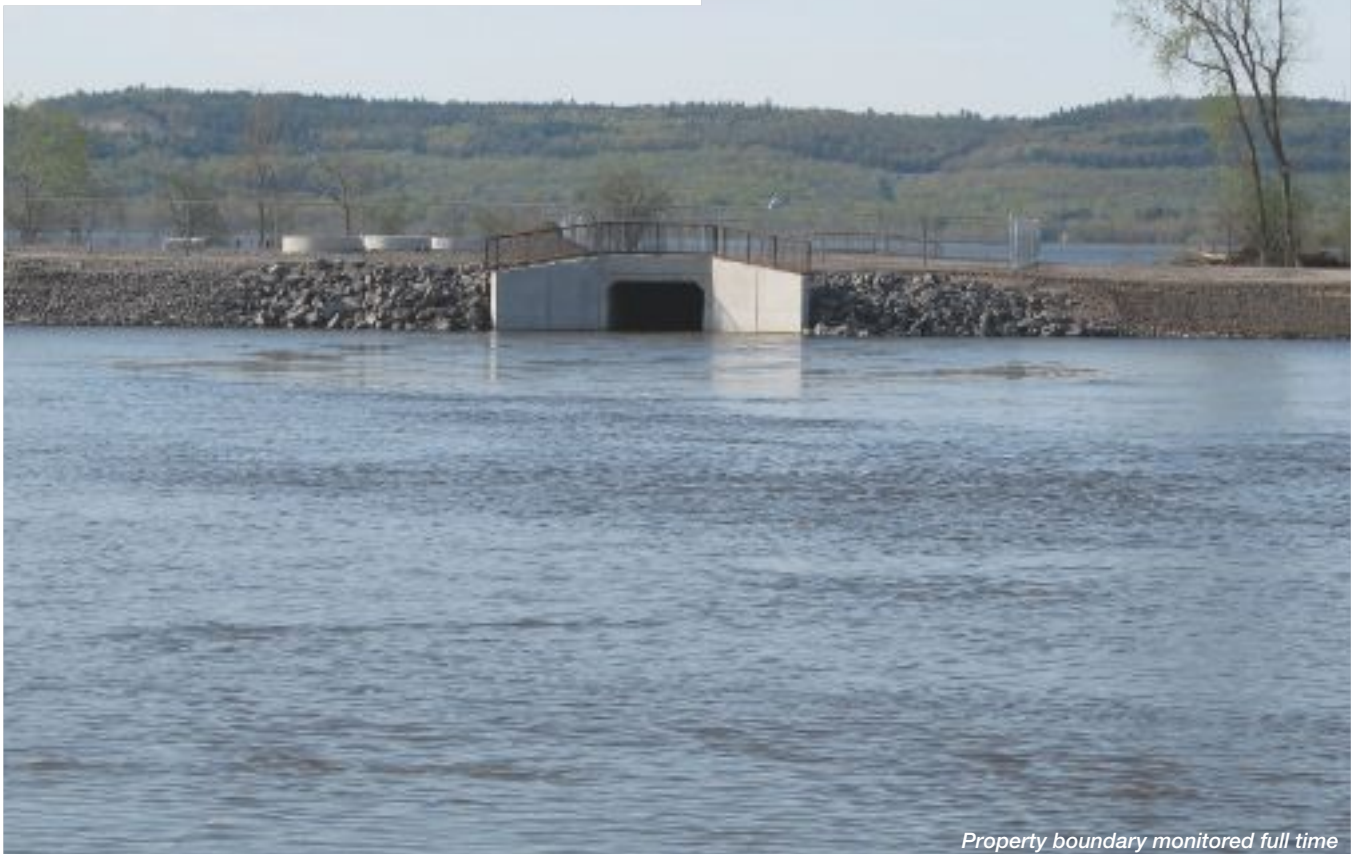
The lagoon's proximity to the property boundary required full time monitoring and controls for air emissions to ensure the protection of public health. The upward vertical groundwater gradient combined with the vertical drains created a natural liner beneath the waste, but also created challenges for removal of the waste from the remainder of the Site. Complex hydrogeo-modelling was completed for the Site with recharge and dewatering rates calculated at various stages of dewatering. Construction was completed over a three-year period aligned with funding. The Site's remediation was accomplished through dewatering, partial excavation of sludge, and cover in place.

Property boundary monitored full time

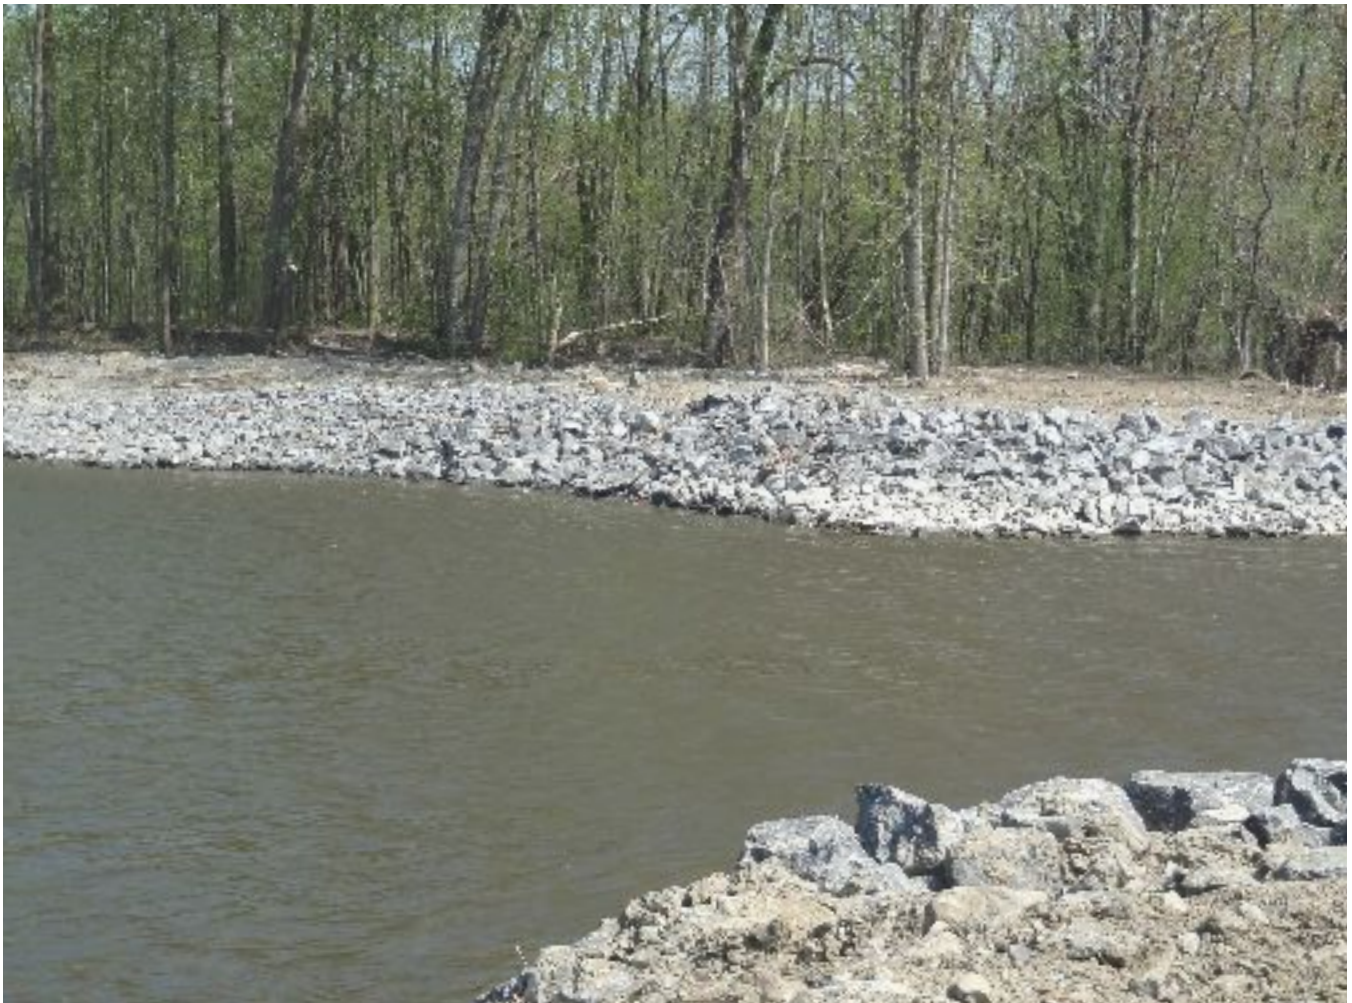
Shoreline after remediation
