Canadian Consulting Engineering Awards 2019
Project: [Humber River Bridge Span Replacement]
Category: [Project Management (Category G)]
April 18, 2019
5:00 pm EDT

1.0 Full Project Description

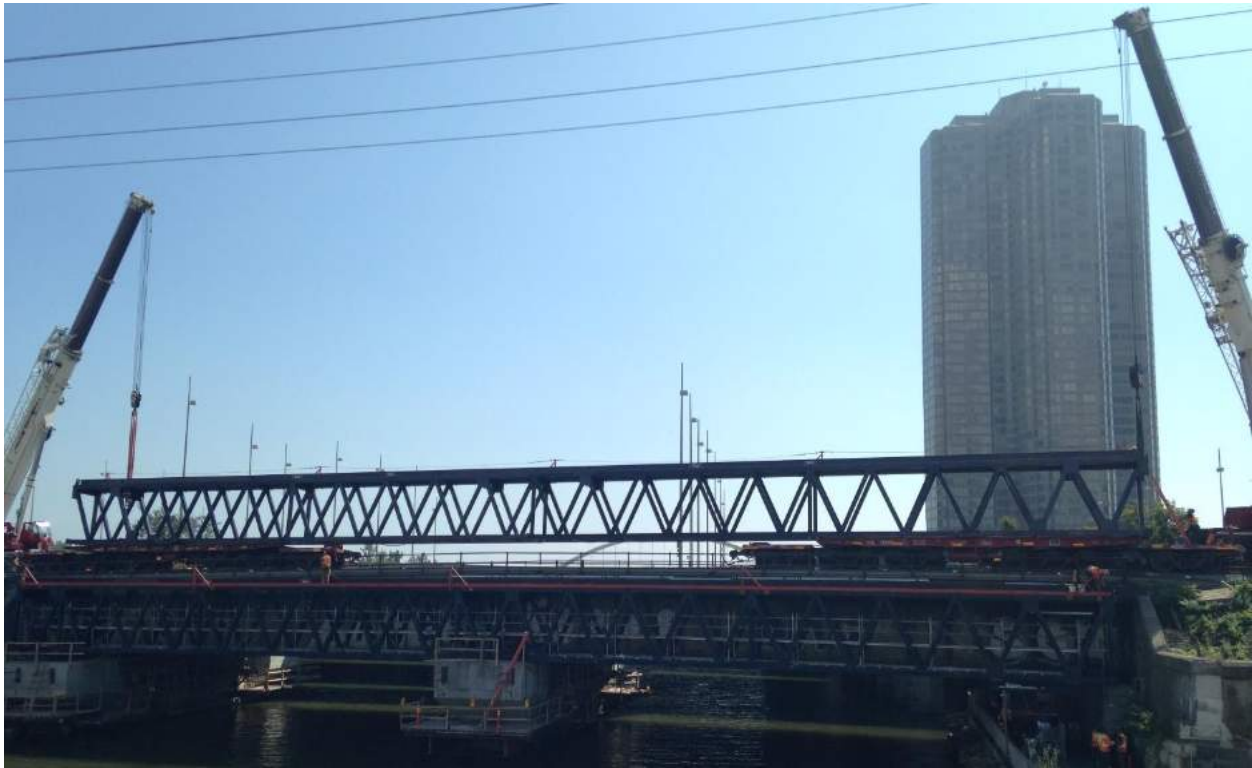
Figure 1: Cranes lifting half of the gantry truss system in to place on concrete corbels.

The existing Humber River Bridge was erected in 1911 in the Lakeshore West Rail Corridor over the Humber River. The bridge is 200 feet long and carries 4 railroad tracks over 8 ballasted deck plate girder spans. Due to a high level of settlement at the east abutment there was a constant need to add additional ballast to keep the vertical alignment correct. In 1946 a "helper pier" was constructed immediately adjacent to the east abutment to help mitigate any further settlement of the bridge. With the structure nearing the end of its structure lifecycle, the client decided that with increasing train service it was time replace the structure. The substructure was rehabilitated while keeping the original 1911 aesthetics in mind while the entire superstructure was replaced with new deck plate girder spans. This project was highly complex due to the nature of the Lakeshore West Corridor and existing site conditions. The corridor is used by multiple rail service providers such as GO Transit, VIA, Amtrak, CN and CP which means having a train pass over the structure every 15 minutes or less very common. This makes a rail corridor closure to replace full bridge spans very difficult to coordinate. With our extensive rail experience and past project within this corridor, we were able to work with the client to schedule 9 complete weekend closures to install and remove the gantry system and replace 8 spans and 8 approach slabs. It was determined that to achieve all of this work, 4 weekends would be used for span replacements, 2 weekends would be for approach slabs and 2 weekends would be for gantry installation and removal. To ensure that the contractor could completely replace 2 full bridge spans in the 50-hour closure, many scheduling workshops were held to break every activity down to the half-hour. Access was also a major concern for this project as there is no direct access to the rail corridor. Through coordination with the owner it was decided that large access ramps would be constructed on each side of the river to grant access to track level. These ramps were partially made of salvaged material and were left for maintenance access after completion. Additionally, the ramps needed to be properly secured to prevent trespassers from entering the rail corridor. All pier and abutment works were completed through temporary platforms constructed from a barge in the Humber River.

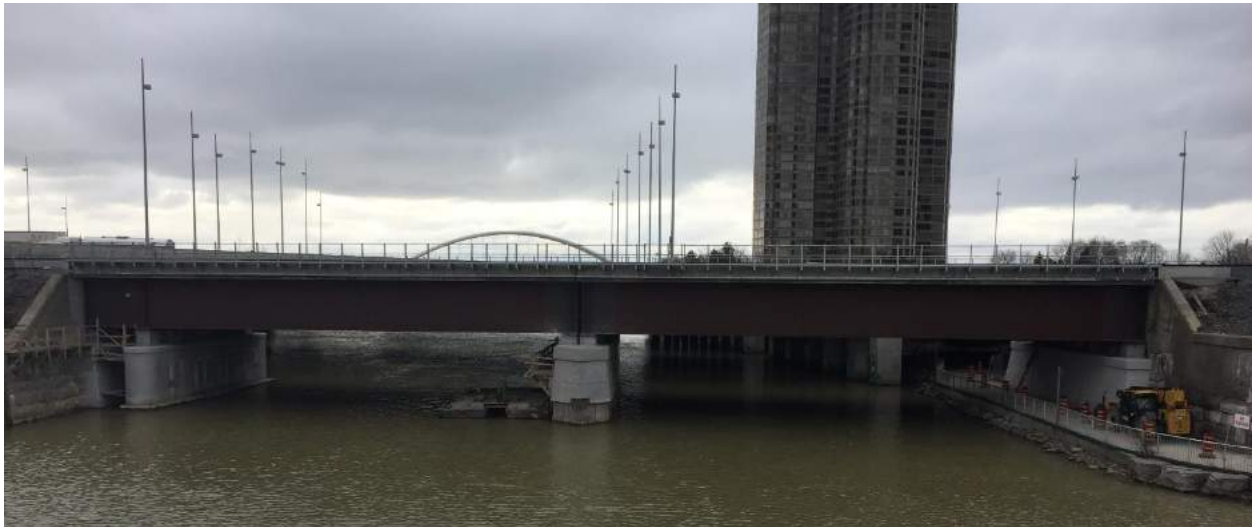
Figure 2: Humber River Bridge with all 8 spans replaced and open for service.

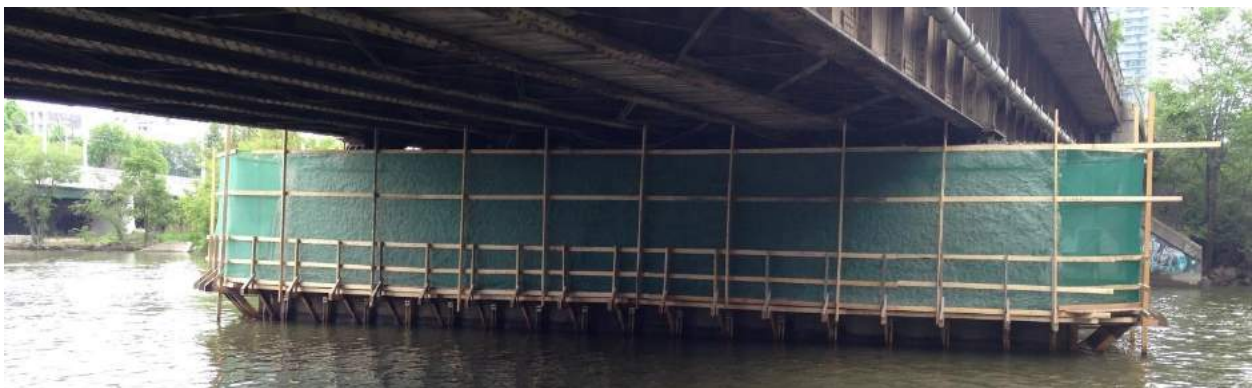
Figure 3: Environmental protection installed around the center pier for concrete chipping.

The Humber River Bridge replacement took place under the jurisdiction of the Toronto Regional Conservation Authority (TRCA) who have stringent environmental requirements that must be met at every stage of a project. Before any work on this project began, we were required demonstrate to TRCA that our design did not impact any water courses or habitats within the project limits throughout construction or thereafter. Throughout the project, materials were reused where possible to help reduce the amount of waste being removed from site. An example of this is the existing ballast that was removed from the bridge decks. Two large access ramps were required to get materials and equipment to track level. The existing ballast being removed from the spans was removed and used in these ramps to reduce the amount of new granular material being imported. This ballast was also used for sloping of the corridor in areas where the erosion had taken away the existing slopes. The existing rail material to be removed was salvaged and used as the guard rails on the new track to reduce the amount of waste coming from the project. Where possible, the old rail was also used for transition rails and temporary rail before being salvaged in the client's storage yard. In line with environmental sustainability, this project involved tree protection zones that were to remain unimpacted by all construction activity. These zones consisted of physical barriers that set a perimeter around an area that is to be unimpacted by any activities.

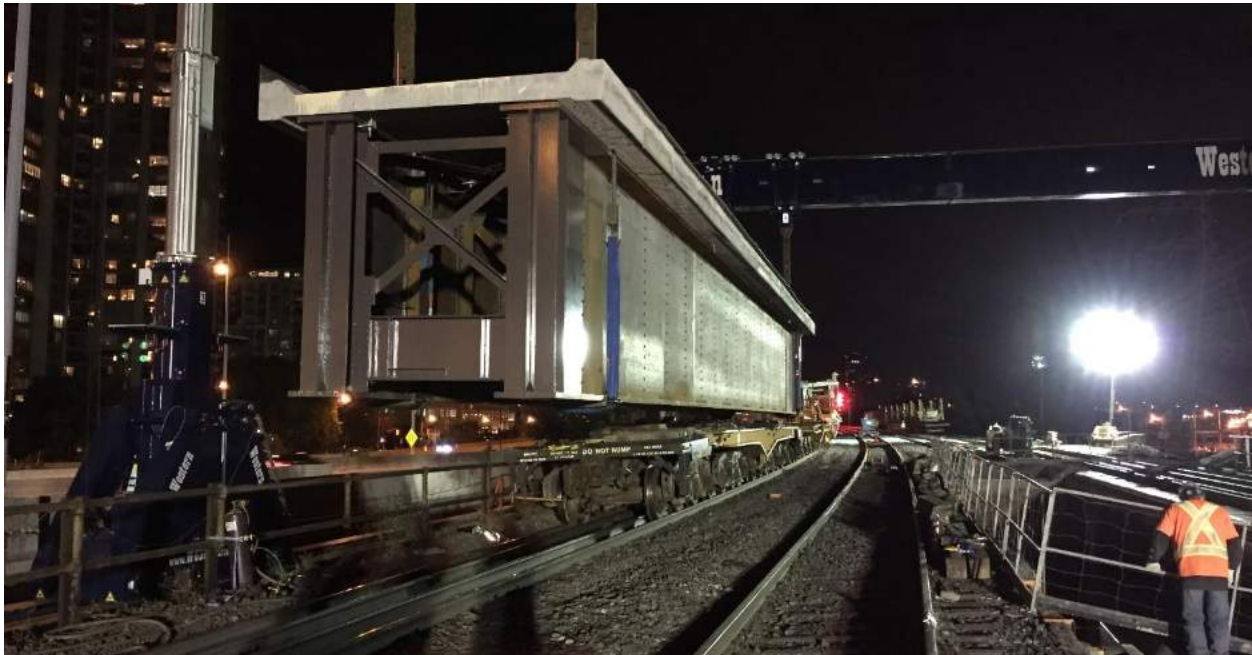
Figure 4: A new span being lifted into position during of the 50-hour weekend closures.

The Humber River Bridge replacement displays innovative engineering practices and techniques in every aspect of the project. Due to the requirement of not impacting revenue train service, the work had to be completed during weekend closures and it was crucial to ensure we were able to replace two spans per weekend. The weekend closures were carefully examined in hourly increments to ensure the amount of work required could be completed in time to open the rail corridor for Monday morning service. It was determined that tandem lifts with heavy cranes would involve too much set up and preparation time which would not allow for two spans to be replaced each weekend. Instead, a gantry system was utilized and was designed to operate on a non-tangent truss system and the existing abutments needed to be examined to determine if they could support the total load applied from the corbels, gantry system and bridge spans. The gantry system was designed specifically for this project but was also designed for reuse in other applications following completion. The time savings and safety benefits over a conventional crane lift are important factors that made this project a success.
