# West Block Parliament Building Rehabilitation

Canadian Consulting Engineering Awards 2020 – Entry Binder

## West Block Parliament Building Rehabilitation

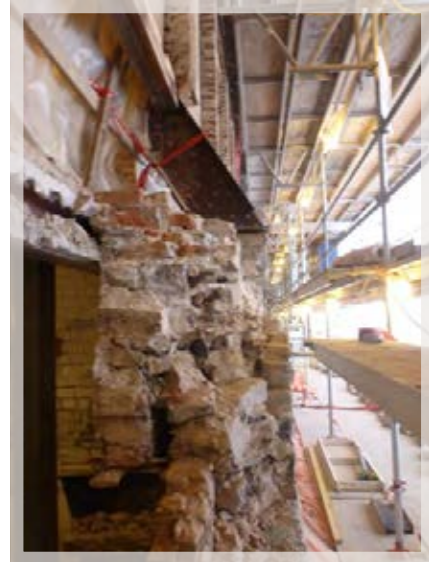
Existing Conditions, Investigation and New Blocks

Masonry Conservation (Exterior):

- Deteriorated masonry below roof eaves on all exterior walls, mostly due to moisture damage. Frost damaged brick and debonded stone. No anchors and few keystones.
- Extensive stone and brick deterioration at chimneys. Over thirty chimneys, all dismantled and rebuilt with seismic anchorage.
- Corroded cramp anchors on Mackenzie Tower pinnacles and chimneys resulting in spalling stone.
- Rebuild of Laurier Tower

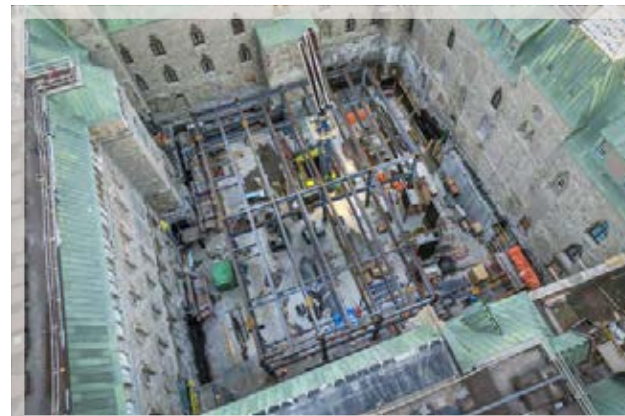
Existing Roof Structure Upgrade:

- Upgrade all existing steel trusses to support new mechanical equipment and the mass of acoustic separations.
- Unique, truss-by-truss, upgrades to accommodate new access and existing geometry.
- Designed temporary support of trusses to allow for large scale dismantle of exterior masonry walls.

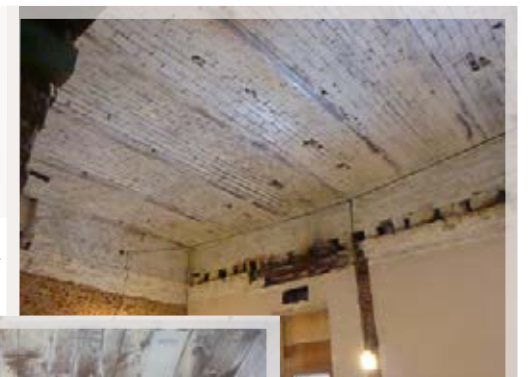
- Removal of Fox and Barrett Floors and replaced with new composite steel deck / concrete slabs
- New structural slab over arch slabs on 4<sup>th</sup> floor level. Existing truss tension ties buried in concrete slab.

Terra cotta brick arch floors ▶

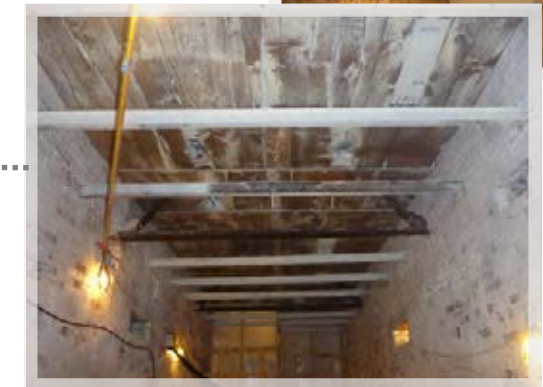
◀ Fox & Barrett floors

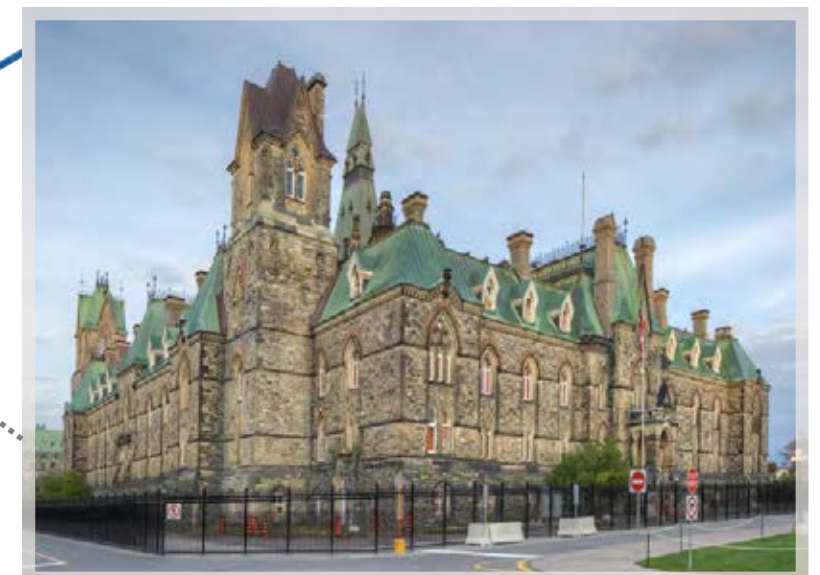
Existing Masonry Walls:

- Stone Foundations; Investigative Openings exposed waterproofing installed in 1960's and its impact on the masonry, trapping moisture.
- Stone Masonry Exterior; Built in three construction phases, dressed in Nepean Sandstone, Potsdam Sandstone and Berea Sandstone.
- Interior Walls and Structure; Brick masonry terra cotta walls

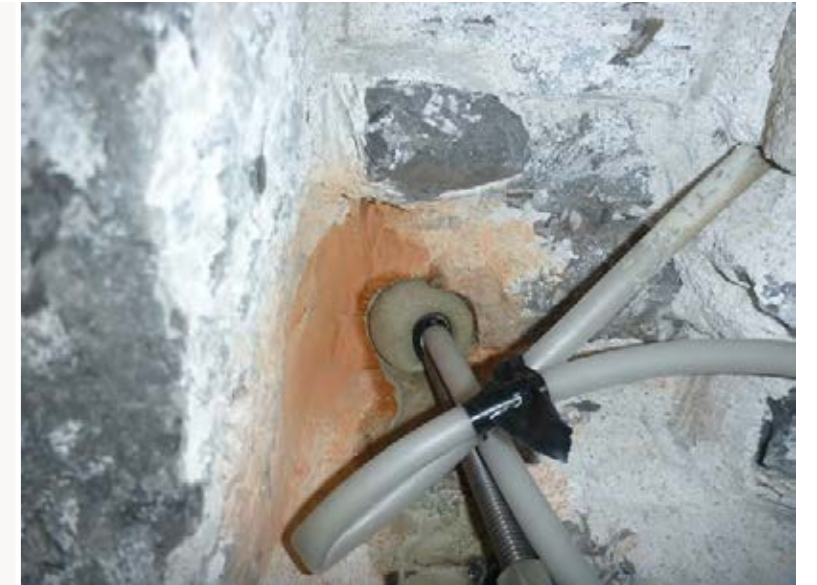
▲ Grouted anchors were used to reinforce masonry wall for seismic forces.

Existing stone masonry walls were rehabilitated with adherence to the principle of minimal intervention while achieving the expected level of seismic resistance through the use of custom grouted steel anchors. Seismically, a hybrid of the existing masonry shear walls along with new shear walls was utilized. The custom anchors were required to ensure appropriate reaction with weaker heritage elements. This hybrid seismic design minimized the amount of new structure that was required to meet code.

The exterior masonry was rehabilitated and upgraded to modern Code requirements using the latest technology in compatible masonry anchor design. This was carefully balanced with conservation principles to ensure minimal intervention into the Heritage Building.

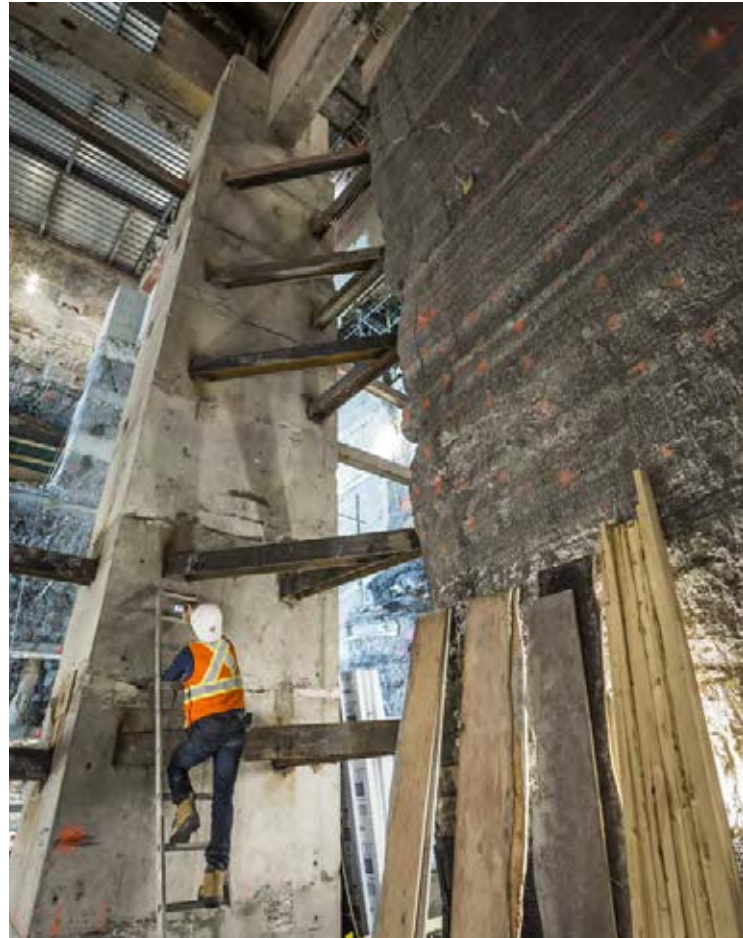
▲ Excavation Under Existing North Wing Building Above

Technical solutions developed to allow for deep excavation of courtyard and passages under the existing building allowed for efficient communication within the building for occupants and visitors. New space provided for new content, such as committee rooms, communication hubs, restaurant, visitors paths and services, etc.

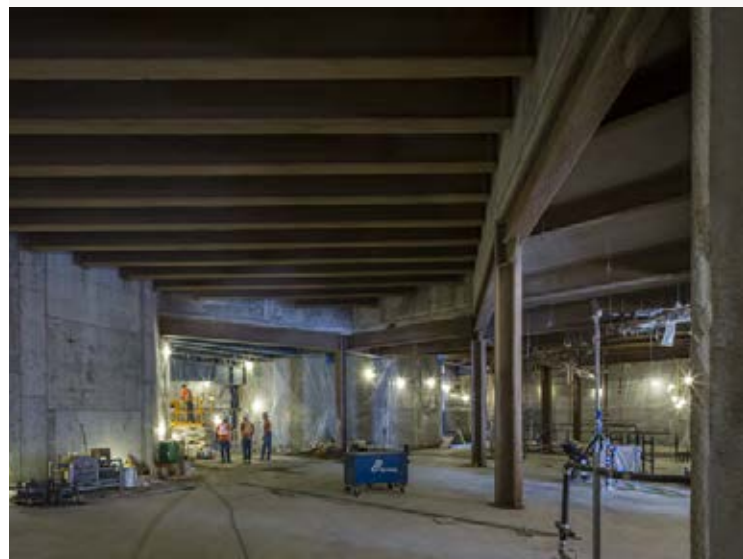
▼ North Court - Underground Structure
