SKINS LAKE SPILLWAY PLUNGE POOL REHABILITATION

AWARD SUBMISSION

CANADIAN CONSULTING ENGINEERING AWARDS 2020

PROJECT NAME Skins Lake Spillway Plunge Pool Rehabilitation

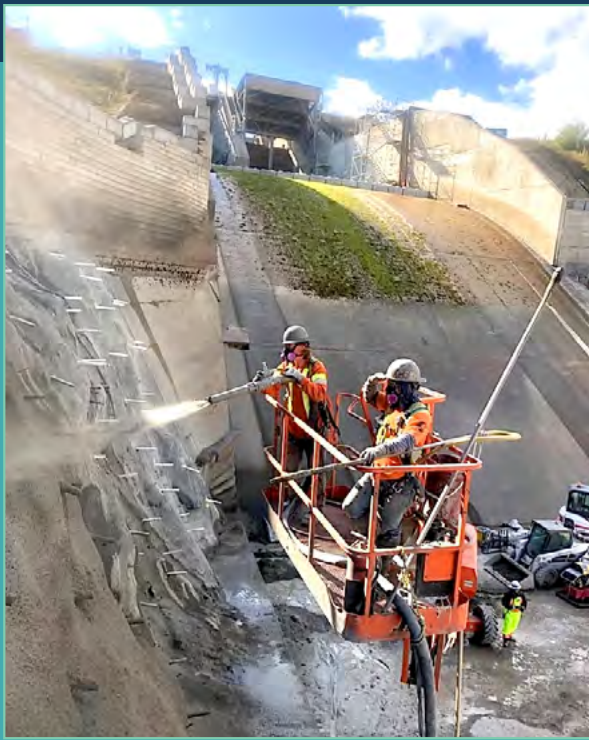
Construction of the spillway plunge pool repairs were accelerated by adopting the latest shotcrete application techniques from highway and tunnel construction.

KCB selected “dry-mix” shotcrete for the repairs, using pre-mixed bags and a compact hopper to deliver the shotcrete. Using dry-mix shotcrete was more efficient and cost effective for this remote site, compared to the alternative which would have involved setting up a small batch plant or delivery of shotcrete by heavy equipment. Before construction, the shotcrete method was tested to meet the design specifications, by applying the same materials and using the same equipment and operators at an off-site location. The shotcrete was applied more safely and efficiently by an operator on a “zoom boom” or telescopic handler, rather than from a scaffold platform.

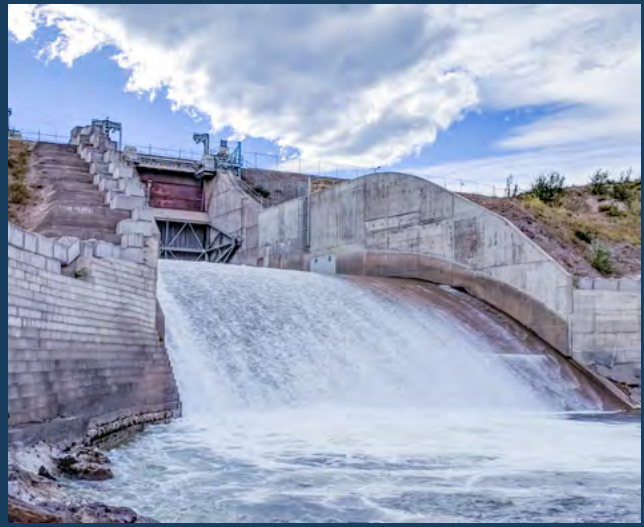
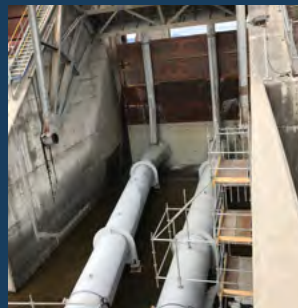
Two steel pipes integrated with the spillway stoplogs were used to bypass the 32 m³/s environmental flow during construction.

RT's preventative maintenance of the SLS enables a sustainable and safe supply of hydropower to local industry. Prior to construction, downstream flow requirements were successfully established using a bypass system and closely monitored throughout construction for water quality. At the completion of construction, the plunge pool was thoroughly cleaned with pressure washers, power sweepers and magnet trollies to pick up steel fibers, preventing their release downstream.
