CANADIAN CONSULTING ENGINEERING AWARDS 2020

BIOENGINEERING TO RESTORE ECOLOGICAL LOSS AFTER WILDFIRES

LOCATION: FORT MCMURRAY AND SURROUNDING AREA
CLIENT/OWNER: REGIONAL MUNICIPALITY OF WOOD BUFFALO
CONSULTANT: ASSOCIATED ENGINEERING
SUBCONSULTANTS: POLSTER ENVIRONMENTAL SERVICES & THURBER ENGINEERING

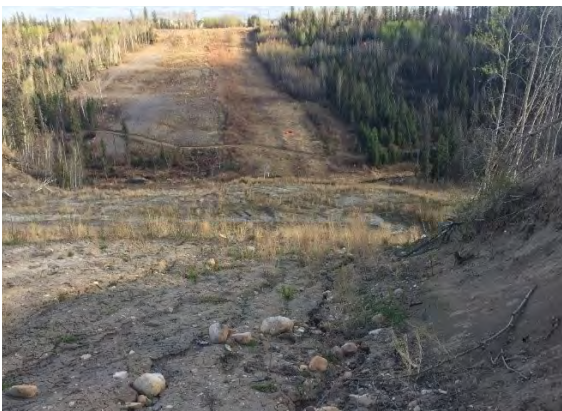
Conn Creek Ravine Firebreak

As part of the immediate emergency response, firefighters created firebreaks by clear cutting trees and shrubs. Firebreaks prevented fire from

spreading to private and public properties, but the equipment used to create the firebreaks altered natural drainage patterns, compacted existing soils, and reduced the ability for these areas to absorb water, instead causing drainage to flow to erosion-prone areas.

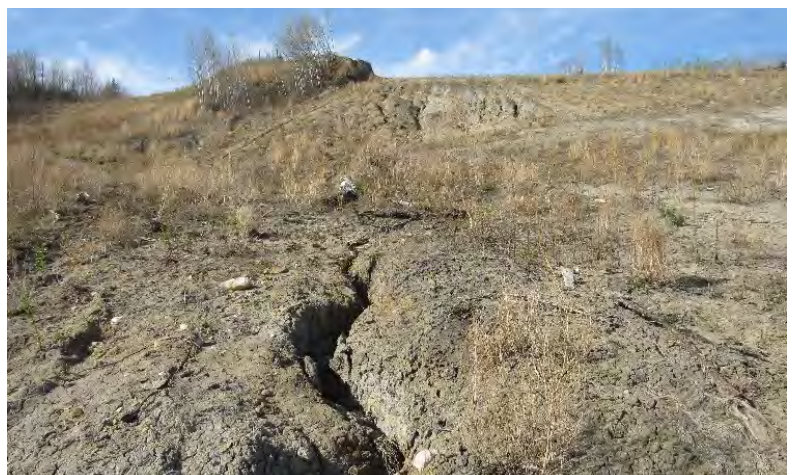
Erosion in fire-ravaged area

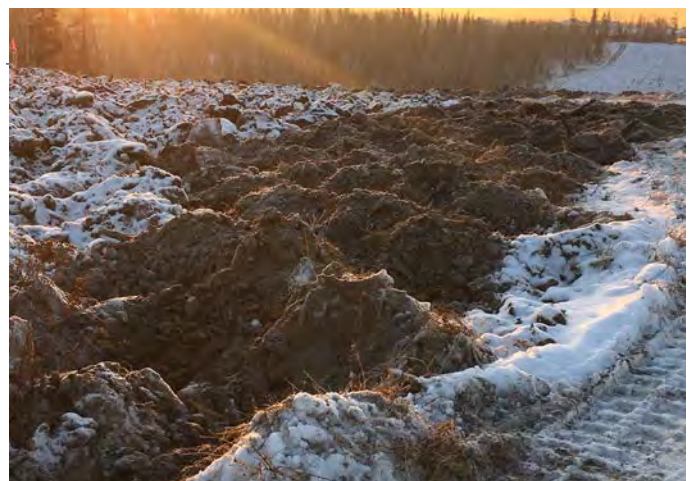
Surface roughening soil treatment at Conn Creek Ravine site

Bioengineering reduces soil erosion throughout the sites impacted by wildfire, and, as a result, sedimentation in waterbodies will be reduced. Soil loss assessment for pre- and post-treatment conditions at the sites shows the effectiveness of soil bioengineering treatments. Slope lengths are shortened by the surface roughening soil treatment and established vegetation increases infiltration.

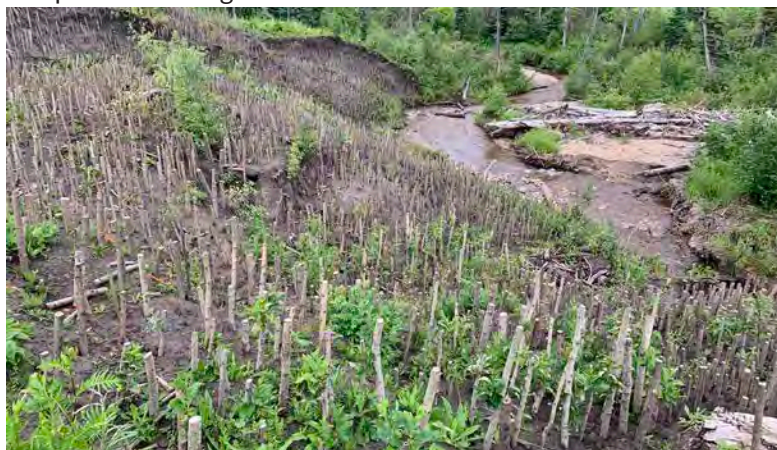
Conn Creek after bioengineering treatment

Bioengineering techniques included surface roughening, dense live toe staking along creeks, live silt fencing, live poplar staking, wattle fences (short retaining walls built of live cuttings on steep slopes) and live pole drains (bundled cuttings in shallow trenches to direct drainage). Bioengineering techniques were integrated with engineering solutions, such as culverts and riprap, to prevent erosion.

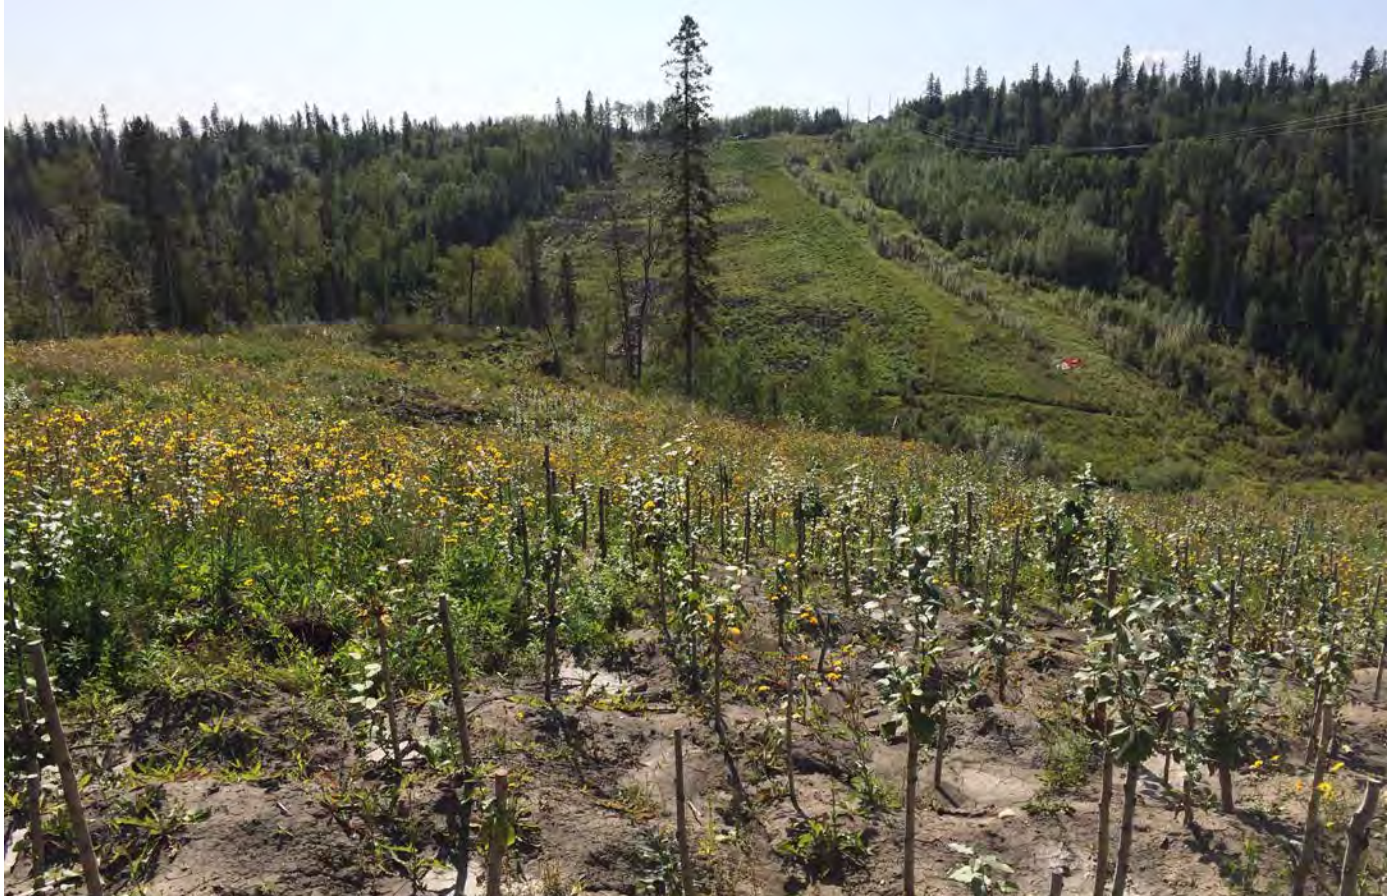
Conn Creek Ravine after bioengineering treatment

The 4-hectare Conn Creek Ravine site, the largest of the 14 sites restored on this project, had a cost of \$1.36 million. By comparison, covering the equivalent restoration area with riprap, a traditional engineered erosion protection approach, was estimated at approximately \$4 million. This project demonstrates that bioengineering is an economical and viable solution for erosion protection.

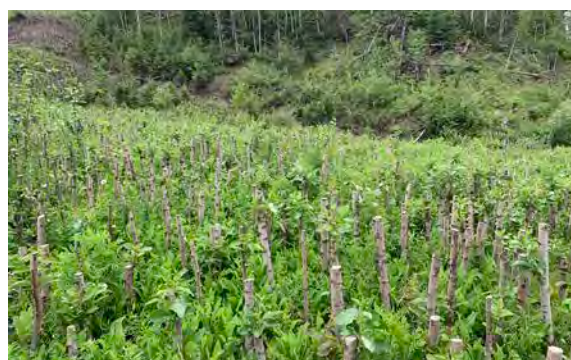
Balsam poplar stakes

Bioengineering techniques for landscape and watershed restoration mimics natural processes, conditioning soil and establishing live plants which accelerate and promote natural revegetation of damaged areas. Live stakes use poplar and willow species, both approved FireSmart trees which have enhanced resilience to fires.
