Grand Falls Dam and Spillway Rehabilitation

2020 Canadian Consulting Engineering Awards

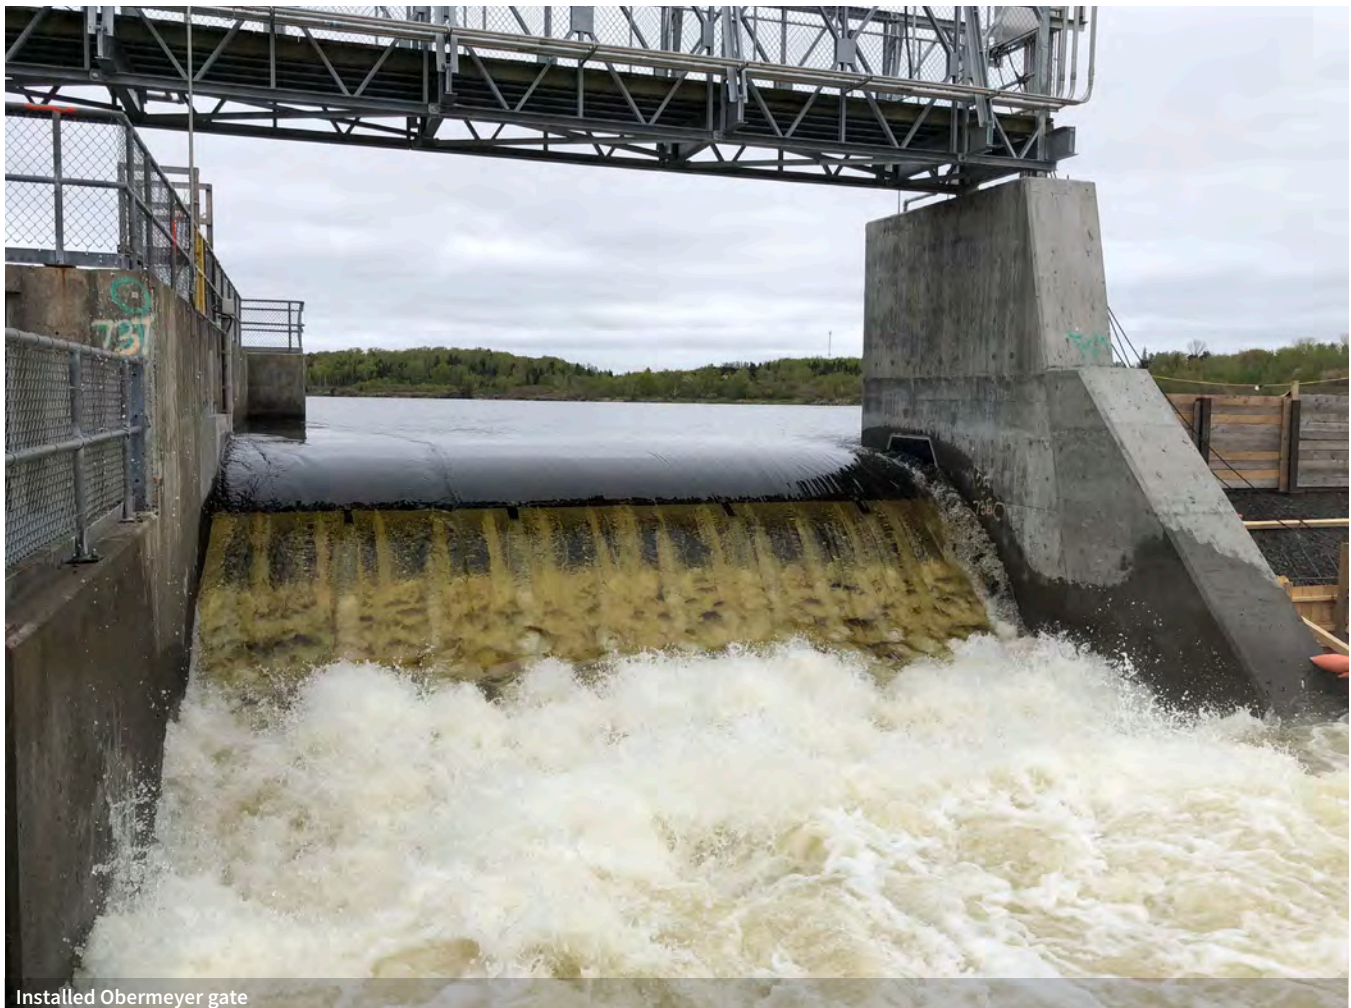
Installed Obermeyer gate

Prior to Hatch's involvement in this project, a single inflatable gate had been installed. The operation of this gate led to concerns that utilizing the gate to pass high flows could impact fish passage during the critical spawning season. To address this environmental concern, Hatch developed a model of the fishway and undertook computational fluid dynamics (CFD) modeling to determine what, if any, remedial works were required to improve fish passage, protecting the critical salmon fishery. The results of the CFD analysis showed that the observed high velocity and turbulent flows only occurred near the water surface. Prior to the installation of the new gate, analyses showed that high velocity flows were occurring at depth along the riverbed, disrupting fish passage demonstrating that the inflatable gate improved the potential for fish passage. This resulted in the avoidance of any need for remedial measures, with ongoing monitoring confirming this conclusion.
