Km 965 Alaska Highway Slope Stabilization Northern, British Columbia

Project Summary

The Alaska Highway Slope Stabilization Project was a Design Build project carried out to stabilize a problem slide area at Km 965 on the Alaska Highway above the Liard River and east and south of Watson Lake, BC.

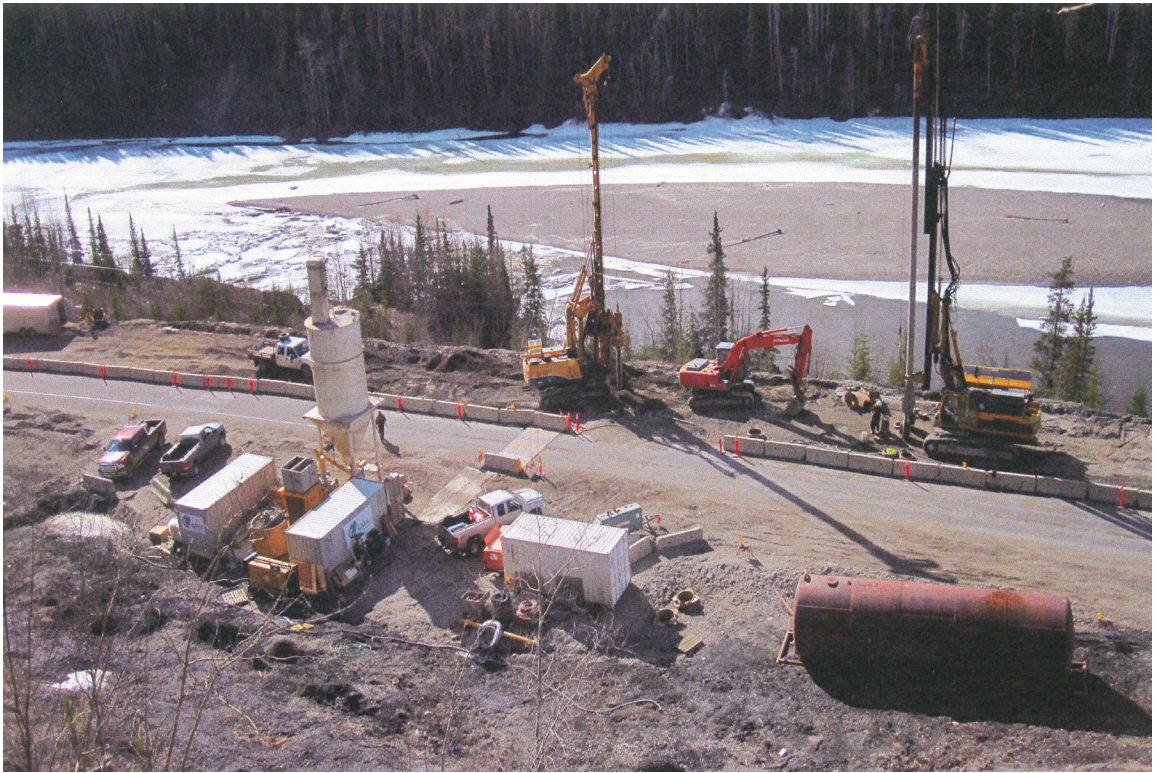
Layout of equipment on site

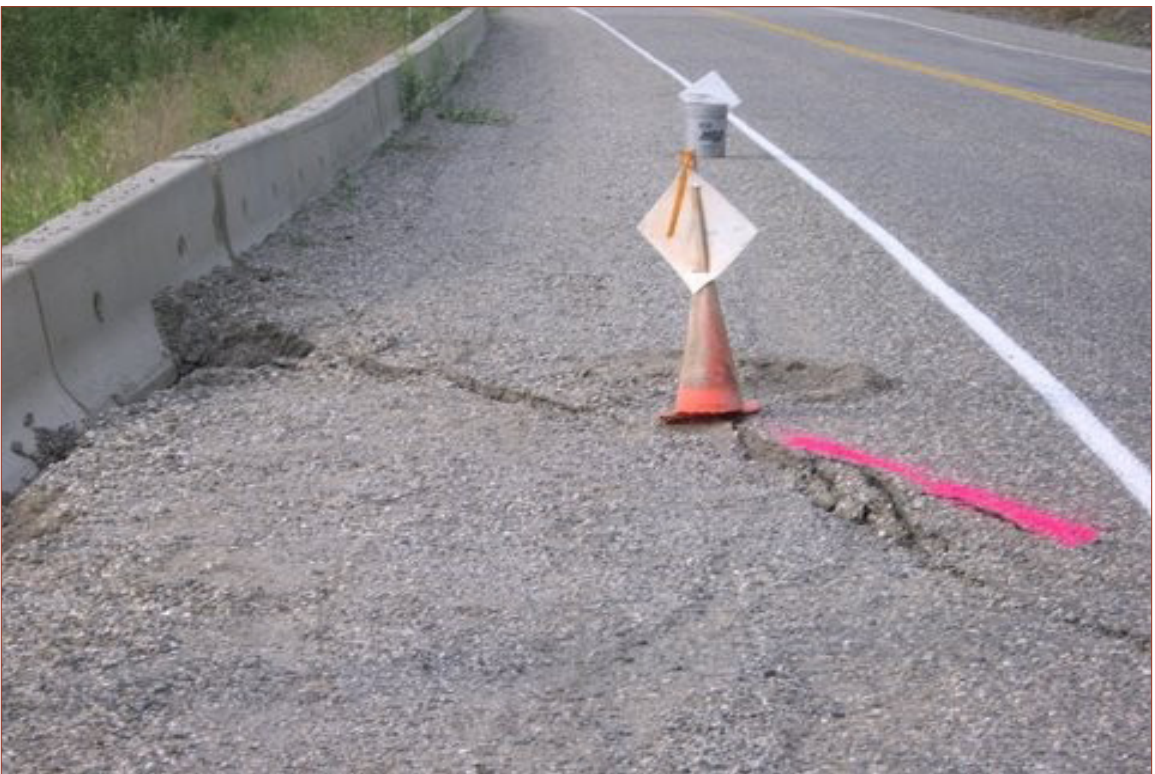
Cracks in pavement

The slope instability which was ongoing for many years was a continual maintenance problem and in 2009 a sinkhole had appeared in the pavement structure directly associated with the slope movement. This situation was becoming critical to road maintenance and needed to be stabilized and repaired for continual road performance. If such a situation were to continue the safety of the road would be impacted and the risk for vehicle damage and potential loss of life due to traffic leaving the road embankment was high.

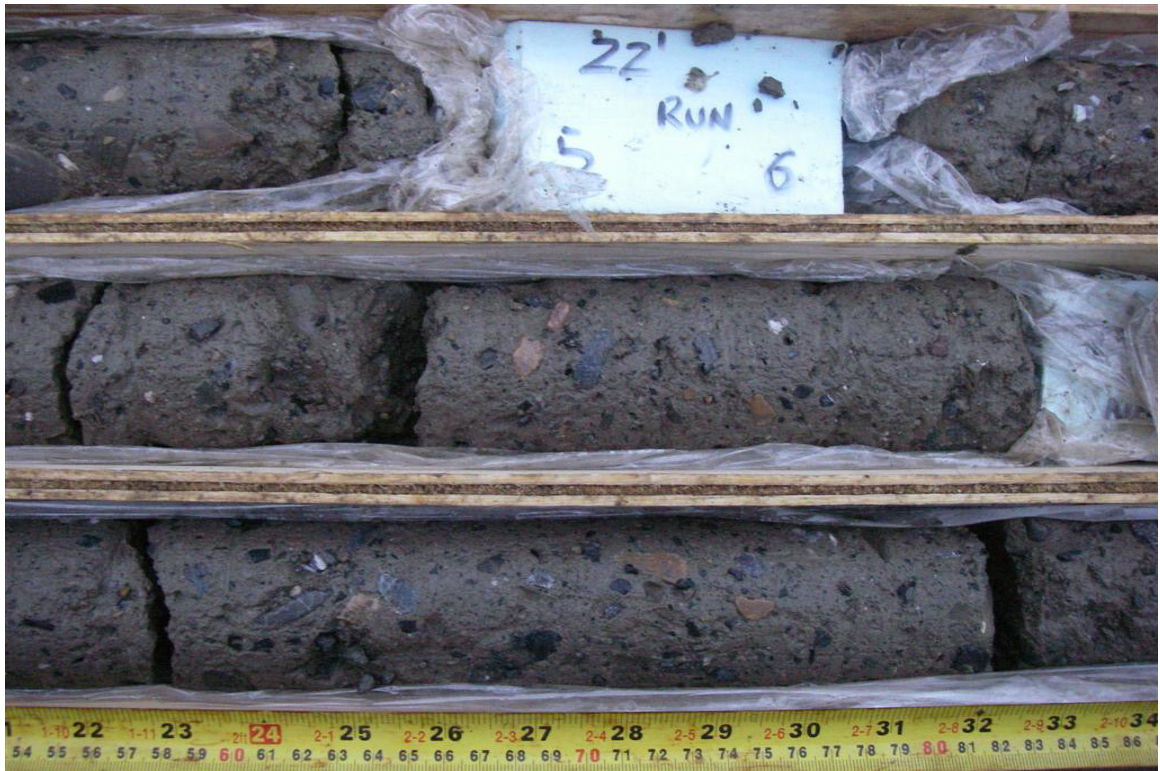
Typical cement/soil mix core

following construction all panels were core drilled and the representative samples of the cored soil/cement tested. These test assured compliance to the compressive strength requirements established from the finite element analyses.

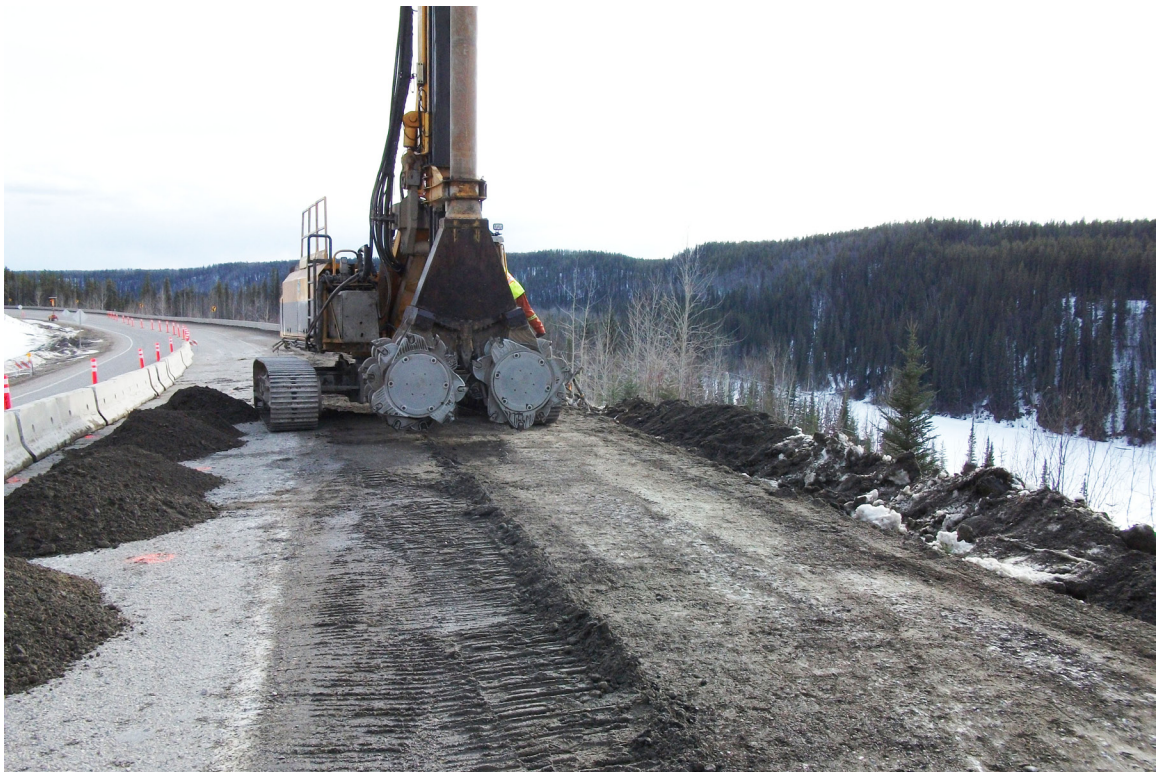
Cutter soil mixing equipment

Cutter Soil Mixing (CSM) equipment consisted of a system capable of cutting and blending the *in situ* soils using cutter wheels which rotate about a horizontal axis and which introduces a suitably designed and controlled cement slurry through a nozzle situated within the cutter head. The equipment was capable of recording applied cutter wheel torque, cutter wheel speed, slurry volume delivery per increment of depth (such increment not to exceed 0.5 m), and cutter head position in all three planes to an accuracy of at least 0.1 m, in real time.

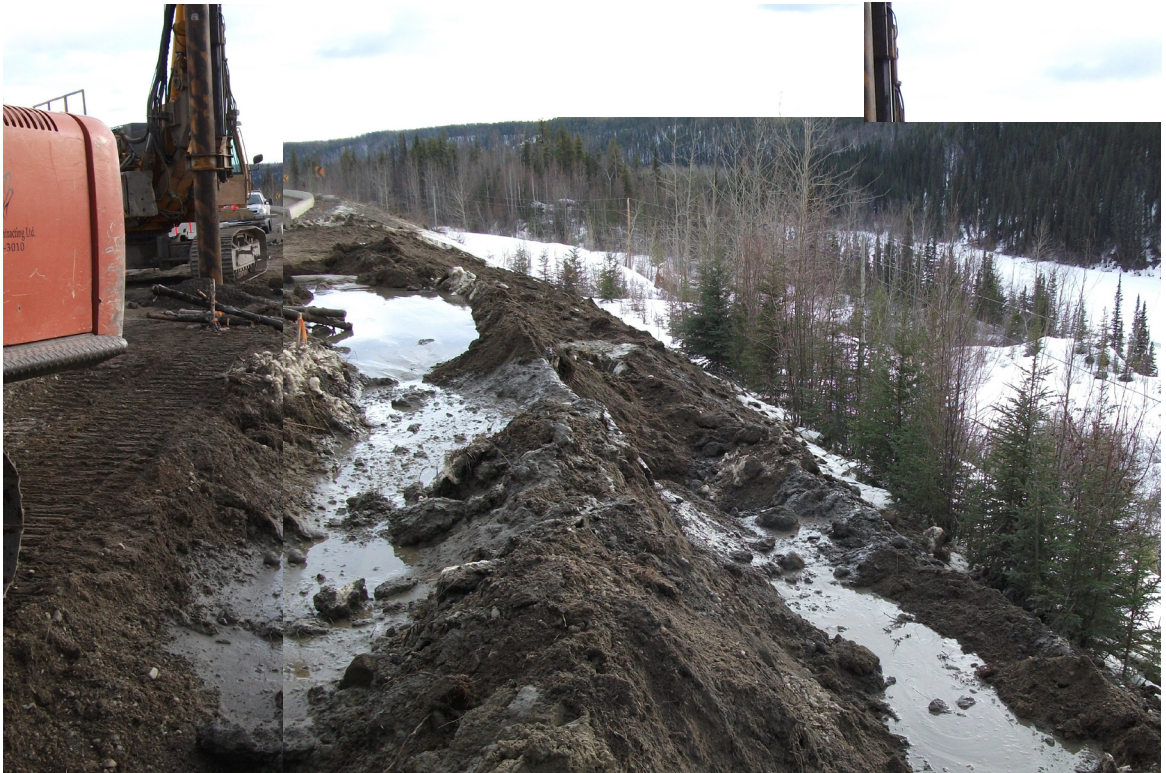
Location of barrette construction

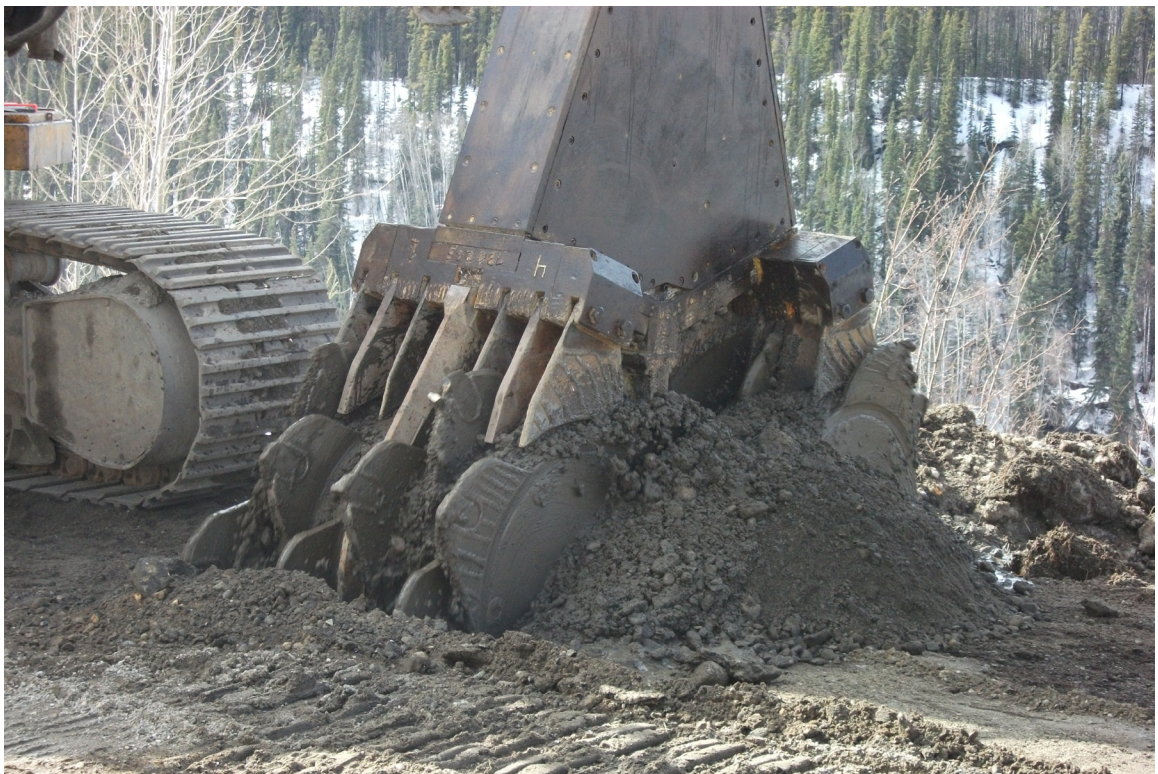
Cutter penetrating road embankment

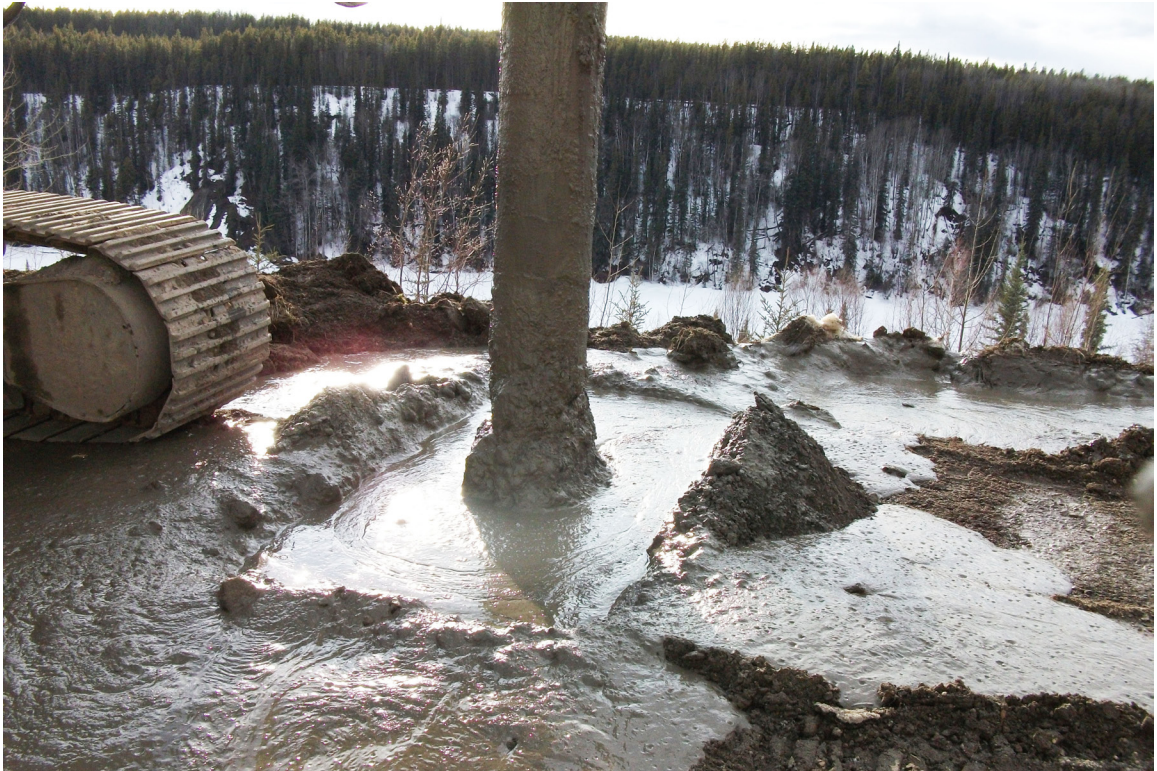
Trench of cement mixed soil

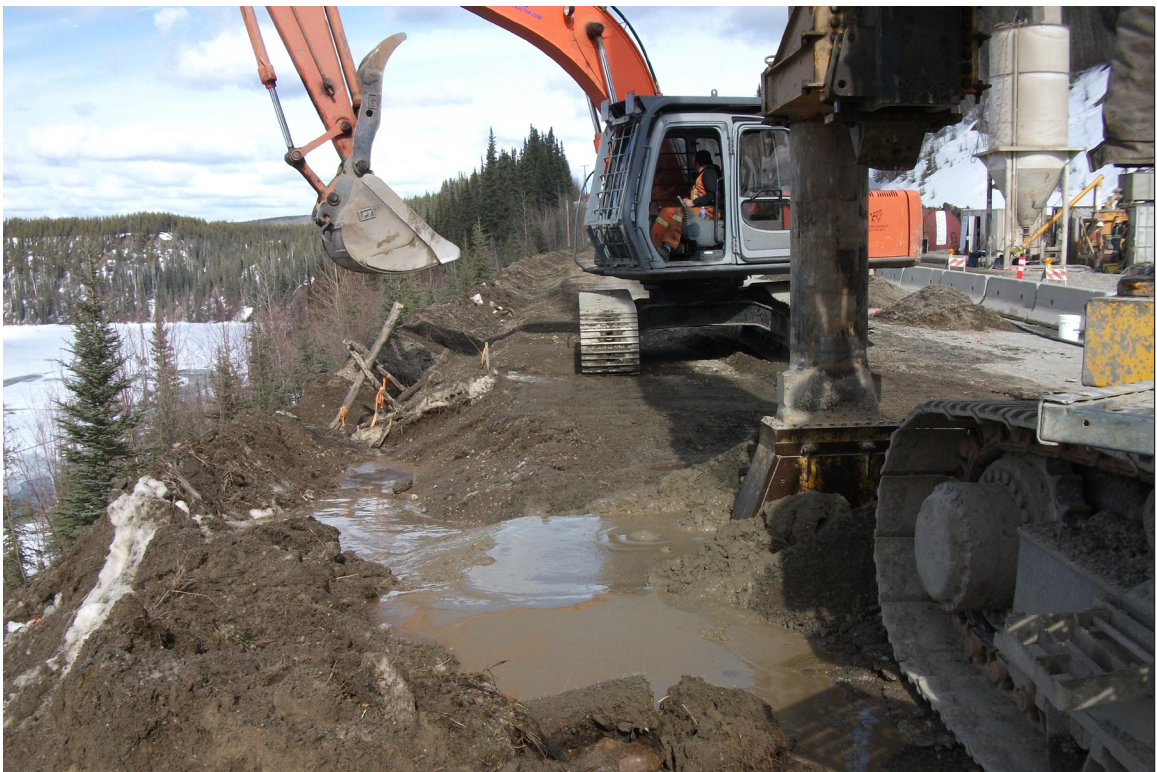
Barrette construction

Thirty seven (37) Cutter Soil Mixed (CSM) *in situ* Barrette Shear walls were constructed with a minimum completed dimension of 5.5 m by 1.0 m in plan, and extended through overburden soils comprising silty sands and sandy silts with gravel and cobbles to depths of between 10 m and 13 m. Completed soil mixed shear walls had a specified design minimum 28 day unconfined compressive strength of 1.5 MPa over the bottom 8.0 m of constructed wall, and a minimum 28 day unconfined compressive strength of 1.0 MPa over the remainder of the wall.

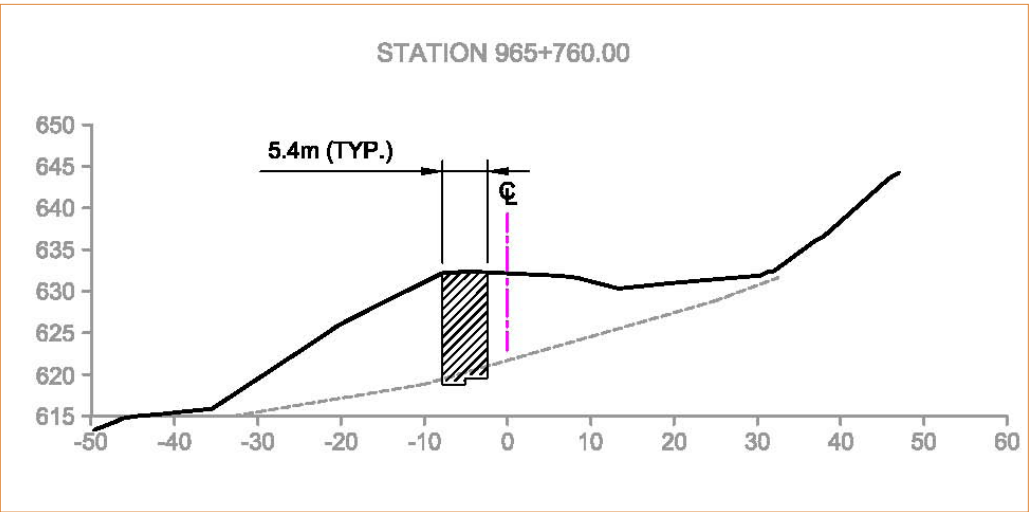
Typical Section

The embankment stabilization works is a series of barrettes (panels) consisting of a mixture of soil and cement blended into a homogenous mixture using a Bauer manufactured deep soil mixing machine. The stabilizing barrettes were oriented perpendicular to the road alignment, approximately parallel to the direction of movement of the embankment. The panels had a minimum wall thickness (along the road alignment) of 1 m and a minimum length of 5.4 m (perpendicular to the road alignment). The spacing of the barrettes was dependent on several factors including; the strength of the embankment materials; the selected strength and modulus of the soil-cement; arching capability of the soil between the panels and compressive and tensile stresses mobilized within the panels resulting from loads imposed on the panels. This barrette spacing was established by detailed analysis at 5 m. The barrettes extended a minimum depth of 1 m into competent bedrock to mobilize the resistance required to provide an overall minimum global factor of safety of 1.5 against continued sliding. The barrettes were situated between the existing highway and the Liard River to optimize the stabilizing benefit of the panel (i.e. located as close as reasonably accessible to the initial failure area) as well as limiting the amount of disturbance to the existing highway and lower portions of the existing embankment.
