Natural Resources Canada Headquarters Booth Street Complex Environmental Remediation Project

CATEGORY: ENVIRONMENTAL REMEDIATION

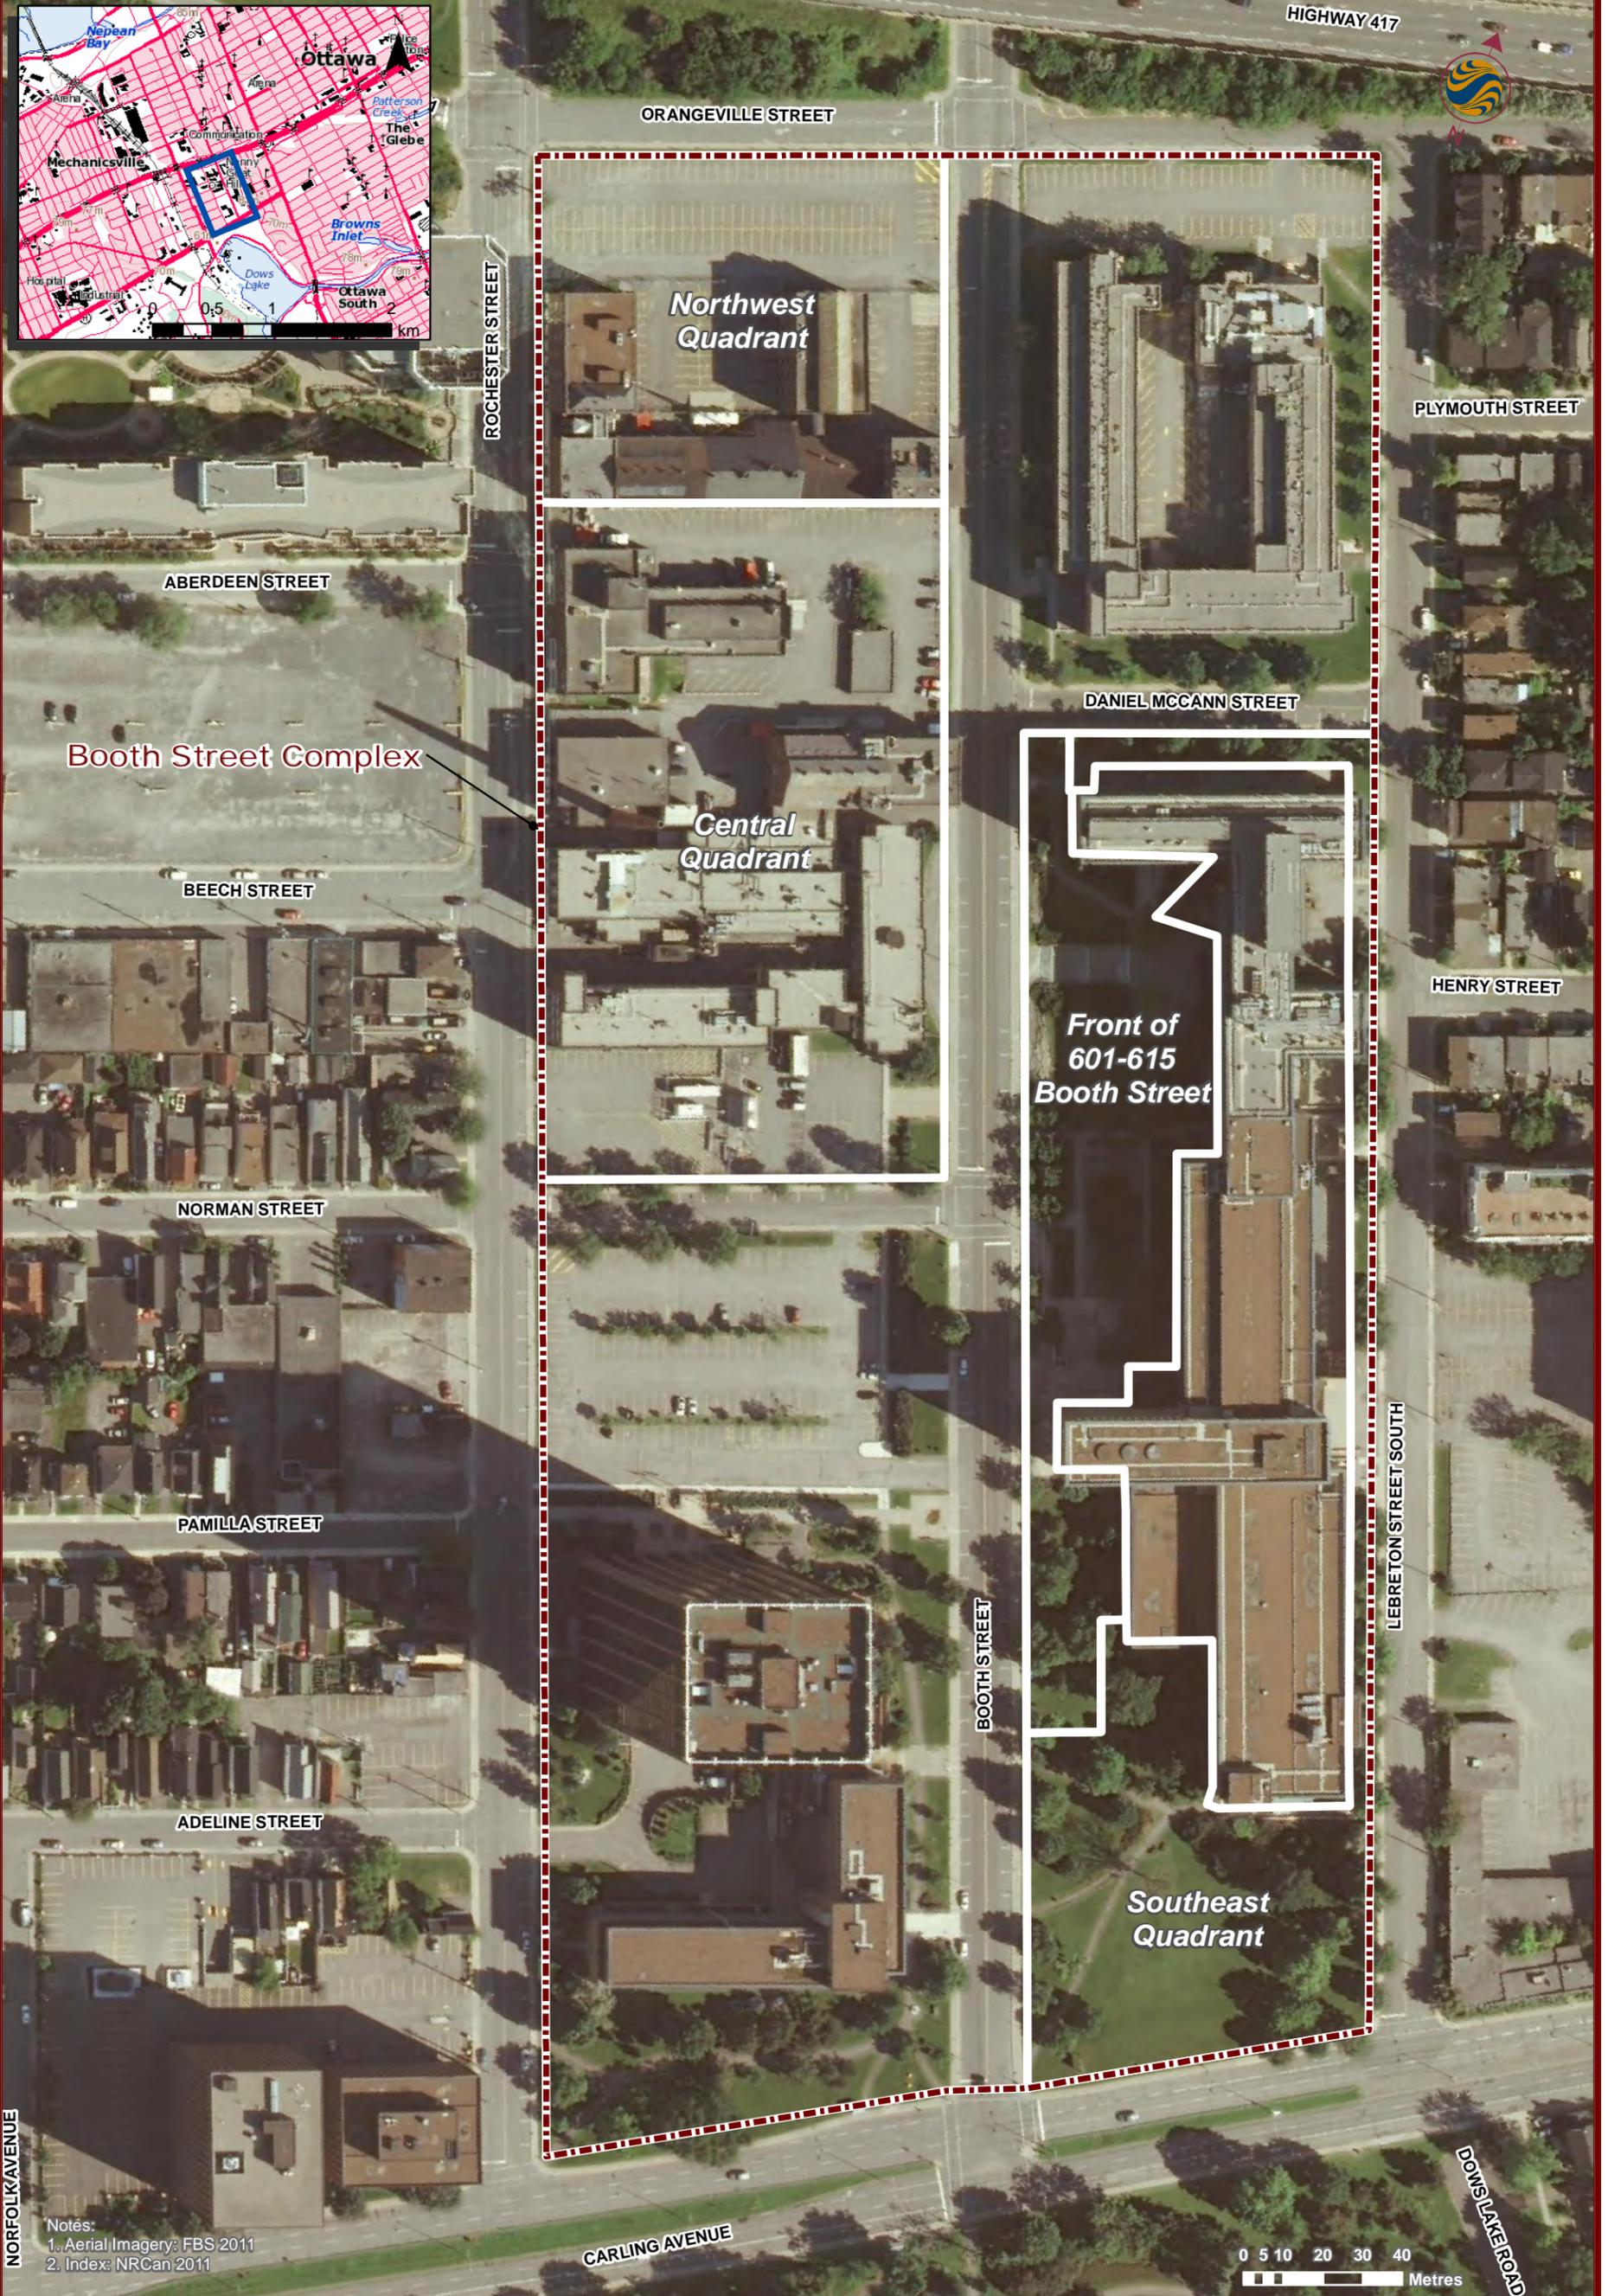
Figure 1: Current site configuration of the BSC

Booth Street Complex Remediation Quadrants

The Booth Street Complex (BSC) is prominently located in Central Ottawa and is occupied by over 3000 people. It has been owned by Natural Resources Canada (NRCan) since the 1930s and serves as NRCan's National Headquarters. The Complex houses a variety of facilities including administrative offices, national air photo libraries, research facilities, commercial space, and a children's daycare. Figure 1 provides an air photo of the current site configuration of the BSC.

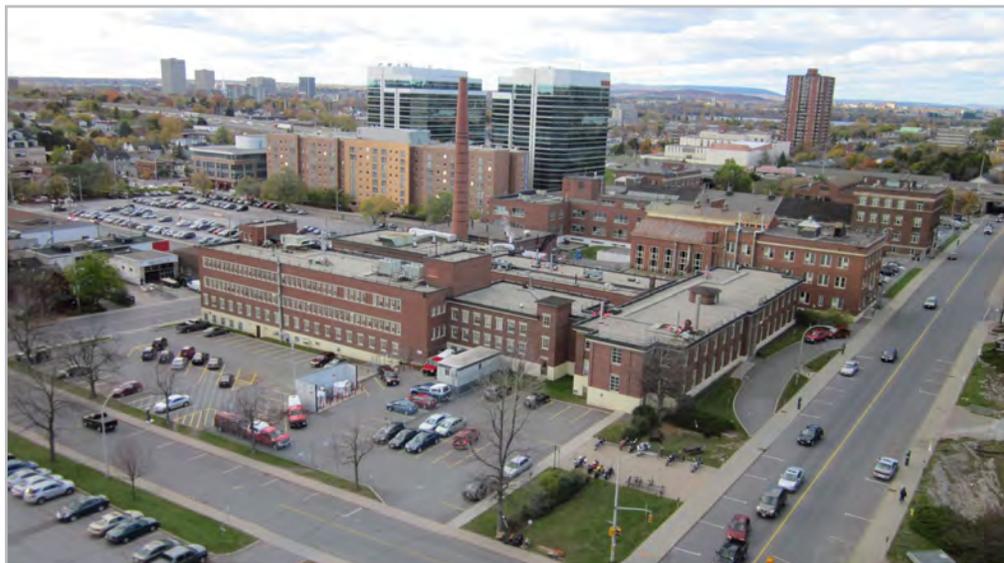
Central and Northwest Quadrants before remediation

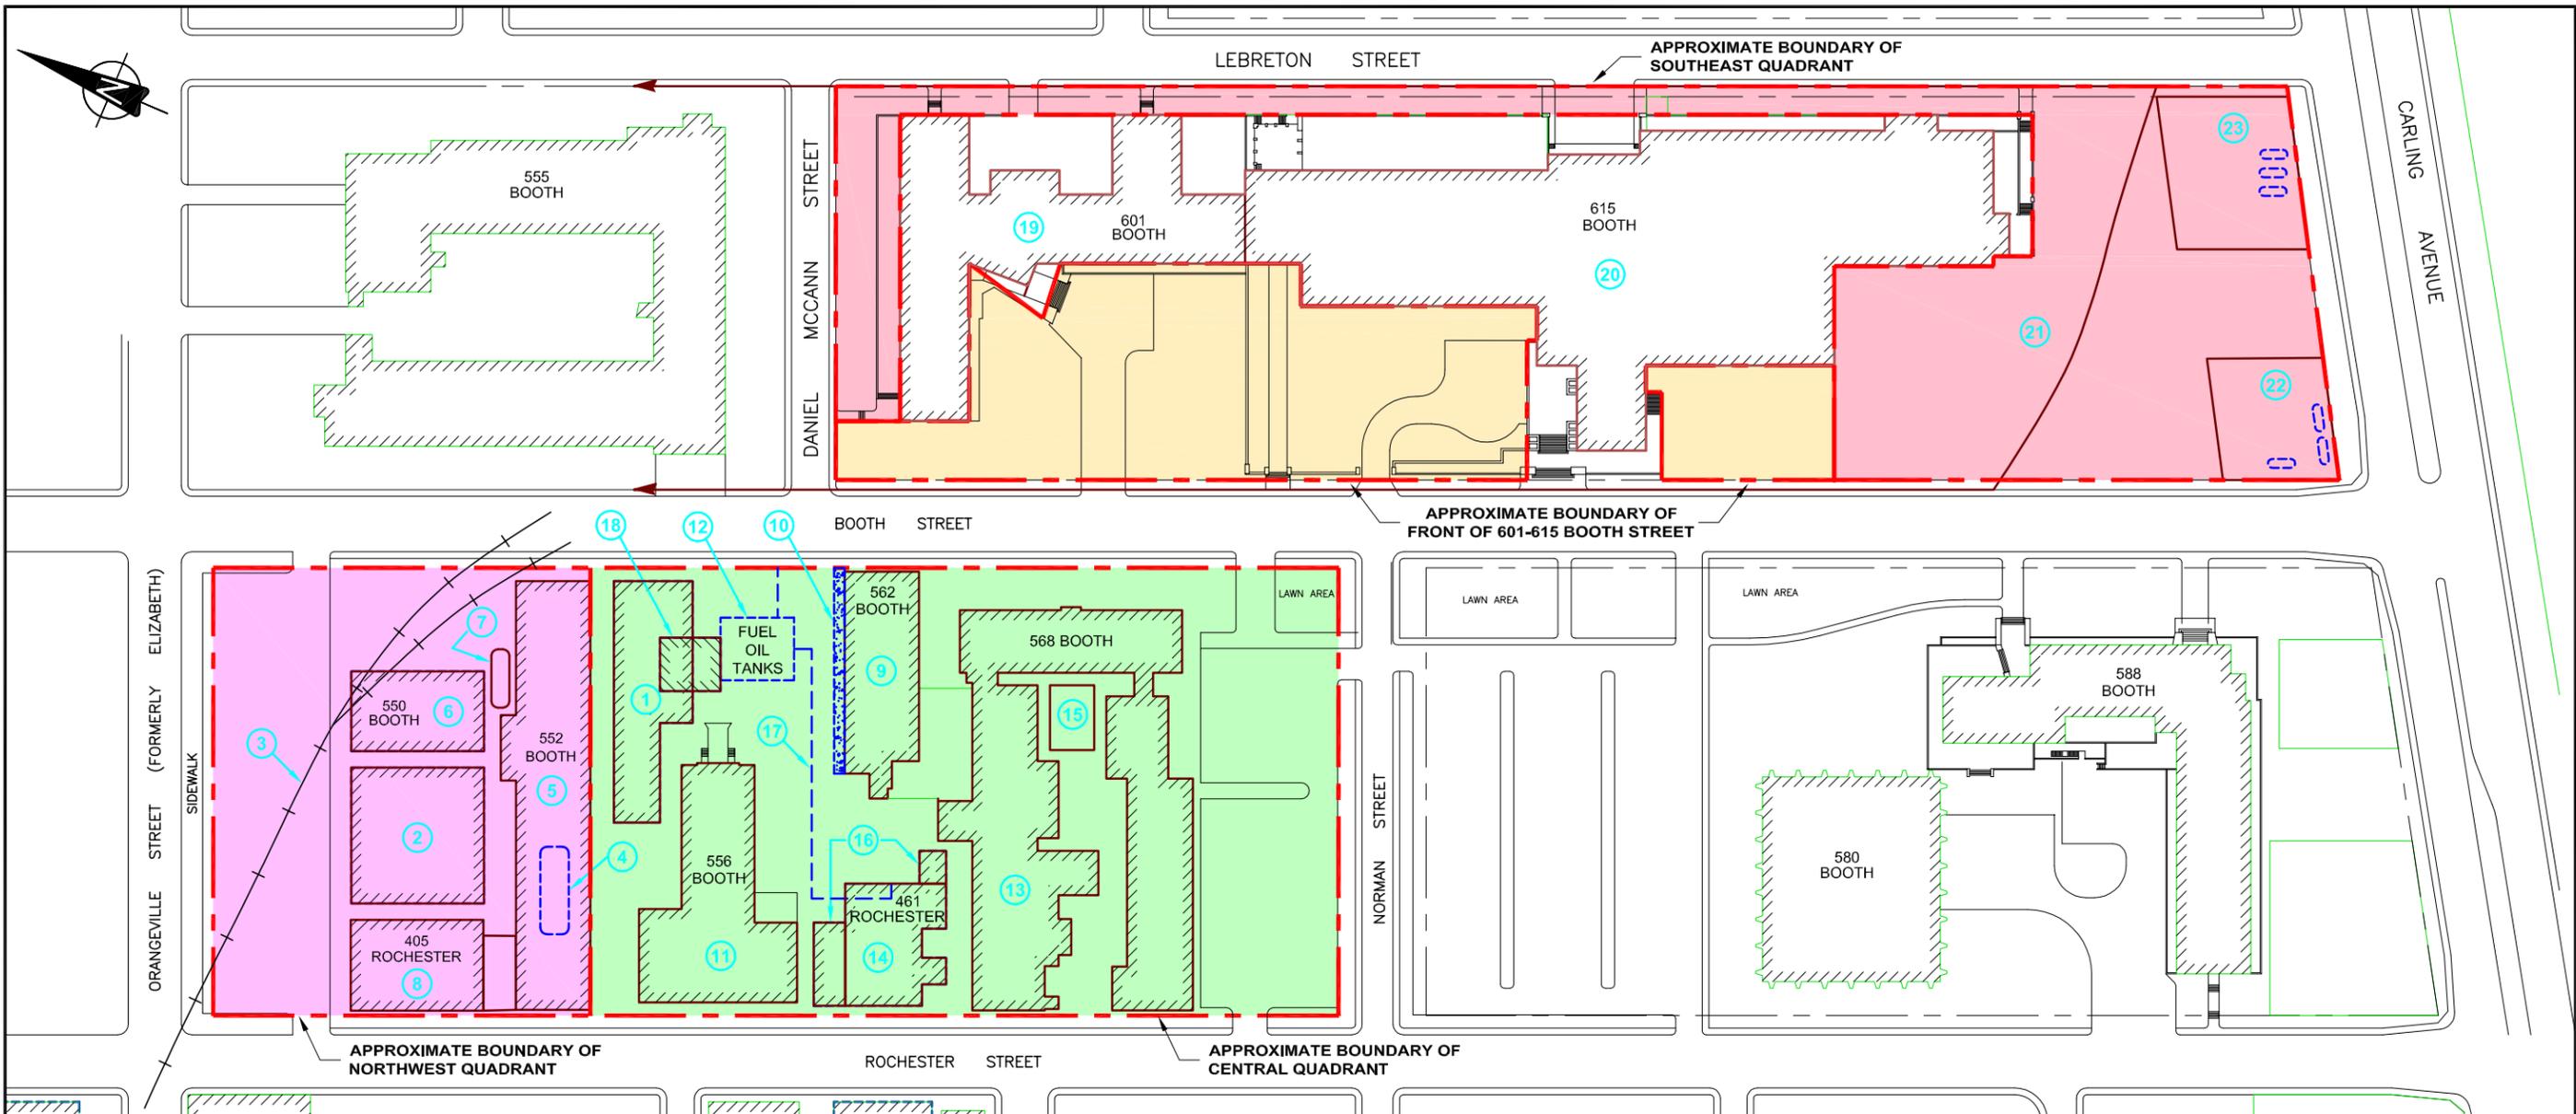
Reference:	Job No.:	122510217	Client:	NATURAL RESOURCES CANADA	SOIL REMEDIATION	POTENTIAL SOURCES OF ENVIRONMENTAL CONCERN	Dwg. No.:	2	
	Scale:	1 : 1500							
	Date:	11/04/28							
	Dwn. By:	GBB							
App'd By:		Site Address:	BOOTH STREET COMPLEX OTTAWA, ONTARIO

SOURCES OF POTENTIAL CONCERN

| <p>1. FORMER AUTO GARAGE/MACHINE SHOP. FORMER LABORATORY – RADIOACTIVITY AND ELECTRICAL. FORMER COKING OVEN/COAL STORAGE SHED.</p> <p>2. FORMER BURIED/PILED WASTES. TWO FORMER QUONSET HUTS – LABORATORY – RADIOACTIVITY, MINING AND COMBUSTION/COAL/FUEL RESEARCH.</p> <p>3. FORMER CNR.</p> <p>4. FORMER UST.</p> <p>5. LABORATORY – ORE DRESSING, FUELS/COAL, INDUSTRIAL MINERAL, CONCRETE TESTING. FORMER LUMBER YARD/ORE AND</p> | <p>MINERAL WASTES DISPOSAL. FORMER HAZARDOUS WASTE BARREL STORAGE.</p> <p>6. FORMER CRN AND BAG HOUSE LABORATORY – ORE DRESSING, INDUSTRIAL MINERAL TESTING. FORMER PCB AND ORE STORAGE IN PARKING LOT.</p> <p>7. FORMER CORRODED DRUM STORAGE.</p> <p>8. LABORATORY – ORE DRESSING, CONCRETE, INDUSTRIAL MINERAL TESTING. REGISTERED HAZARDOUS WASTE</p> | <p>GENERATOR REGISTERED PCB STORAGE SITE.</p> <p>9. LABORATORY – COAL/GAS, COKE BYPRODUCT, DUST (METALS), SEA WATER CORROSION, URANIUM, CHEMICAL TESTS. FORMER FOUNDRY AND HAZARDOUS WASTE BARREL STORAGE.</p> <p>10. FORMER OIL STAINING.</p> <p>11. PAINT SHOP. FORMER MACHINE SHOP, WORK YARDS. LABORATORY. FORMER PCB AND HAZARDOUS WASTE. BARREL STORAGE AND DISPOSAL ON-SITE. REGISTERED HAZARDOUS WASTE</p> | <p>GENERATOR. REGISTERED PCB STORAGE SITE.</p> <p>12. FORMER USTs – TWO OF THE THREE FORMER USTs (54,600 L) WERE LEAKING UPON REMOVAL. CURRENTLY CONCRETE BUNKER – TWO 125,000 L ASTS (NO. 2 OIL). FUEL SPILL FROM BUNKER IN 1987.</p> <p>13. FOUNDRY AND LABORATORY – PHOTO PROCESSING AND METALS TESTING. X-RAY MACHINERY. HYDRAULIC OIL SPILL. FORMER UST. AST FOR HEATING OIL. DEGREASER PIT. WASTE STORAGE IN FOUNDRY.</p> | <p>5,000 L WASTE OIL DISPOSED OF ON-SITE. REGISTERED HAZARDOUS WASTE GENERATOR. REGISTERED PCB STORAGE SITE.</p> <p>14. CENTRAL HEATING PLANT – COAL, NO. 2 HEATING FUEL, AND NOW GAS POWERED. HYDRAULIC LOADING DOCKS. BULK FUEL STORAGE. SUMPS, FLOOR TRENCHES AND DRAINS. FUEL OIL DISCHARGES TO COMBINED SEWER FROM SUMP. NO OIL/WATER SEPARATOR AT SUMP OR DRAINS. CHEMICAL TREATMENT FACILITY. MACHINERY STORAGE.</p> | <p>FUEL LINES BETWEEN BOILERS ARE RUSTED/LEAK.</p> <p>15. DRUM STORAGE. LEAKING TRANSFORMER. CORRODED BAG HOUSE BARRELS.</p> <p>16. FORMER COAL STORAGE.</p> <p>17. UNDERGROUND FUEL TRENCH.</p> <p>18. FORMER BUTLER BUILDING.</p> <p>19. 601 BOOTH STREET – PRINT SHOP AND LABORATORIES. GENERATOR OF HAZARDOUS WASTE</p> <p>20. 615 BOOTH STREET – PRINT SHOP AND LABORATORIES – PCBs STORED ON-SITE – GENERATOR OF HAZARDOUS WASTE</p> <p>21. FORMER RAIL YARD AND TRACKS</p> | <p>22. FORMER GARAGE/AUTO REPAIRS – 3 USTs</p> <p>23. FORMER GASOLINE SERVICE STATION – 3 USTs</p> |

Figure 2 presents a summary of historical activities of environmental concern that have occurred at the BSC.

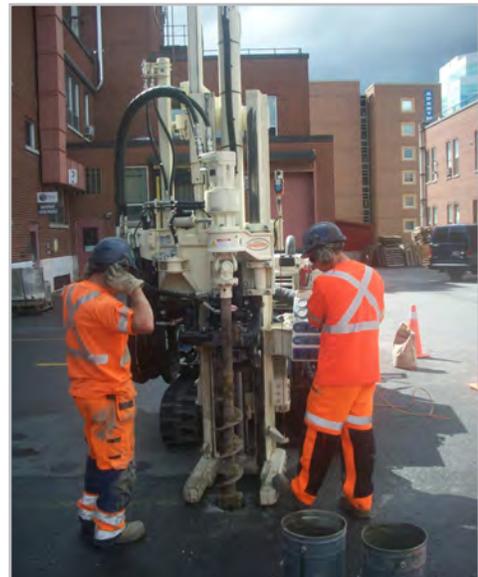
Drilling a borehole using a solid stem auger drill rig

Based on the results of the Phase I ESA and the Data Gap Analysis, a detailed field program or a Phase II ESA was initiated in 2009 to obtain updated soil and groundwater data where needed to confirm the best approach to remediate the BSC. The field program included a total of 145 boreholes and the instrumentation of 30 holes as groundwater monitoring wells. The boreholes were advanced across the BSC using multiple drilling methods (e.g. portable, direct push, solid stem auger, diamond coring, etc) based on the accessibility of the borehole location and the subsurface conditions anticipated.

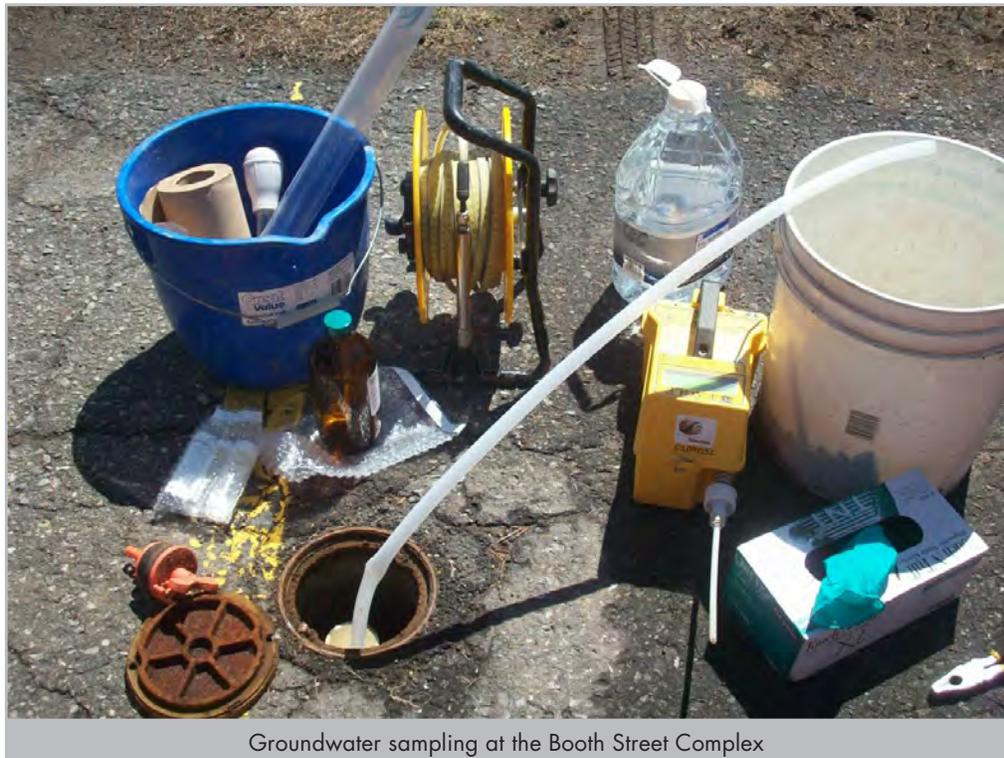
Groundwater sampling at the Booth Street Complex

The depth to groundwater was measured in all recently installed monitoring wells, as well as all accessible historical monitoring wells. The depth to groundwater ranged from between 2.0 and 9.8m bgs and was generally within the bedrock. Groundwater samples were collected from the recent and historical monitoring wells and submitted for analyses of the project contaminants of concern.

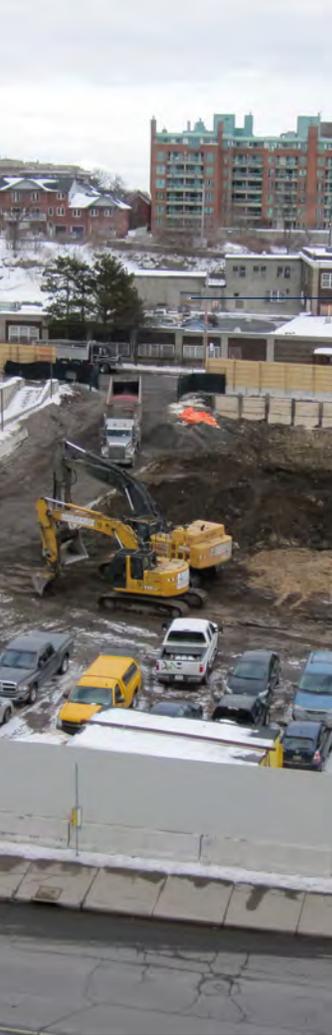
Excavating through frozen ground in the Southeast Quadrant

Excavating in frozen ground, particularly with a collection of older active and abandoned utilities and underground structures – both known and unknown, is difficult. Further complicating the issue at the BSC was the age of the buildings adjacent to many of the excavations and limited information regarding the building foundations and underlying materials. Test excavations were completed adjacent to buildings to confirm the type and condition of the building foundations, and hydrovac equipment was used where possible to confirm the location or condition of known utilities since excavating by hand as is typically done in warmer conditions, is difficult and time consuming in frozen ground. Exposed building foundations and underground services were protected from freezing to prevent damage.

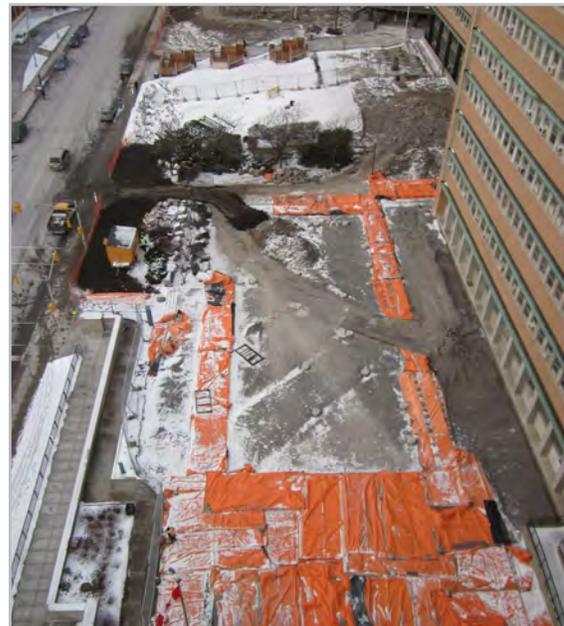
Protection of exposed features and concrete from freezing during the remediation of the front of 601-615 Booth St in the Southeast Quadrant

Protection from freezing temperatures was also a design requirement for the concrete retaining walls, curbs, walkways, stairs, fuel containment structures, and pads in the Central Quadrant. A combination of insulated tarps, heaters, and glycol lines were used to maintain the design temperatures needed to ensure the integrity and strength of the concrete.

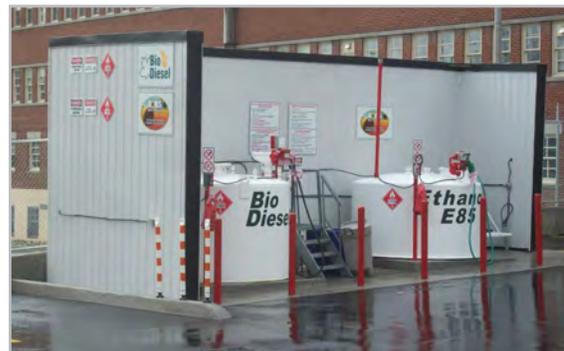
Reinstated vehicle fuel tanks in Central Quadrant

The reinstatement of the vehicle pool area in the Central Quadrant presented a unique challenge to the team. The vehicle pool area was a small fenced area within the south parking lot in this quadrant and included biodiesel and ethanol fuel tanks used to fuel a fleet of NRCan vehicles. The pre-remediation layout of this area did not function very well for the occupants and a slight redesign was requested as part of the reinstatement. A coordinated multi-disciplinary team of engineers was involved in redesign of the area which included the following key elements.

- Enlarge the fenced area to facilitate refilling the fuel tanks.
- Replacement of an approximately 3:1 slope with a 29.5-m long concrete retaining wall to add additional parking spaces.
- Redesign the parking lot grading and relocating catchbasins to provide proper surface water drainage without altering the drainage to neighbouring City property.
- Designing a concrete structure comparable to a 10,000-L concrete bathtub positioned to work in conjunction with the revised site grading and serve as a secondary fuel containment area in the event of a fuel spill. The secondary containment area was needed to ensure the fuel tank area applies with applicable federal standards.

- Parking lot light standards and electrical outlets in the vicinity of the fuel tanks were replaced with explosion-proof fixtures as required by applicable codes.
- Relocation of fuel tank emergency shut-offs to enhance employee safety.
- Installation of extra subsurface electrical conduit to facilitate the anticipated future installation of electrical power outlets for vehicle charging stations and the addition of automated, secure gates to vehicle fuel area.
