IMROSE
HOTEL

Canadian Consulting Engineering Awards 2016

111 Carlton Building Renew

Read Jones Christoffersen Ltd.

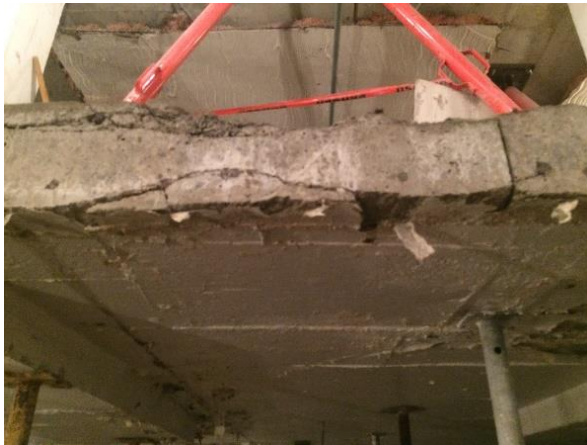
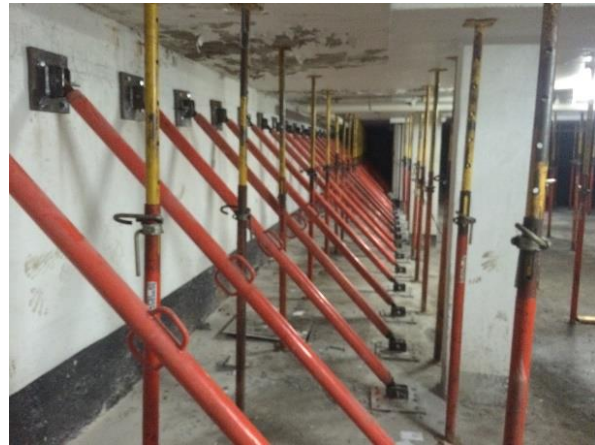
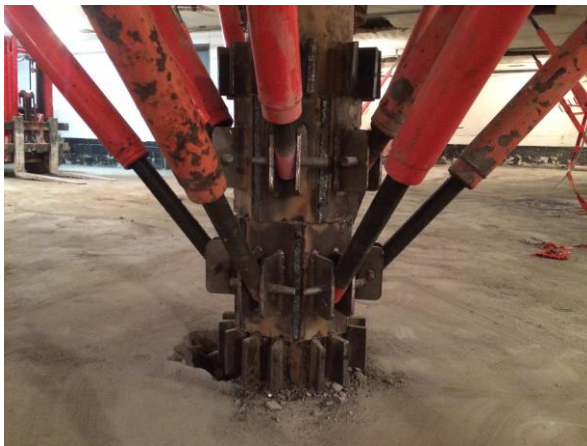
- The underground parking structure, which included the wholesale demolition and reconstruction of the upper parking level structural slab.
- The entrance/exit ramp down to the underground parking, which included the removal of the existing concrete topping and ineffective waterproofing system and replacement with a new hot rubberized waterproofing and asphalt paving system complete with a new embedded electrical snow melting cables.
- The podium deck around the perimeter of the ground floor of the building (i.e. the basement roof slab), which included the removal of an existing concrete topping, extensive structural slab restoration and the installation of a new waterproofing system and architectural concrete topping.

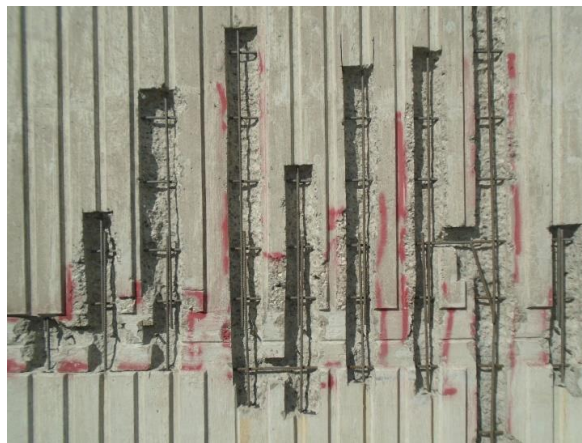
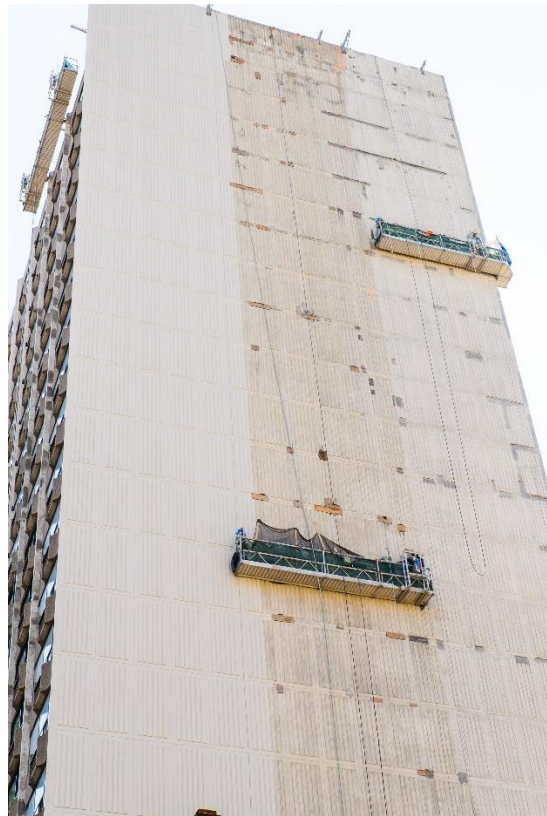
- The building's main east and west exterior walls and shear wall ends, which included extensive concrete repairs requiring a mast lift to undertake the installation of a new protective coating on all concrete elements.

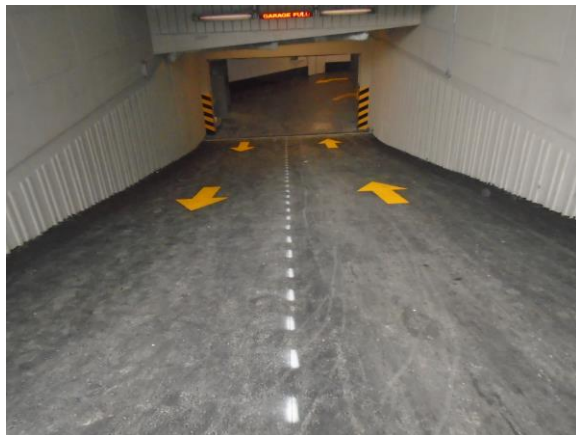
- The surface of the upper parking level slab and interconnecting ramps.
- On the surface of the entrance/exit ramp complete with a new electric snow melting system.
- On the surface of the podium deck slab, including a new concrete topping driving surface.
- The replacement of the roofing system on the upper main roof.
