CCE AWARDS SUBMISSION

BANK STABILIZATION – HOME ROAD

PROJECT SUMMARY

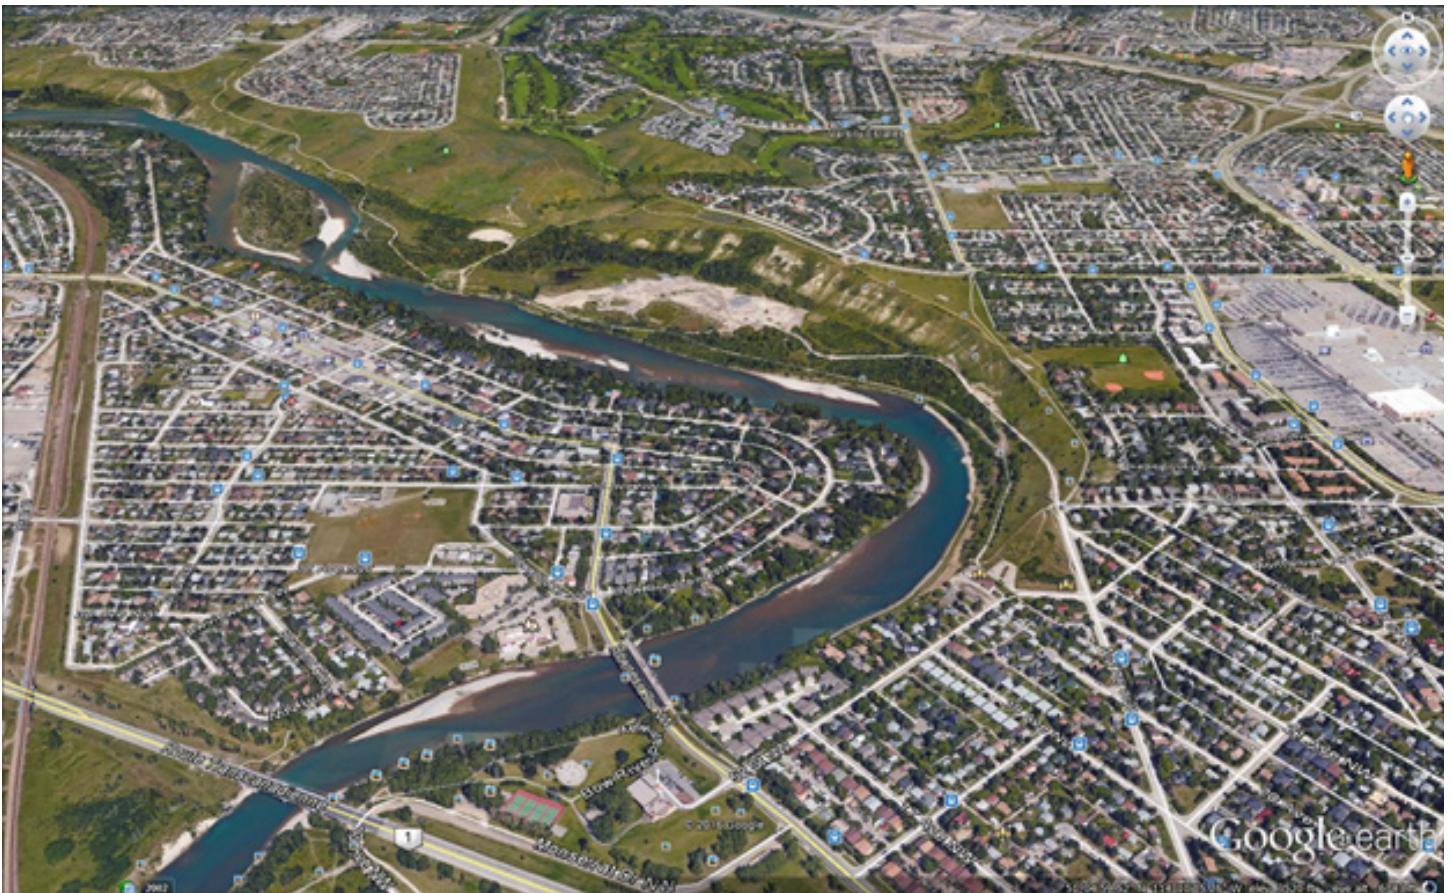
From a geotechnical perspective, the area is also the site of an historic slide. Over time the large bank, shown in Figure 1, is moving into the river. Geotechnical services, including drilling investigations, were conducted to gain an appreciation of the bank stability to secure the morphology of the river for years to come. Figure 1 and 2, show the extent to which the river was inundated. This combined with the shift of the bank over time, posed increased challenges in ensuring immediate and future stability.

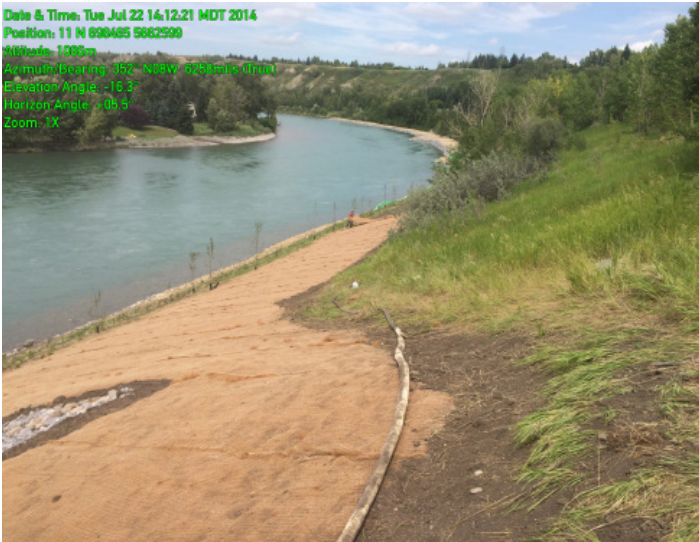
Photo 1

Date & Time: Tue Jul 22 14:12:21 MDT 2014
 Position: 11 N 698465 5662599
 Altitude: 1009m
 Azimuth/Bearing: 192° S68W 0230mils (True)
 Elevation Angle: -16.3°
 Horizon Angle: -06.5°
 Zoom: 1X

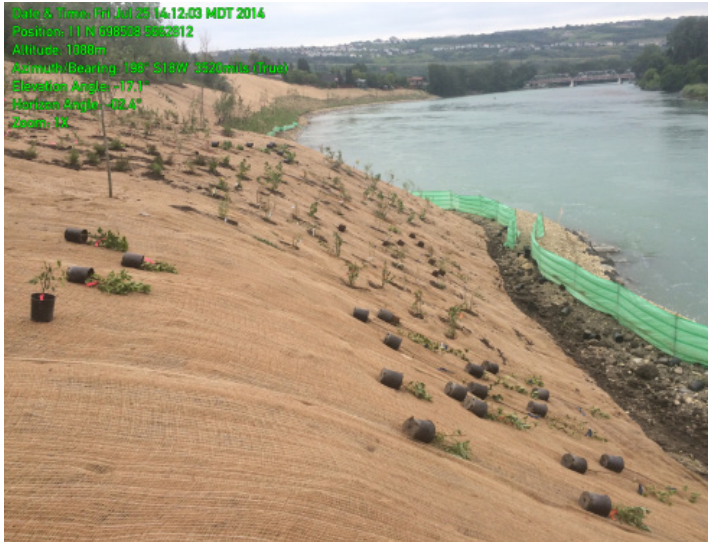
Photo 2

Date & Time: Fri Jul 25 14:12:03 MDT 2014
 Position: 11 N 698905 5662612
 Altitude: 1008m
 Azimuth/Bearing: 168° S70W 3250mils (True)
 Elevation Angle: -17.1°
 Horizon Angle: -08.4°
 Zoom: 1X

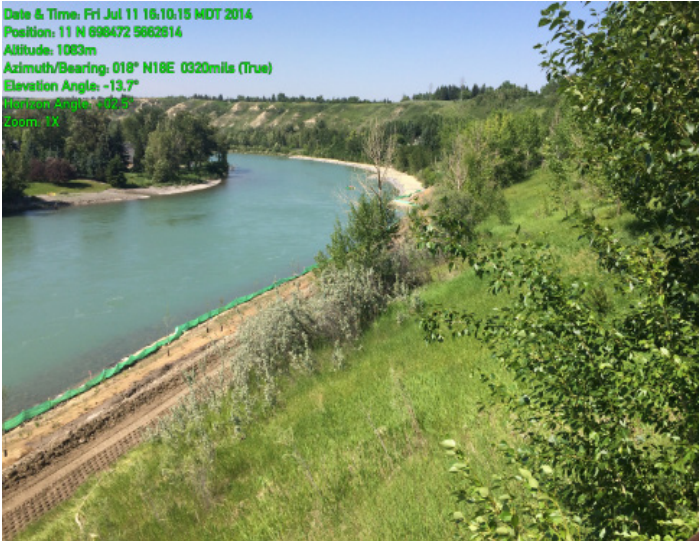
Photo 3

Date & Time: Fri Jul 11 16:10:15 MDT 2014
 Position: 11 N 698472 5662614
 Altitude: 1083m
 Azimuth/Bearing: 018° N18E 0320mils (True)
 Elevation Angle: -13.7°
 Horizon Angle: -06.5°
 Zoom: 1X

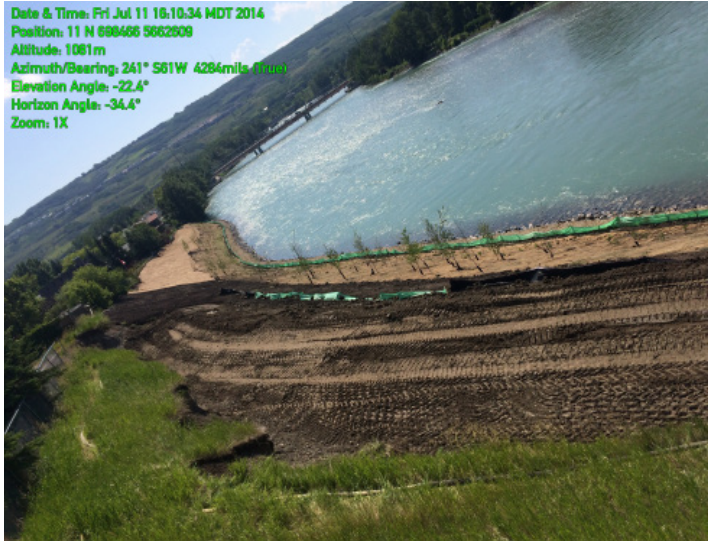
Photo 4

Date & Time: Fri Jul 11 16:10:34 MDT 2014
 Position: 11 N 698466 5662609
 Altitude: 1081m
 Azimuth/Bearing: 241° S61W 4284mils (True)
 Elevation Angle: -22.4°
 Horizon Angle: -34.4°
 Zoom: 1X
