CCE AWARDS SUBMISSION

**SAINT LUCIA'S JOHN COMPTON DAM (JCD)
DE-SILTING AND REHABILITATION PLAN**

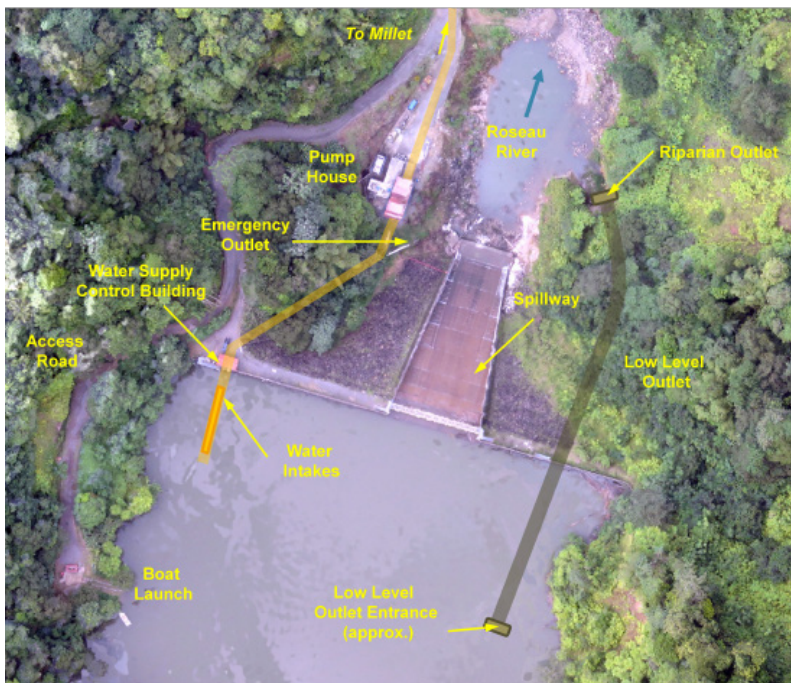
Figure 1: John Compton Dam General Arrangement (imagery from Golder UAV survey, October 2014).

The general configuration of JCD is shown on Figure 1.

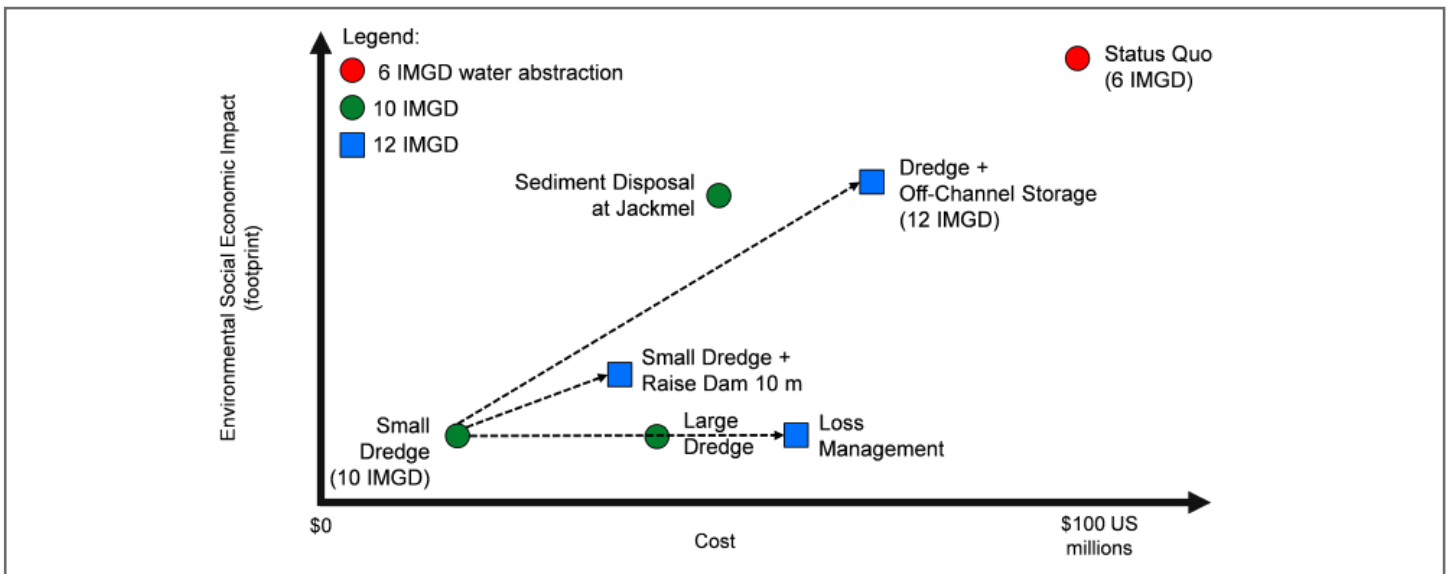
Figure 2: Summary Comparison of Selected Water Management Options

An assessment of benefits of costs was used to compare a short list of key options to de-silt the reservoir. The assessment priorities focused on restoring the water supply at a reasonable cost, providing management measures for long-term sedimentation, avoiding environmental impacts where possible, and facilitating further measures to enhance the water supply from Roseau River. The assessment results summarized on Figure 2 provide a basis for selecting a preferred option.

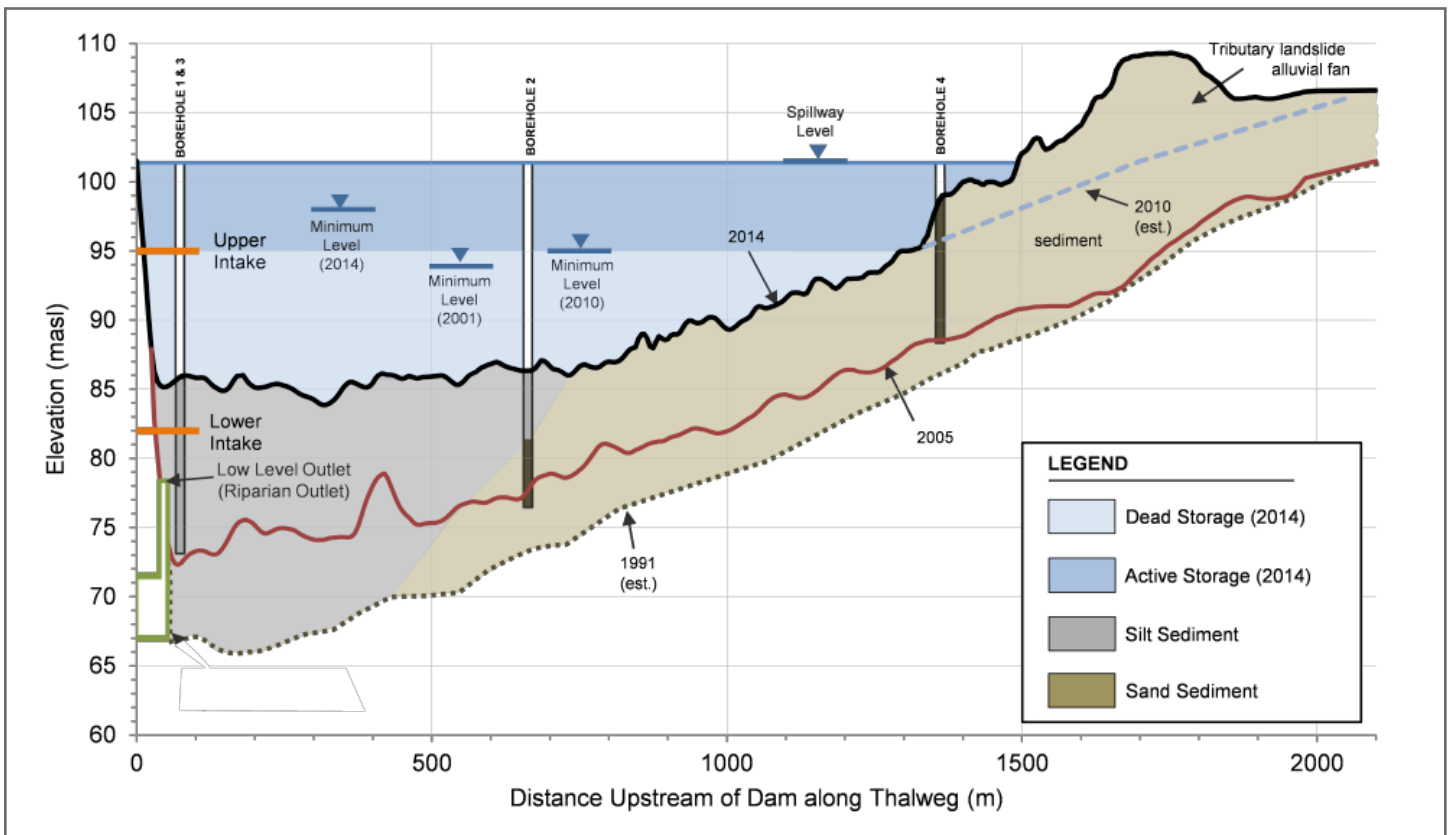
Figure 3: Distribution of Reservoir Sediment (as measured along the Original Roseau River Thalweg)

The original water storage capacity was 3 million m³. As of October 2014, there were at least 1.5 million m³ of sediment accumulation, of which 1.1 million m³ or 75% of the sediment is within the reservoir below the spillway elevation of 101.5 m. The remaining 0.4 million m³ is deposited on the upstream beach above the spillway elevation. About 2/3 of all the sediment was deposited as a result of landslides triggered during Hurricane Tomas in 2010.

Sediment covers the lower of the two water supply intake ports (see Figure 3) by 3 m to 4 m. The remaining upper intake port has access to the top 6.5 m of water in the reservoir. Below the lower port, the water in the reservoir is “dead” storage because it is not accessible at the intake elevation. The resulting water supply reliability is about 37%, implying that water rationing is needed in most years during the dry season, most likely in the months of March through June.

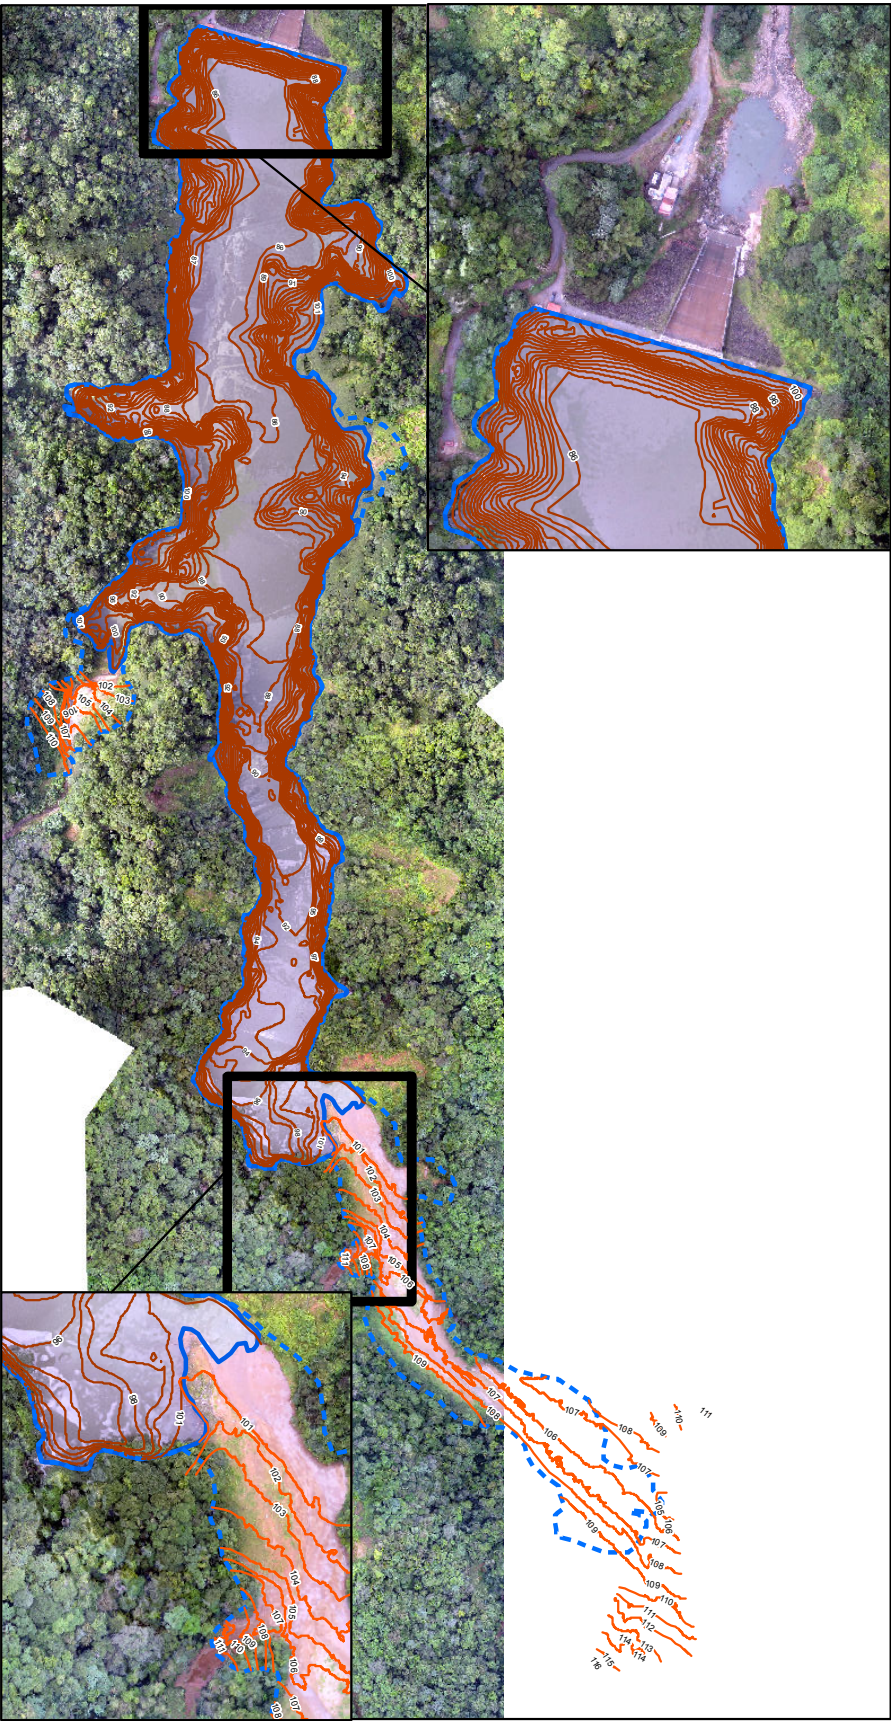
TITLE
RESERVOIR IMAGERY AND
SEDIMENT TOPOGRAPHY

- 1m CONTOUR (UAV SURVEY)
- 1m CONTOUR (BATHYMETRY)
- ROSEAU RESERVOIR AT 101m (2005) APPROXIMATE
- ROSEAU RESERVOIR AT 101.5m (2014)

REFERENCES)
IMAGERY AND TOPOGRAPHIC CONTOURS BASED ON UNMANNED AERIAL VEHICLE SURVEY BY
GOLDER ASSOCIATES ON OCTOBER 4, 2014. BATHYMETRY CONTOURS BASED ON
BATHYMETRY BOAT SURVEY BY GOLDER ASSOCIATES ON OCTOBER 8, 2014.
DATUM: WGS84 PROJECTION: UTM ZONE 20N

The local partners will also be the target of technology transfer through the construction phase of the project, and are expected to play a large role through construction. New technologies were also utilized, including an unmanned aerial vehicle (UAV) survey of the reservoir and sediment beach. The UAV survey allowed the project to accurately measure the quantity of beach sediment, and provided WASCO and local forest managers with the first high resolution imagery of the surrounding landslide areas. The attached map (Appendix B) shows the UAV imagery, the UAV-derived beach topography, and underwater bathymetry from a survey by boat.
