MAYERTHORPE RAIL BRIDGE REPLACEMENT MAYERTHORPE, ALBERTA

CANADIAN CONSULTING
ENGINEERING AWARDS 2017
KLOHN CRIPPEN BERGER

PROJECT NAME Mayerthorpe Rail Bridge Replacement

SUMMARY DESCRIPTION OF PROJECT Klohn Crippen Berger (KCB) was retained by CN to complete a site investigation, design and supervision construction for a rail bridge replacement near Mayerthorpe, Alberta destroyed by fire on April 26, 2016. The goal was to restore service to Whitecourt and beyond within 3 weeks, which was achieved and service was restored on May 15, 2016. KCB worked in close collaboration with CN and other contractors to facilitate the fast-tracked construction.

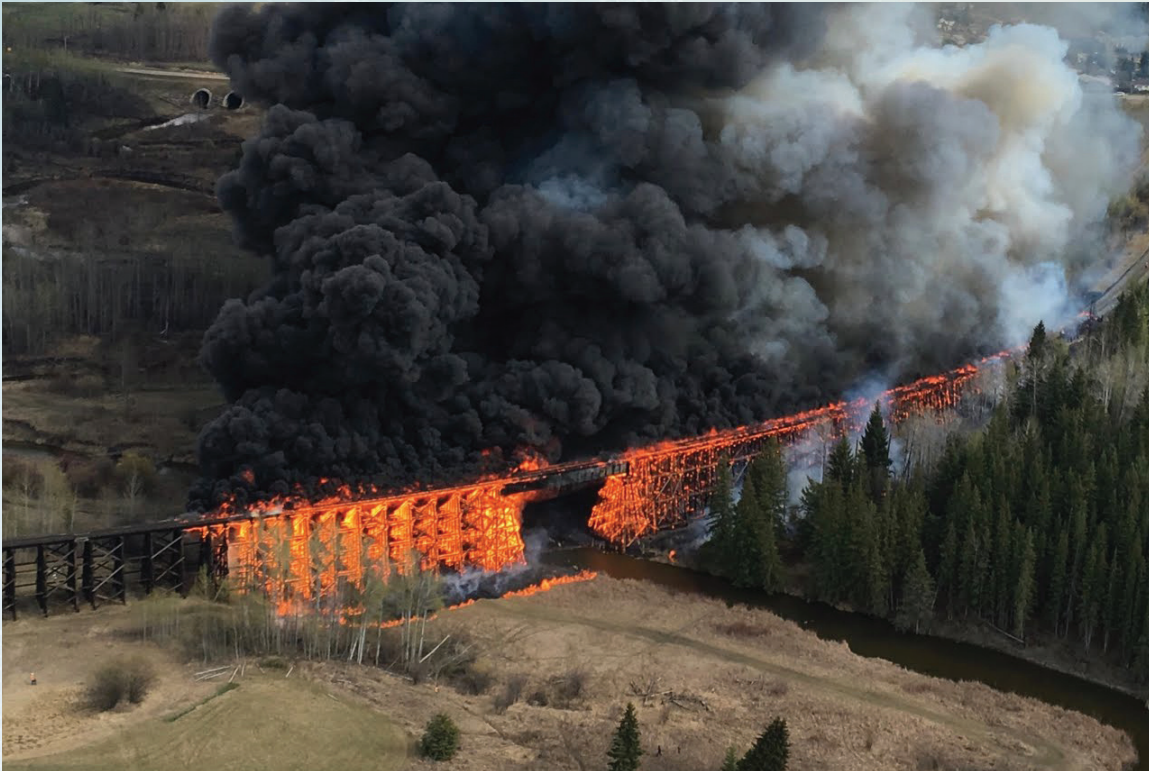
APRIL 26 Trestle bridge on CN rail line between Edmonton and Whitecourt is destroyed by fire, causing several million dollars worth of damage and impacting service to nearby communities.

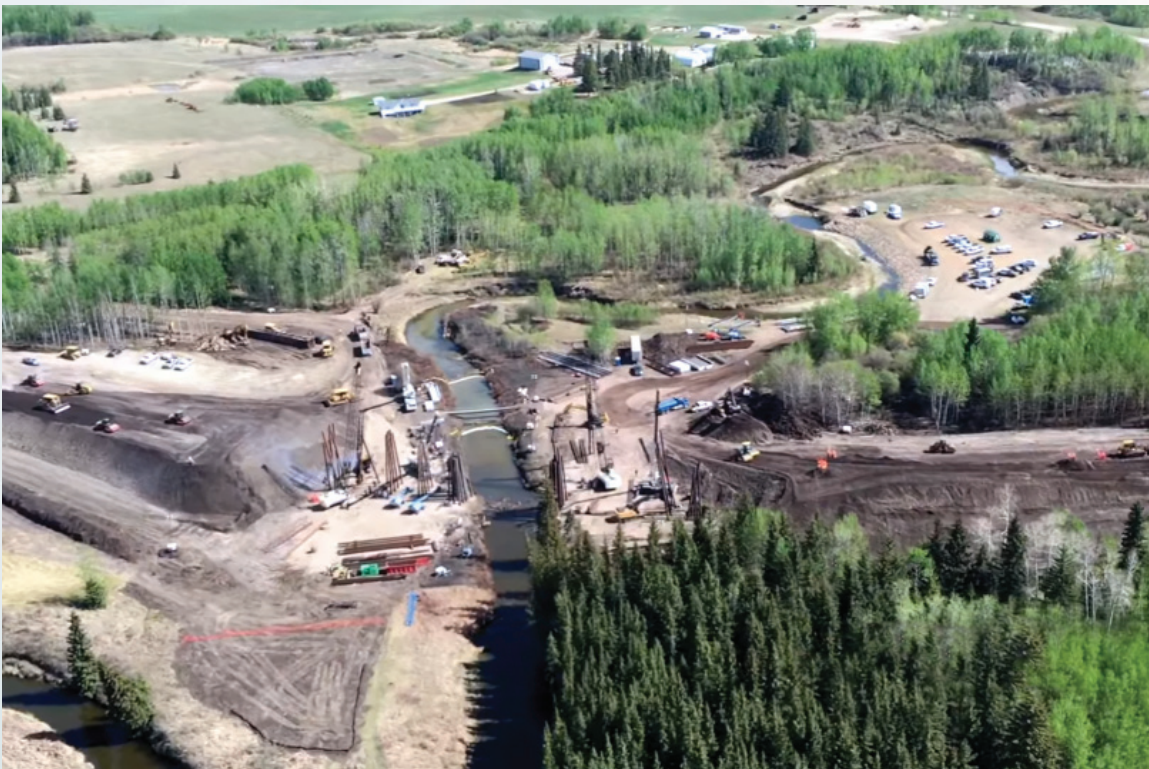
APRIL 30 To expedite construction, earthfill activities, installation of piles and bridge piers, installation of monitoring instrumentation, and fabrication of the bridge sections took place simultaneously on site.

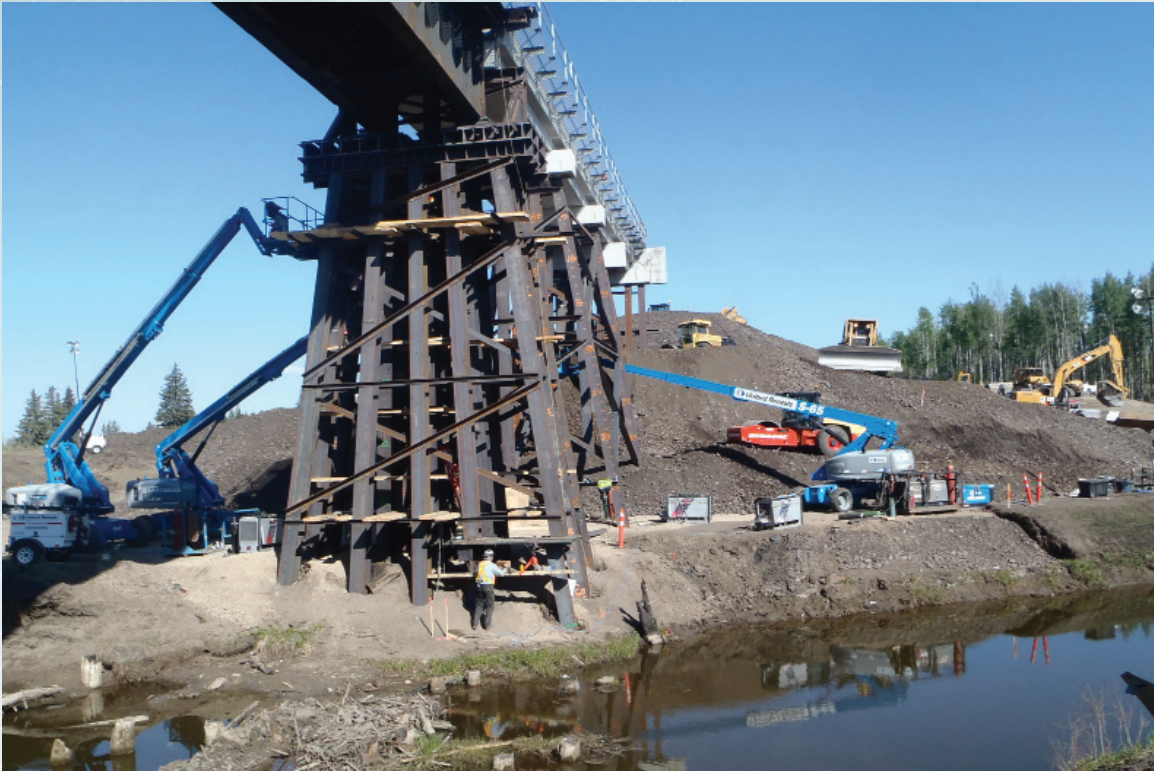
MAY 9 As construction nears completion, the final instrumentation is installed, new piers were welded together and backfill of the bridge approaches is completed.

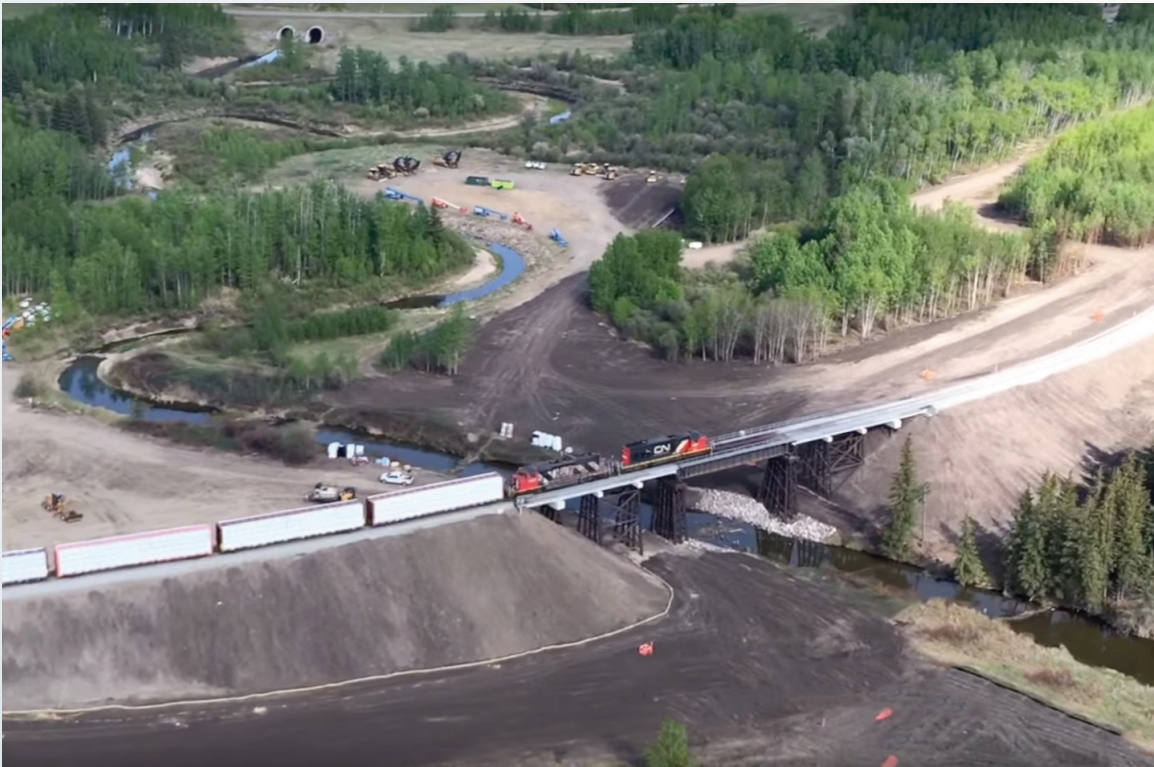
MAY 15 Rail service is restored and the site cleanup is complete. More than 190,000 metric tonnes of material was used to build the new bridge constructed of steel, concrete and fill. The completed structure stands about 14m tall and 335m long.
