## Background of Completed Project

In response to the 2016 Fort McMurray Wildfire, the Regional Municipality of Wood Buffalo (RMWB) engaged Stantec to assist in the expeditious recovery of the storm water drainage and wastewater collection and treatment systems in Fort McMurray and in the other communities throughout the Municipality. Because of the nature of the emergency and the terms of engagement, the project scope and specific work activities were developed as the engineering teams were mobilizing, and continued to develop after work on the project had been initiated.

## 2016 RMWB Wastewater and Storm System Recovery Plan

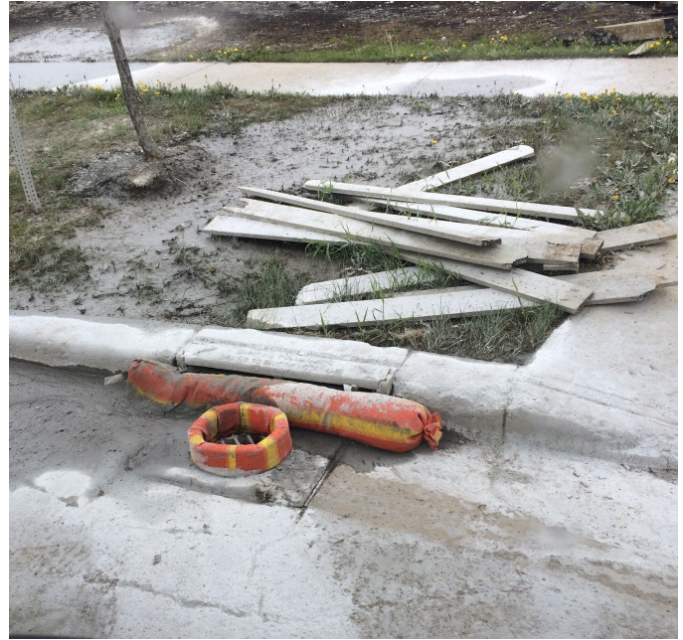
Most of the catch basins in the RMWB have sumps to collect silt and other heavy debris that enters through the catch basin grate. It was decided to clean out all the catch basin sumps in the fire destroyed neighborhoods to ensure any heavy debris that entered the storm system had a place to collect, rather than overflowing the sump and ending up in a waterbody.

Protecting the storm sewer system was particularly important considering that a tackifier material was applied to all the fire damaged homes to stabilize the ash from blowing around and becoming a hazard. Some of this tackifier material washed away and was trapped by the silt socks and catch basin sumps. This alone validated the need for these programs.
