# Canadian Consulting Engineering Awards 2017

## Southern Alberta Rock Slope Stabilization & Other Work

### Amec Foster Wheeler

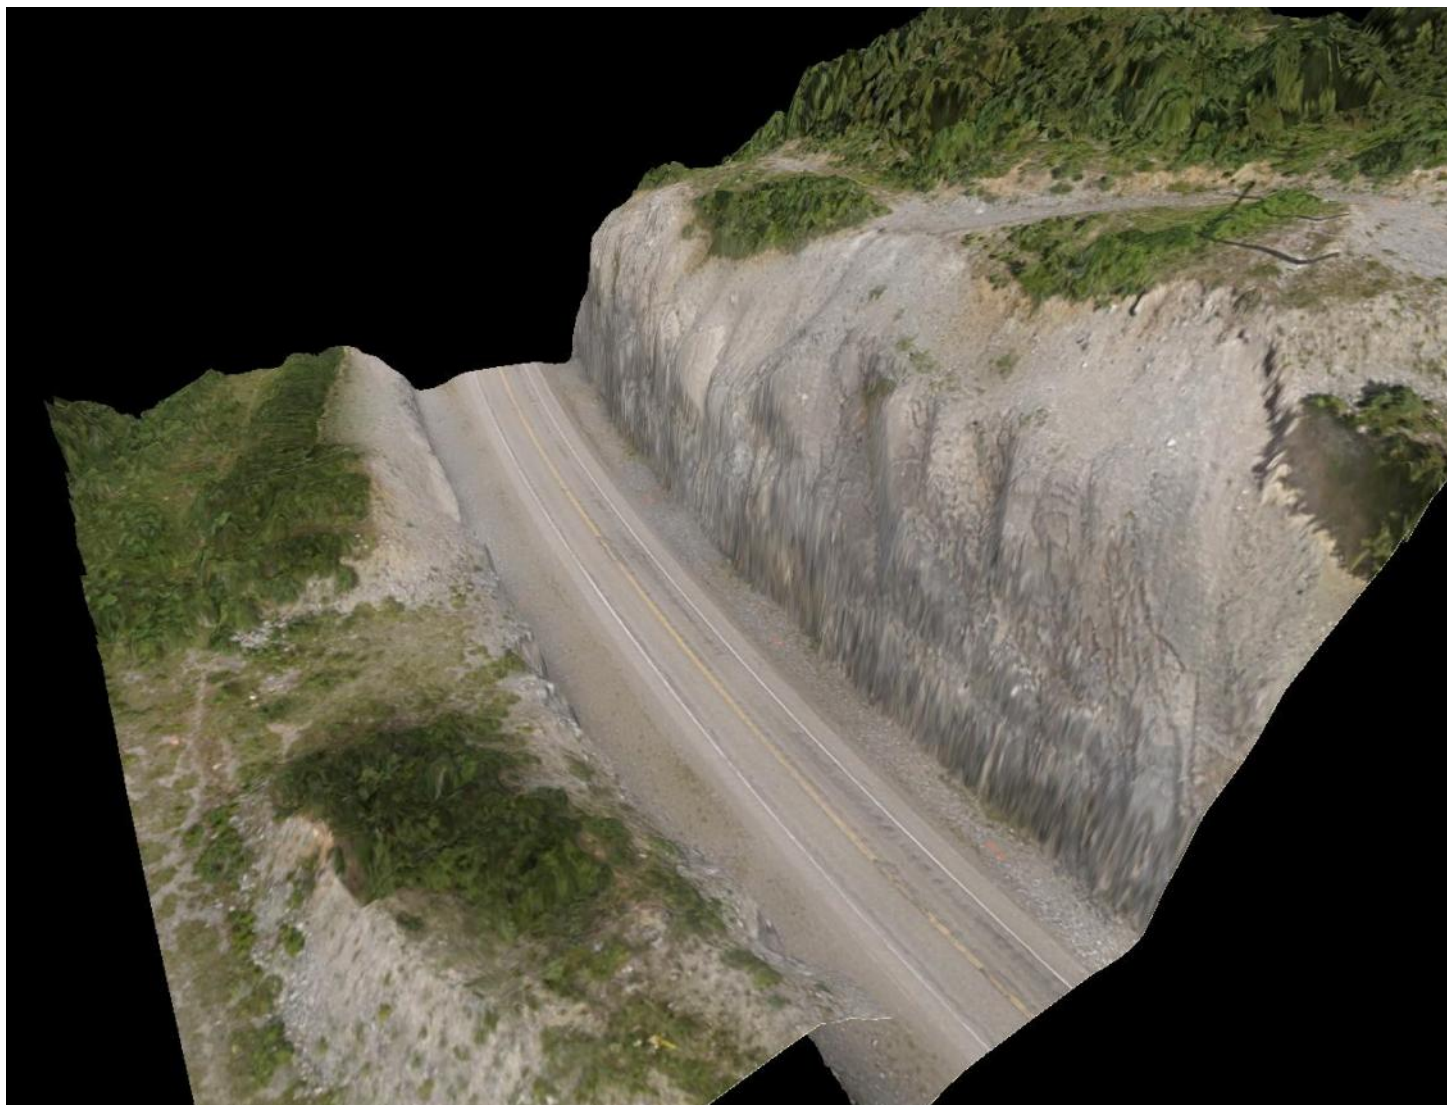
Figure 2

Galatea site as rendered with data acquired by UAV survey. This picture accentuates the level of detail and depth of information gathered by the UAV. This rendering can be turned 360° to view the through-cut from all angles.

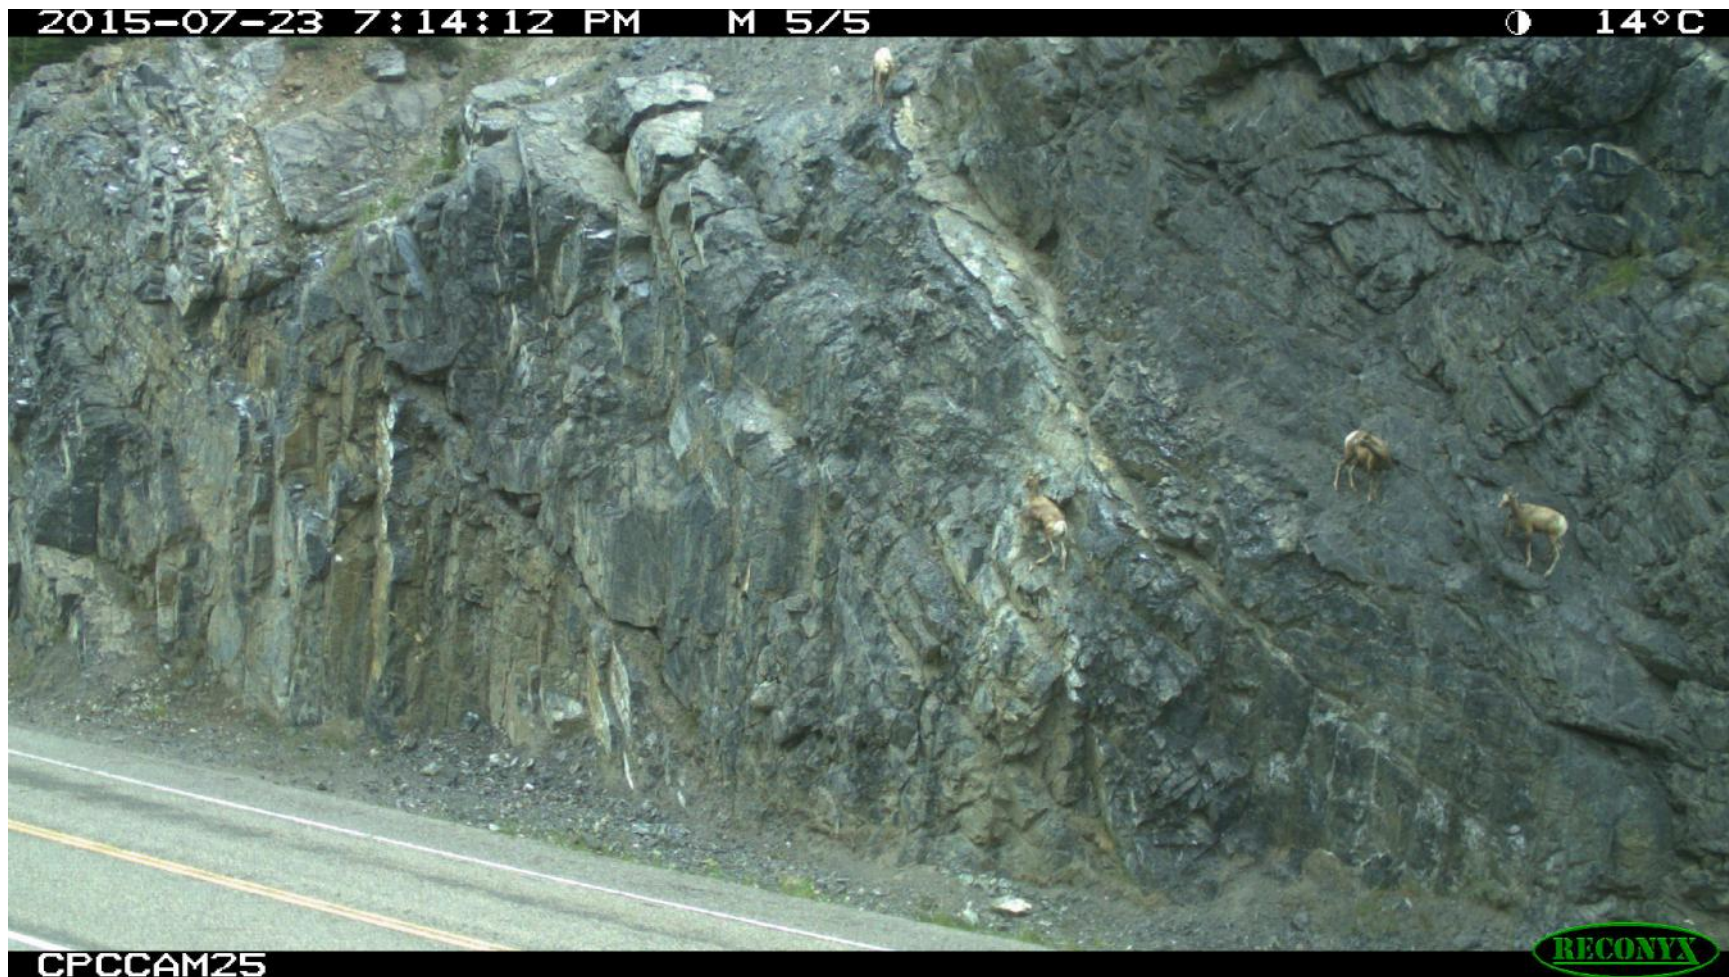
Figure 3

Screen capture from wildlife study video footage at the Galatea site. Sheep are seen on the right-side of the picture negotiating the rock cut slope.

In addition to the use of a mitigation measure that was new to Alberta Transportation, there was a need to accommodate movement of Rocky Mountain Bighorn Sheep across the rock faces at both the Galatea and Mt. Baldy sites. To accomplish this, Amec Foster Wheeler completed a wildlife study using motion-activated video cameras to capture the preferred sheep routes across each rock cut. There were three (3) cameras installed at Mt. Baldy and four (4) cameras installed at Galatea between June 2017 and July 2015. There were seven (7) routes identified at Mt. Baldy, four (4) of which would be affected by the installation of slope mesh. At Galatea, four (4) routes were identified, all would be affected by mesh installation. These paths represent the most common travel paths and essential escape routes used by the sheep. Based on this study and with input from Alberta Parks and Environment, sheep path locations were chosen and the draped mesh pattern was adjusted to accommodate the paths. A post-construction monitoring program is underway to confirm that the paths are being used and to identify locations where adjustments are required. To the applicants knowledge this is the first time a study of this nature has been used for this purpose in Canada.

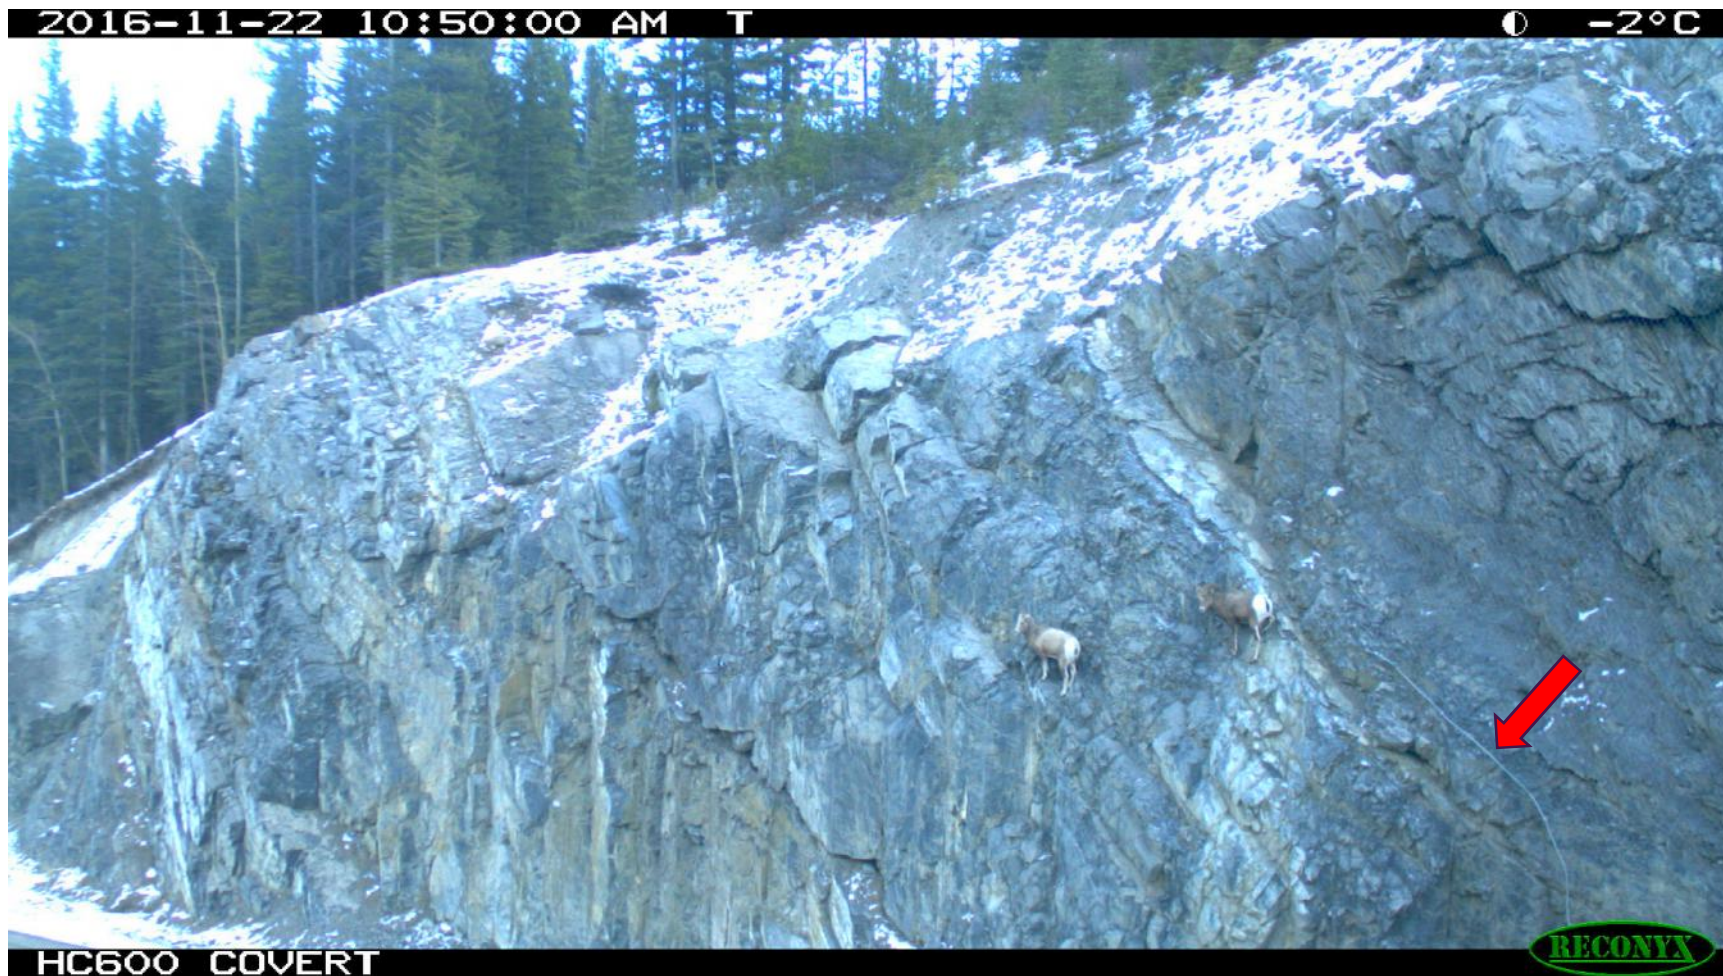
Figure 4

Screen capture of wildlife monitoring post construction at the Galatea site in the same location as Figure. 2. The arrow is pointing to the slope mesh installation and sheep can be seen continuing to negotiate the rock cut slope.

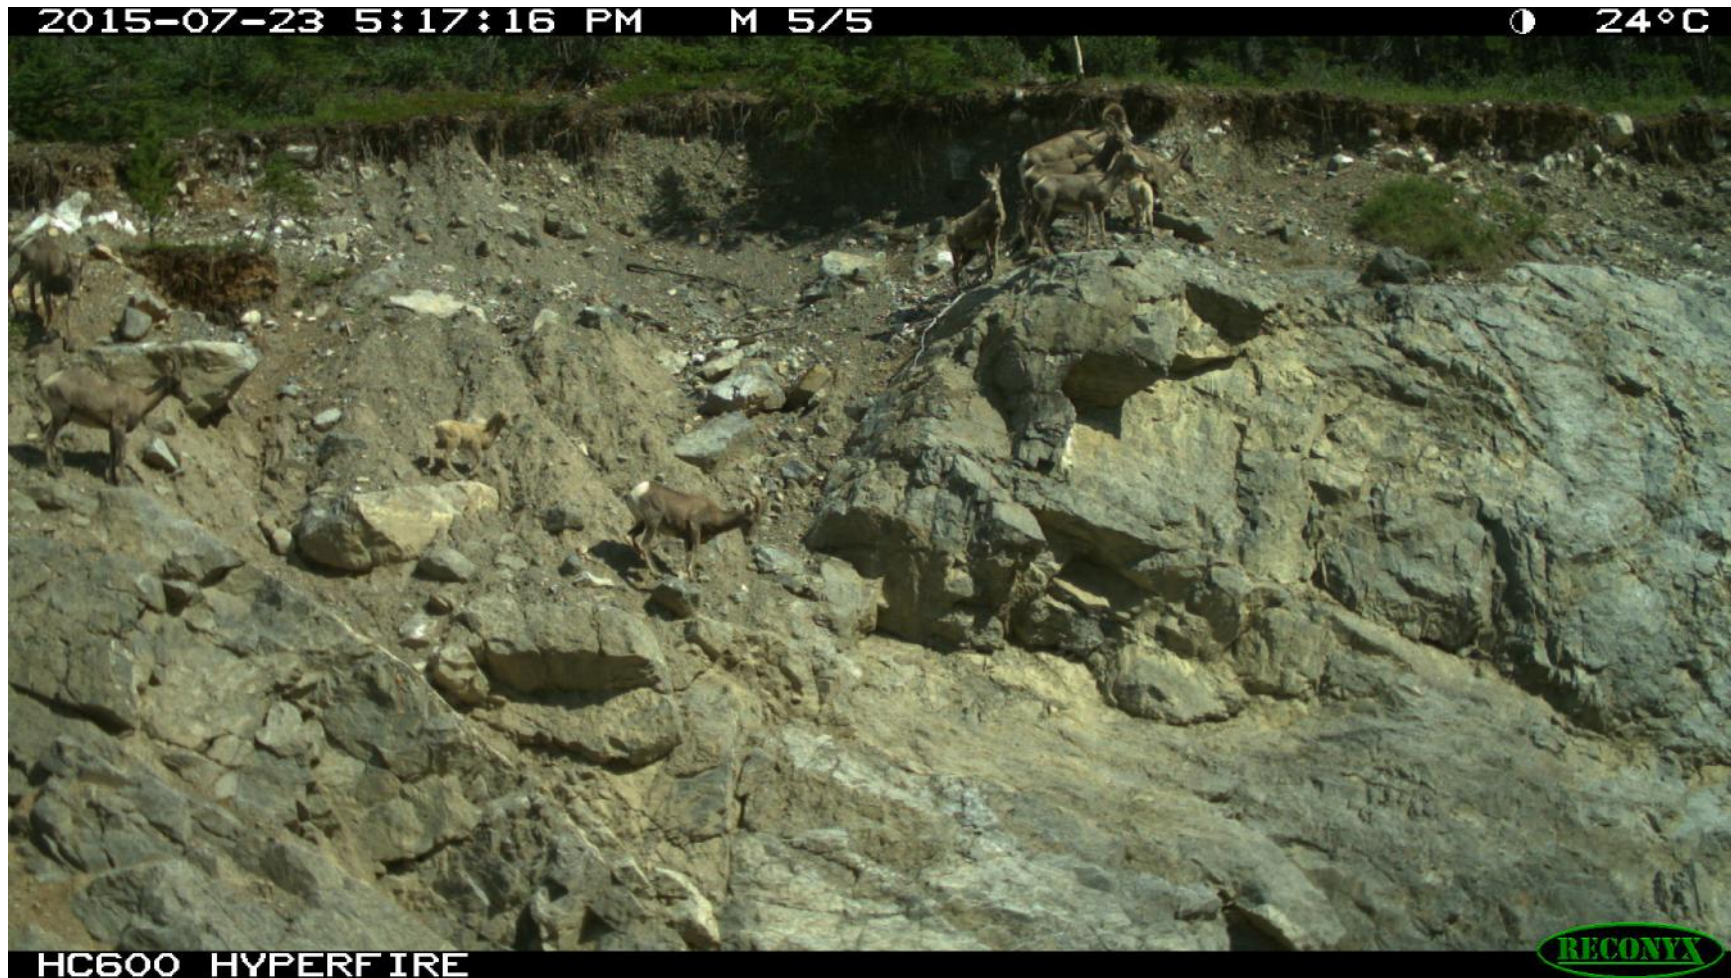
Figure 5

Screen capture from wildlife study video footage at the Mt. Baldy site. Sheep are seen on the left-side of the picture negotiating the rock cut slope.

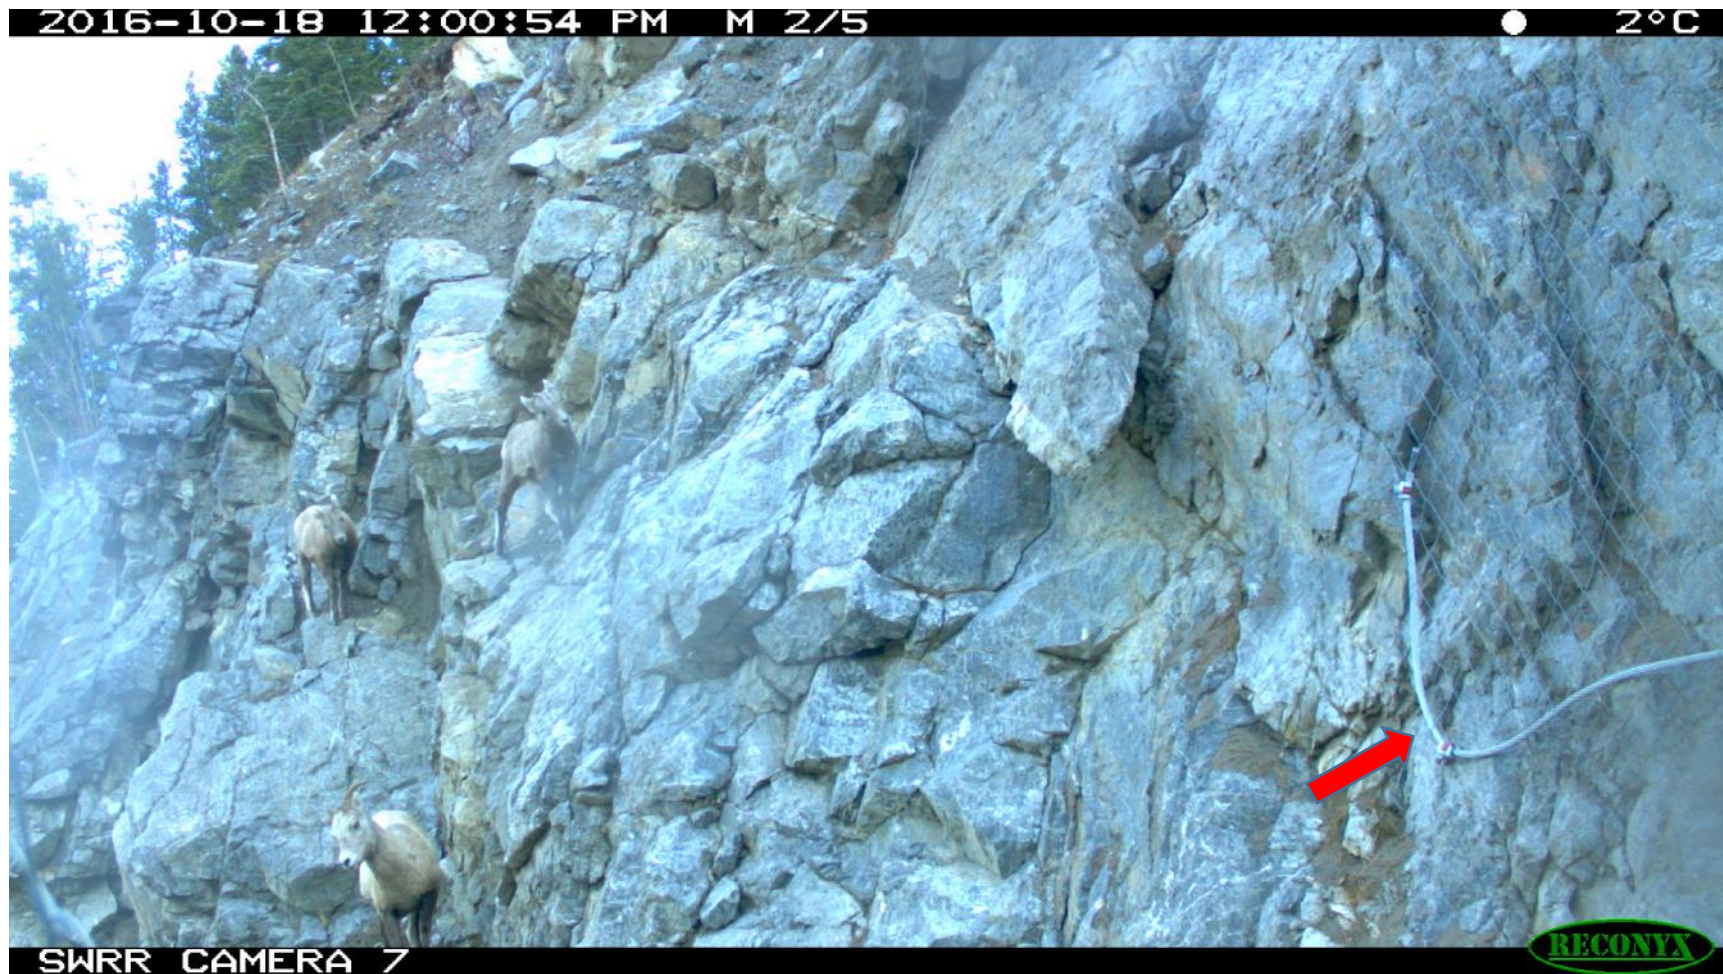
Figure 6

Screen capture of wildlife monitoring post construction at the Mt. Baldy site in the same location as Figure. 4. The arrow is pointing to the slope mesh installation and sheep can be seen continuing to negotiate the rock cut slope.

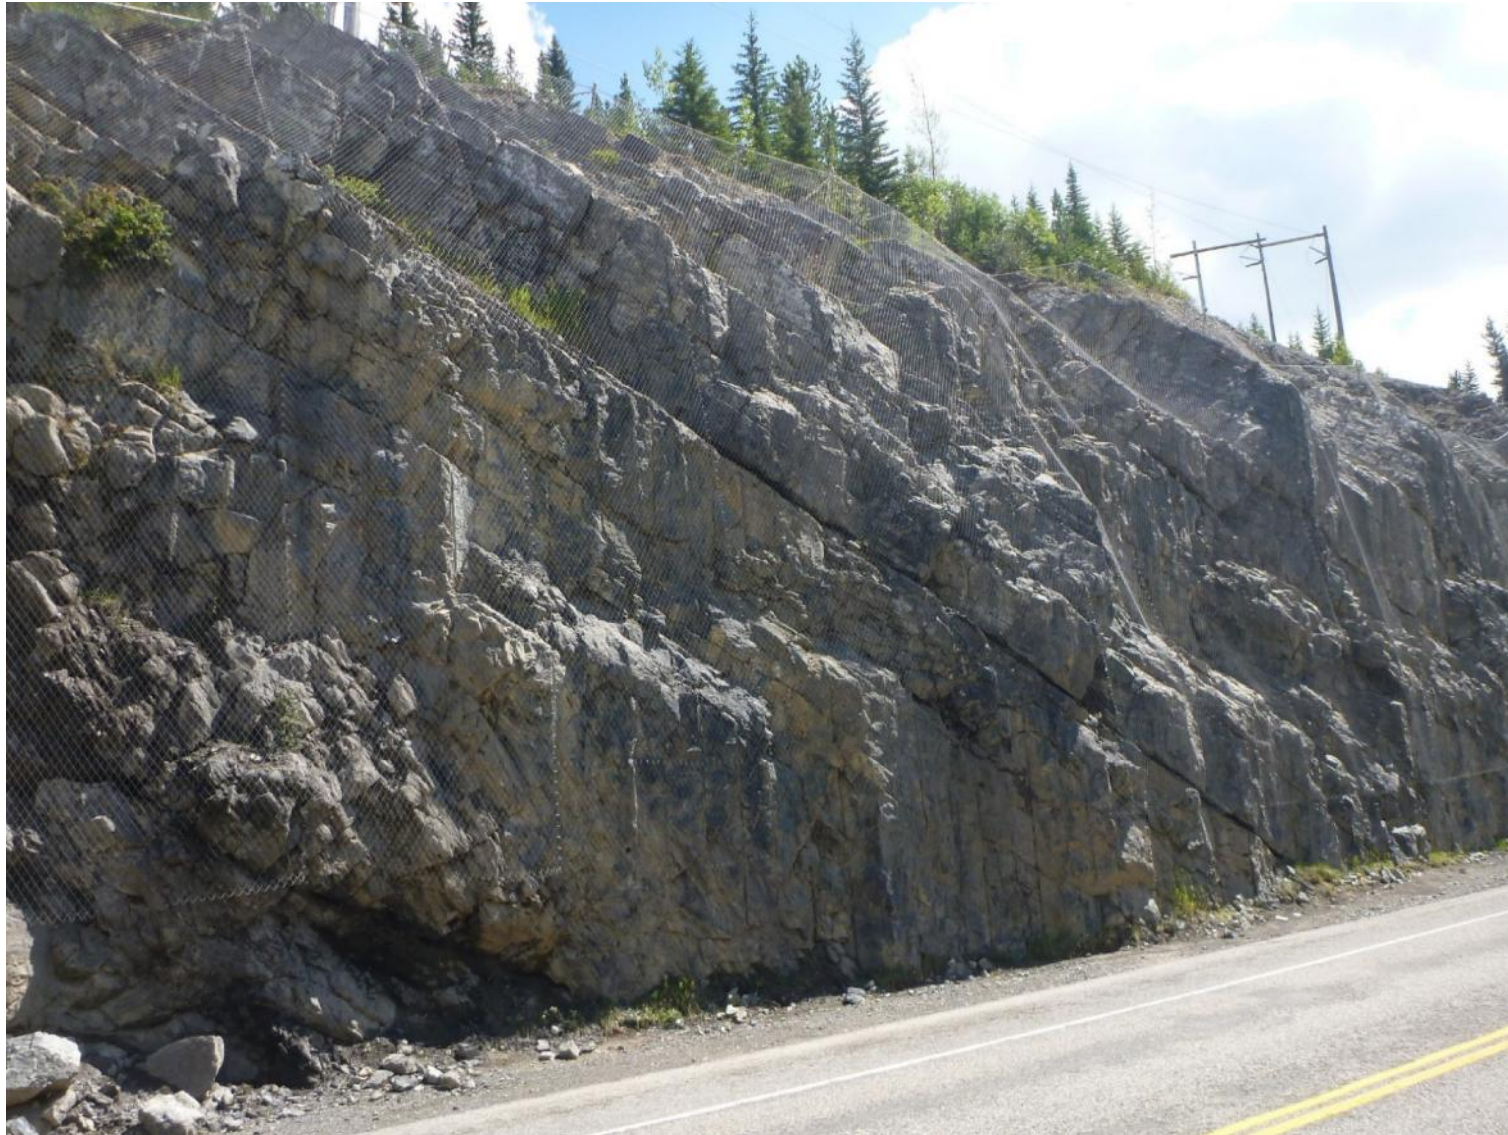
Figure 8

View of the rock cut at Galatea post construction. The mesh is barely visible from the road, making it less distracting to the travelling public.

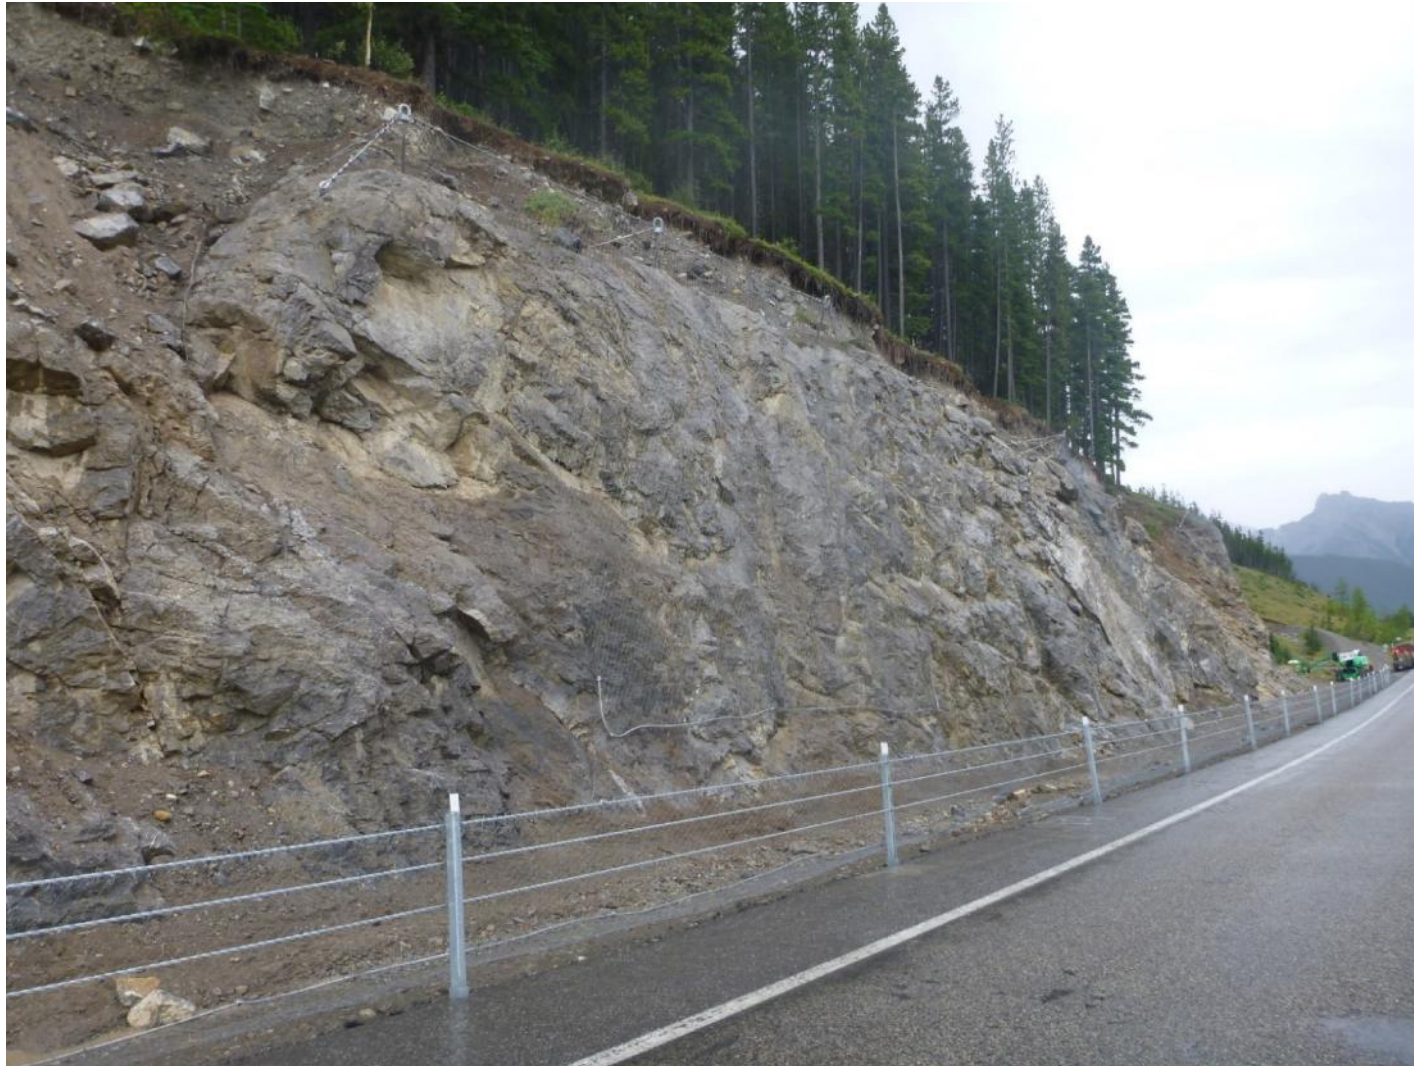
Figure 9

View of Mt. Baldy rock cut site post construction. The mesh is only visible because of the anchoring cable at the bottom of the installation. The High Tension Cable Barrier (HTCB) is being used to hang slope mesh that lines the ditch to contain rock fall where gaps in the slope mesh are present to allow bighorn sheep access. There are gaps in the mesh in the ditches to also promote bighorn sheep access.

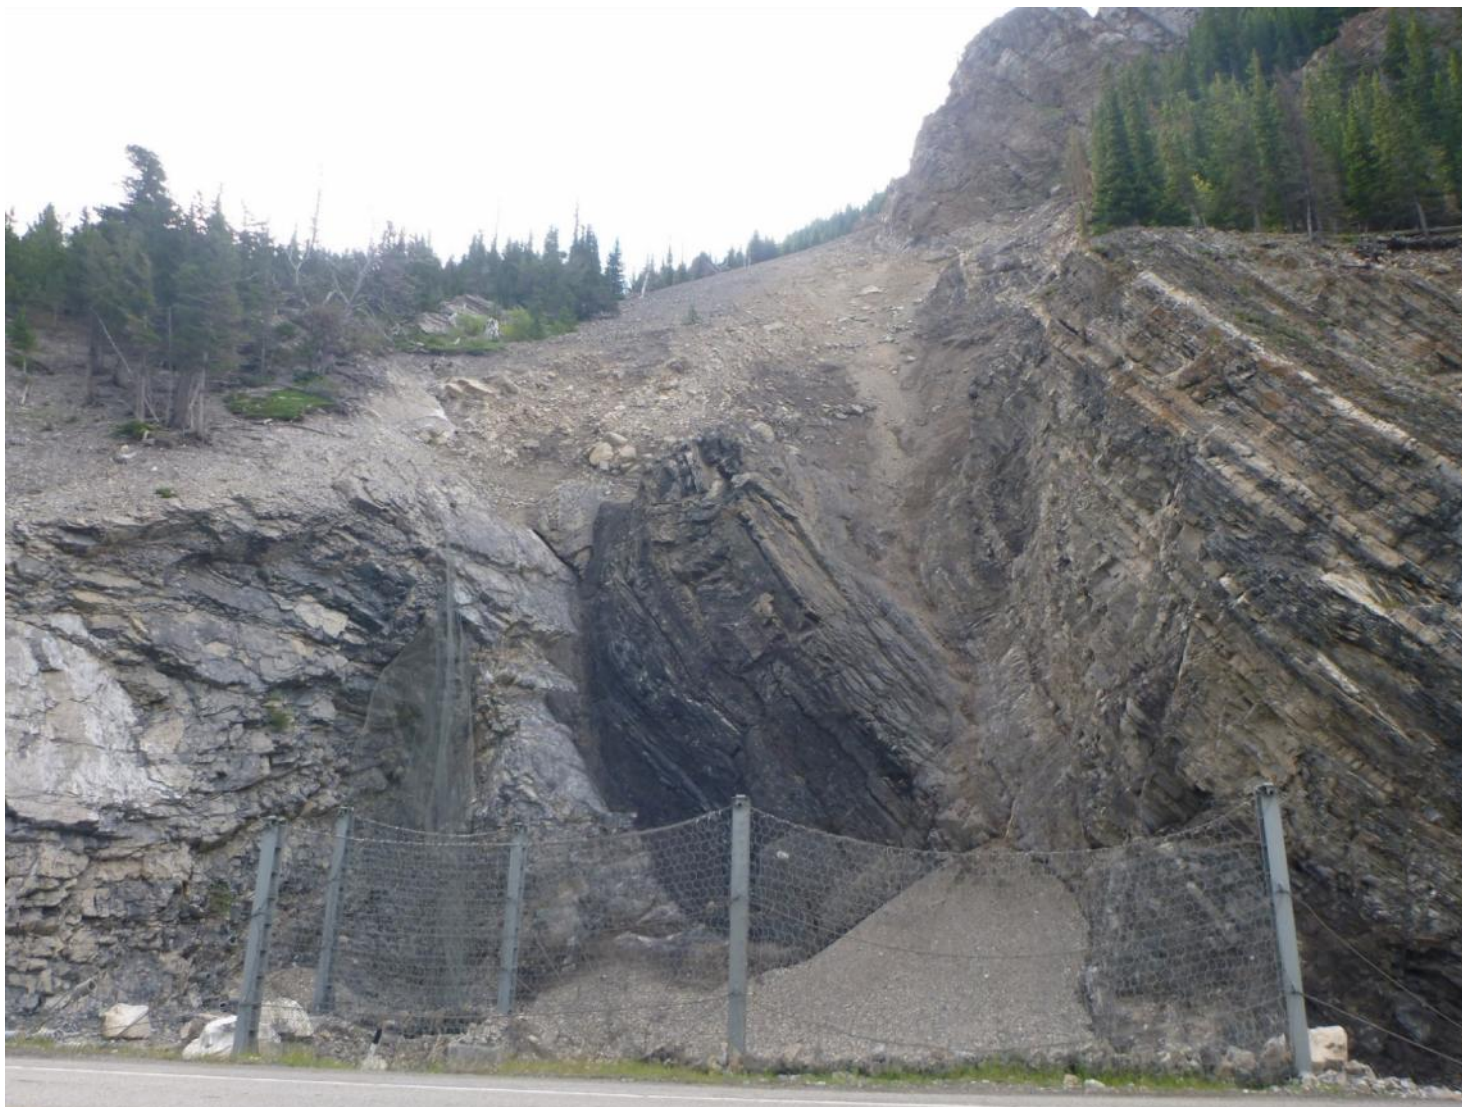
Figure 10

Crowsnest lake talus filled gully pre-construction. Visible in the foreground is a previously installed rock fall barrier. The resulting high talus cone can be seen behind the fence filling up the ditch.

The Crowsnest Lake site is subject to persistent rock fall from a mountain slope above a rock cut, as well as from a talus-filled gully. Various iterations of rock fall barriers were previously installed at the talus gully to mitigate the main rock fall source but were frequently damaged, required ongoing maintenance which was difficult due to worker safety concerns, the sheer volume of rock fall debris that accumulated and the occasional large block rock fall that destroyed elements of the barrier structures. Small gravel sized debris falls continually at the talus site accumulating as a high talus cone. Large rocks are able to roll along the talus cone with high velocity and impact forces that occasionally exceeded the barrier capacity. As a result the barrier often operated in a compromised condition which put highway users at risk. A quantitative risk assessment was done that determined the rock fall frequency, and a rock fall analysis was done to estimate the quantity of rock falls that might bypass a given mitigation scheme and ultimately reach the highway. The major rain event in June 2013 caused significant rock fall along the entire 400 m long rock cut so, for the flood mitigation program, the study area was extended to the entire rock cut. The risk of rock fall to cause a fatality was calculated for several mitigative options. The risk was compared to societal risk acceptance limits to determine which mitigative options could reduce the risk to acceptable levels.

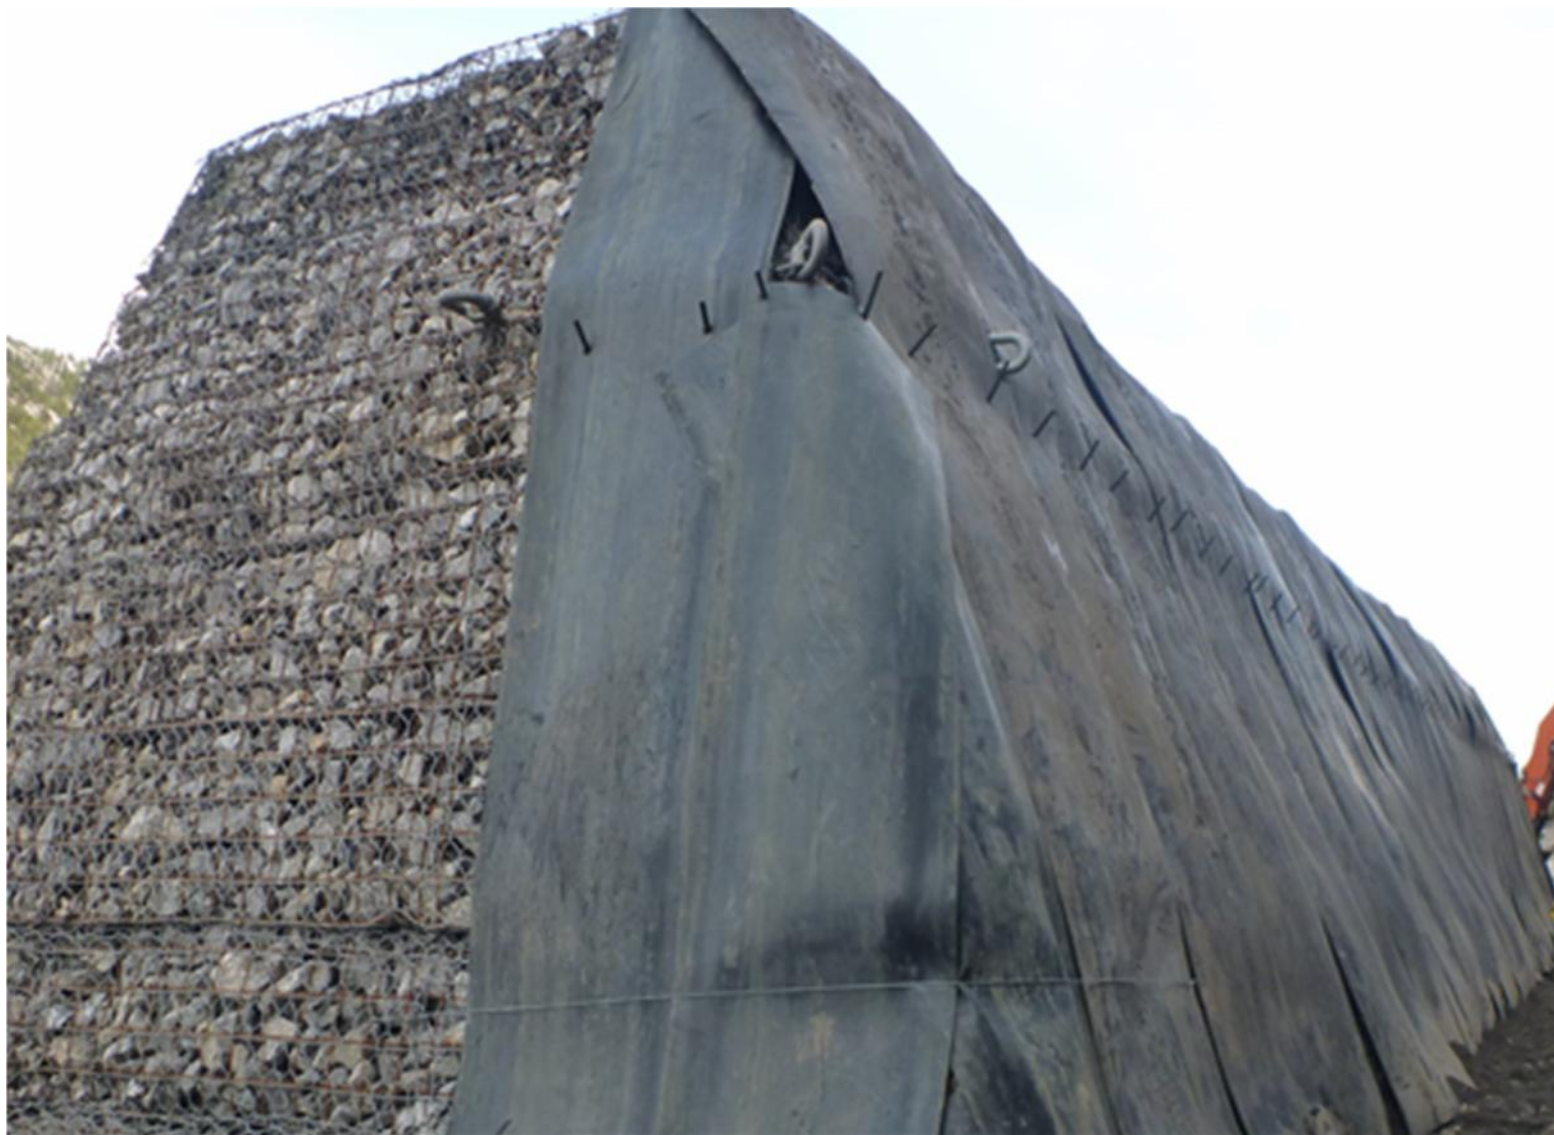
Figure 12

The completed GCS wall with strips of recycled conveyor belt used as impact cushioning on the uphill facing aspect of the structure
