Minton Lake Dam Rehabilitation

2021 Canadian Consulting Engineering Awards

Project Name: Minton Lake Dam Rehabilitation

Category: **E. Natural Resources, Mining, Industry & Energy**

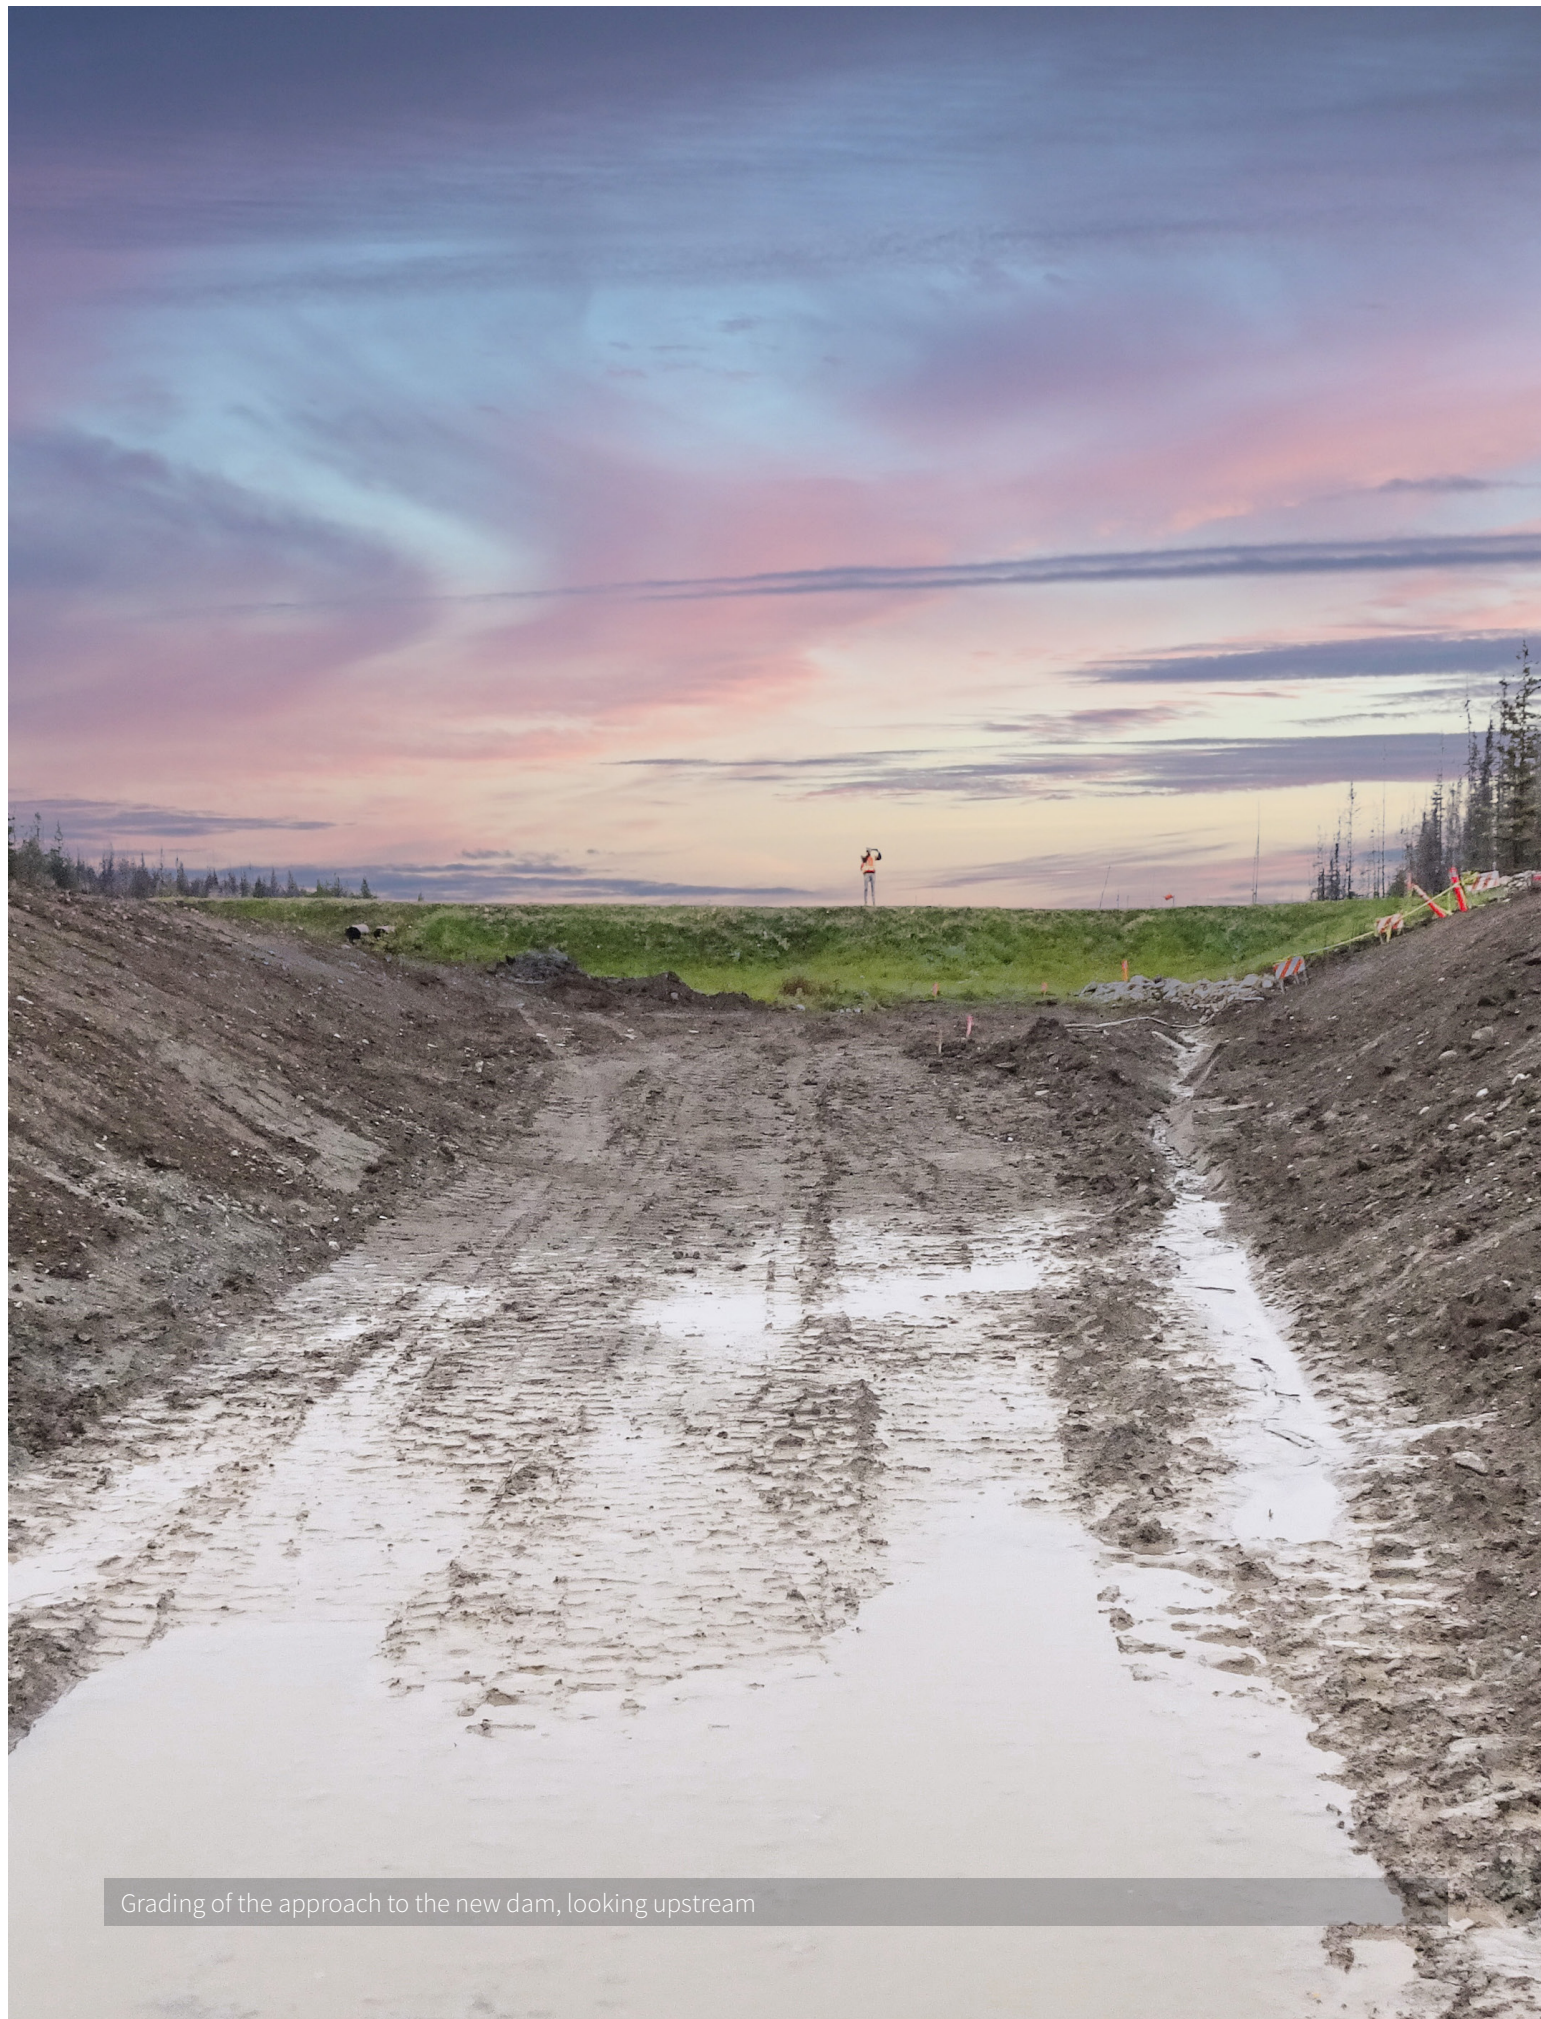
Grading of the approach to the new dam, looking upstream

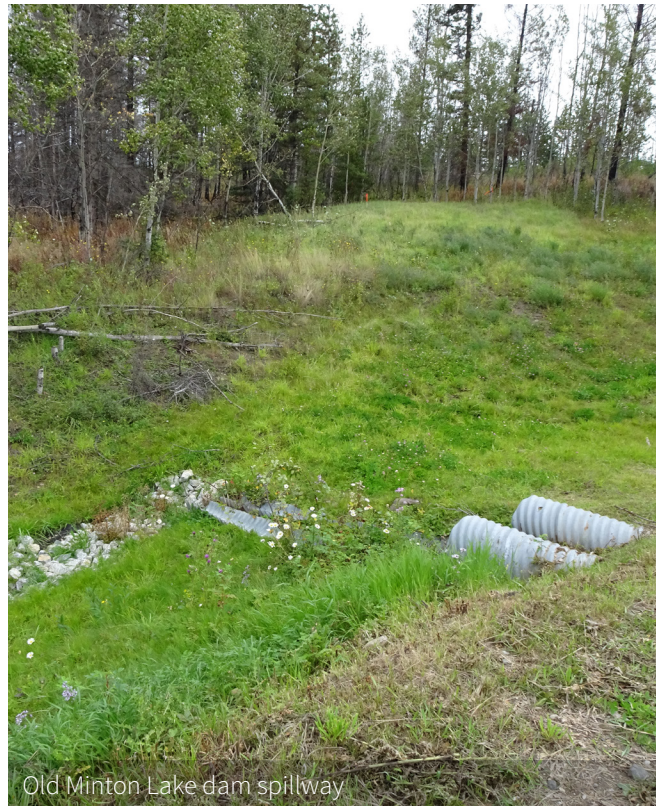
Old Minton Lake dam spillway

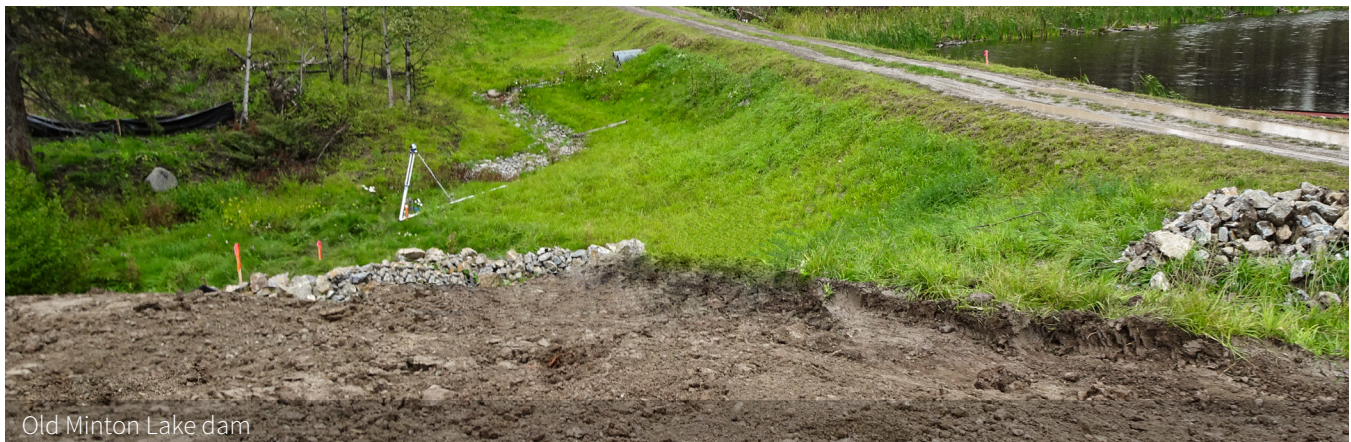
Old Minton Lake dam

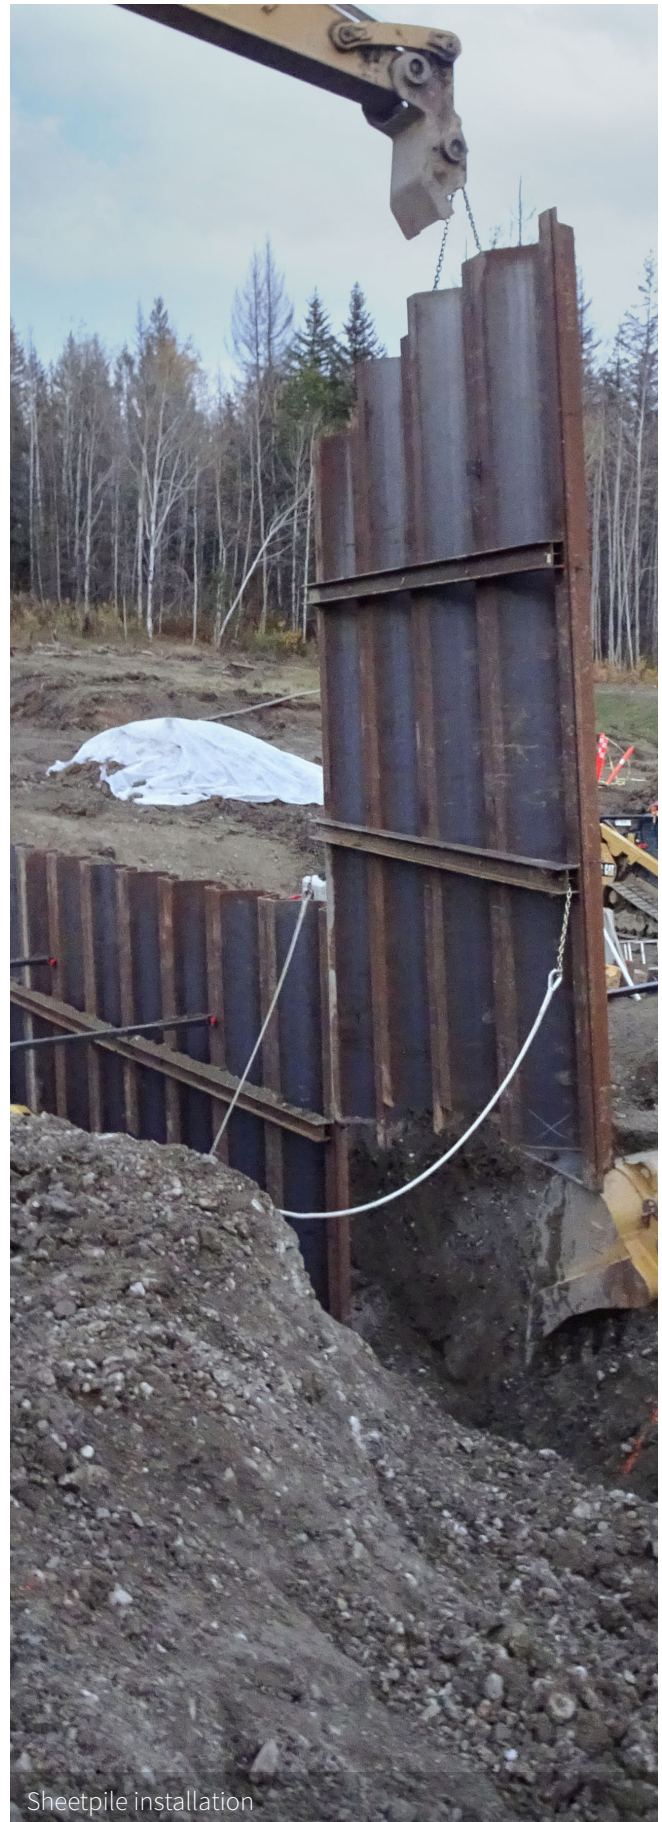
Sheetpile installation

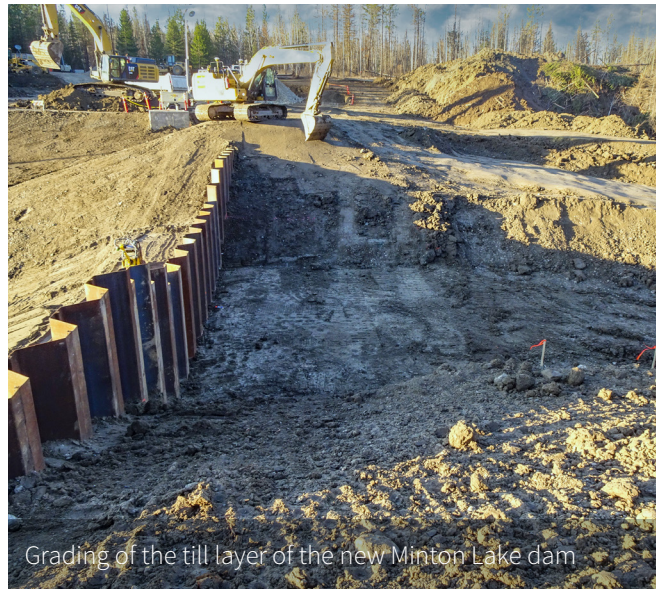
Grading of the till layer of the new Minton Lake dam

The design of the new dam is considered sustainable. The earthen structures used the glacial till produced during excavation as the main water barrier element with minimal cutoff wall use. All the other construction materials were produced locally through the pits or quarries and were considered environmentally suitable and sustainable. Future maintenance will require use of similarly local material and common methodology so that it can be done by local construction companies and will not require the mobilization of specialty contractors.

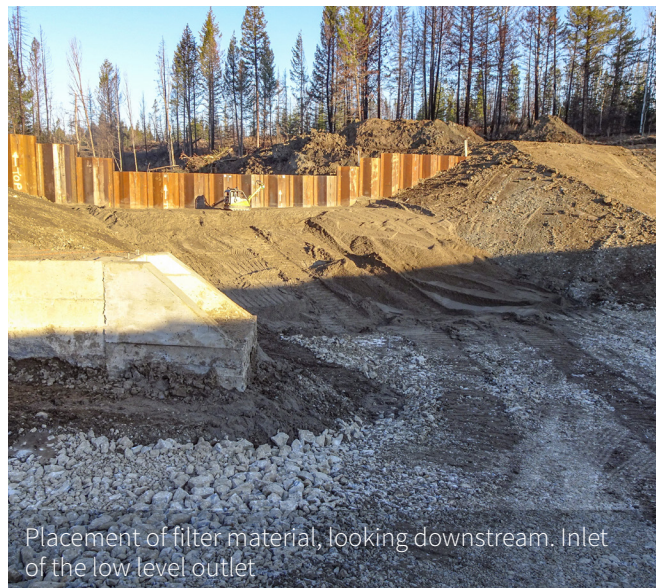
Placement of filter material, looking downstream. Inlet of the low level outlet

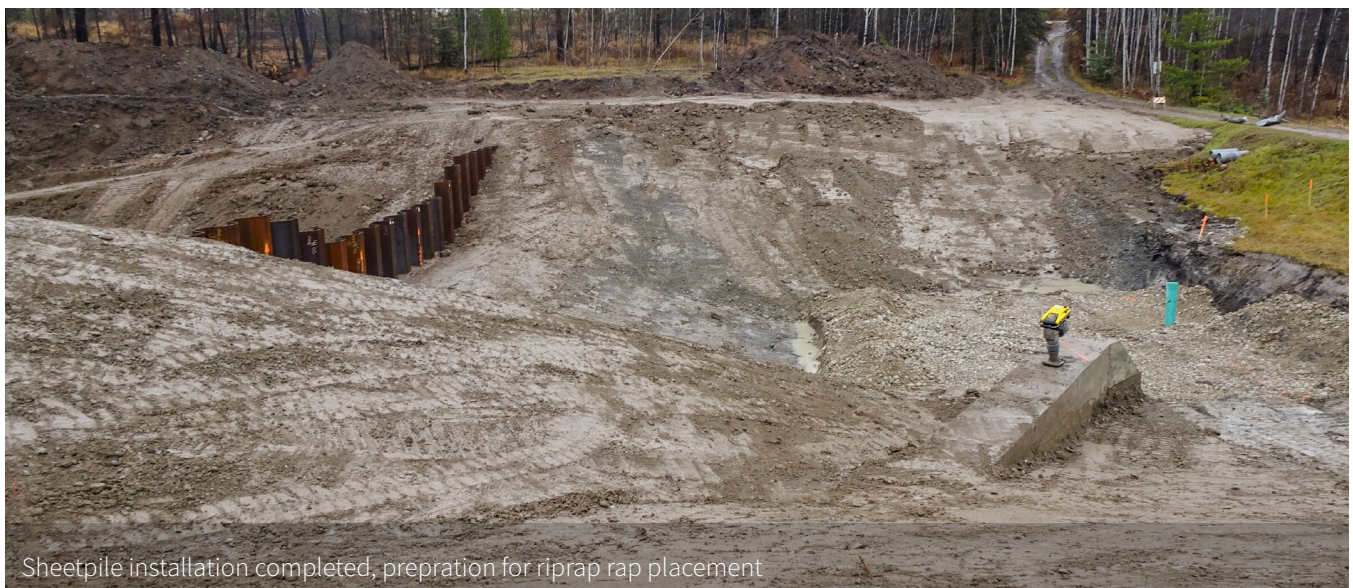
Sheetpile installation completed, preparation for riprap placement

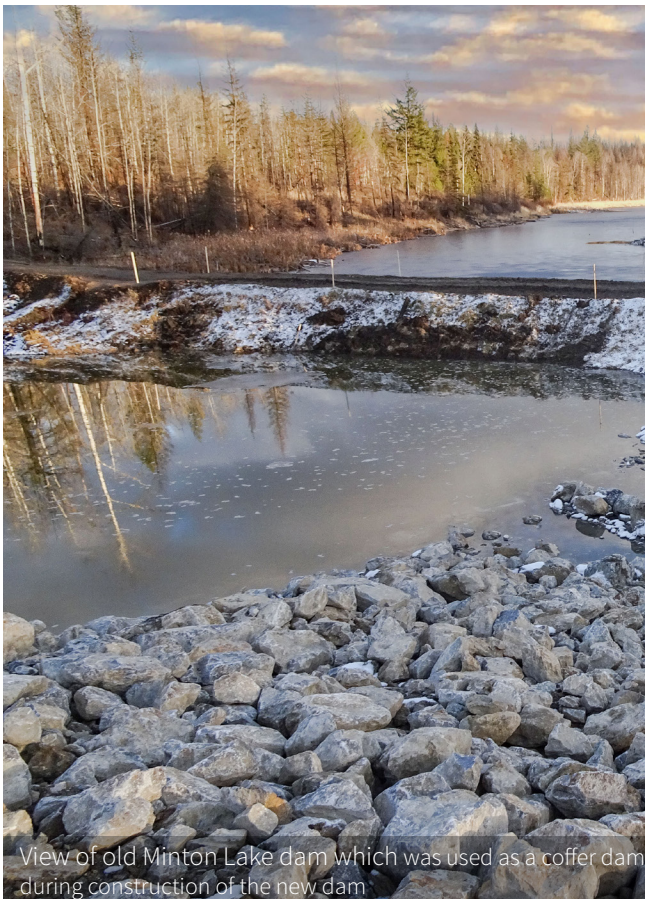
View of old Minton Lake dam which was used as a coffer dam during construction of the new dam

The team decided to build a new earthfill embankment 35m downstream of the old dam. The old dam was the cofferdam for the new construction. In July 2022, when the new structure was completed, the old dam was breached. The reservoir returned to regulation level very quickly.

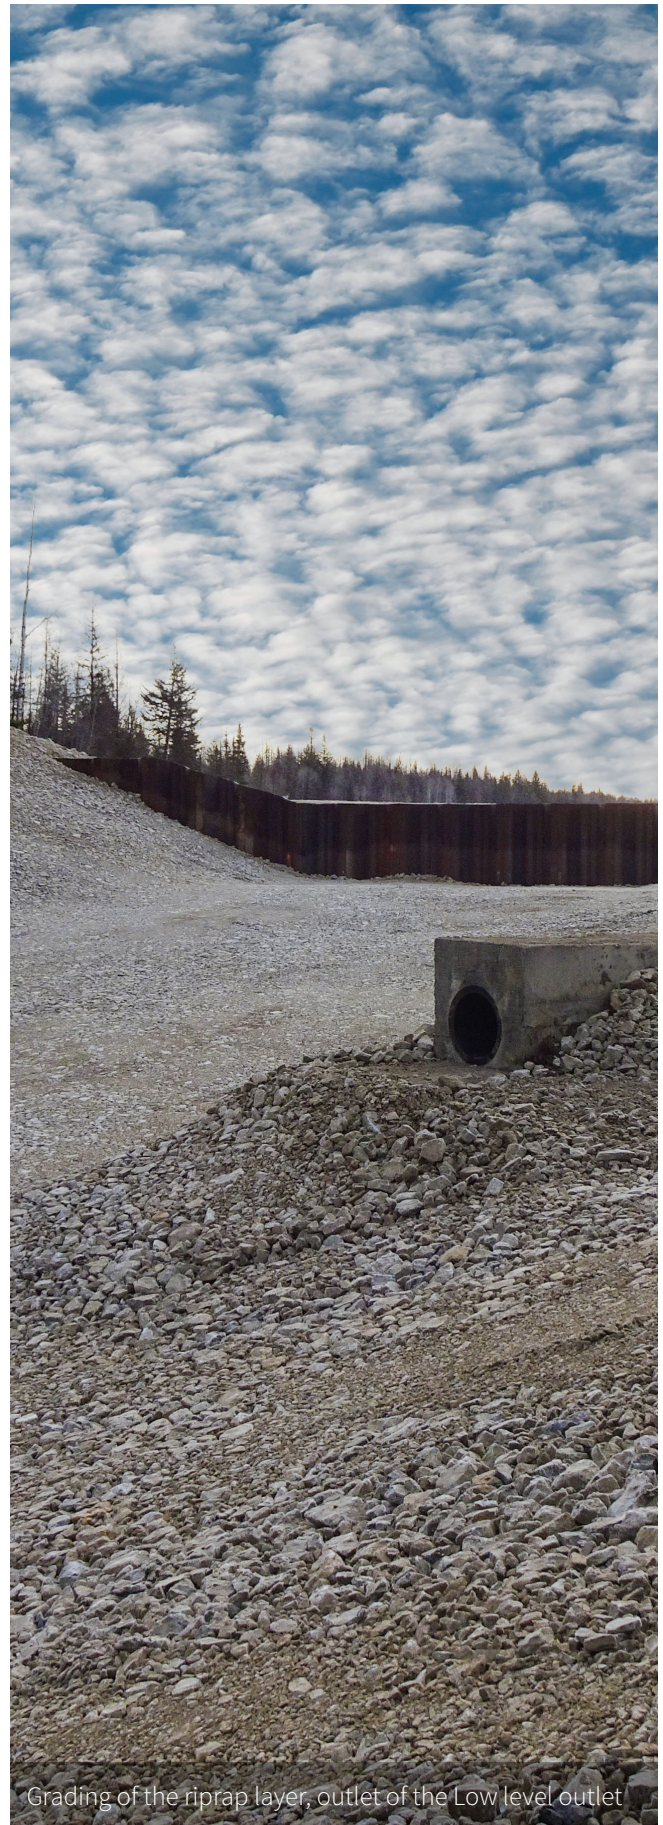
Grading of the riprap layer, outlet of the Low level outlet

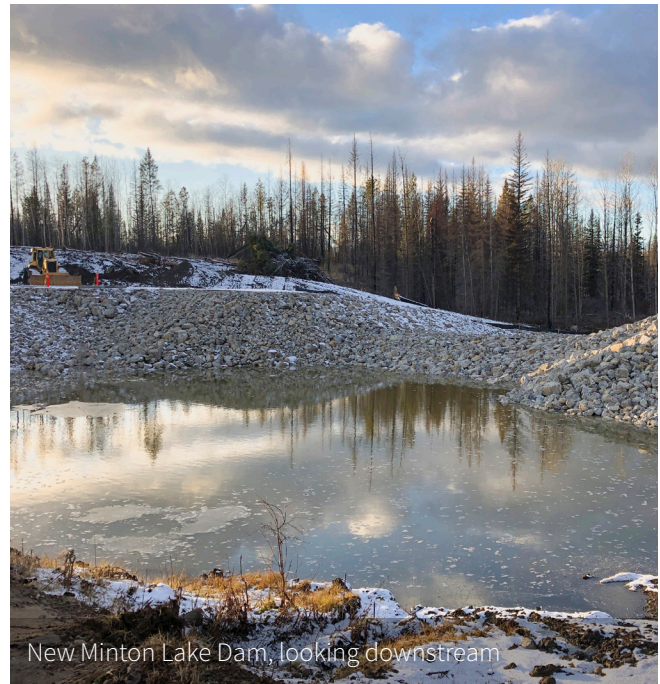
New Minton Lake Dam, looking downstream

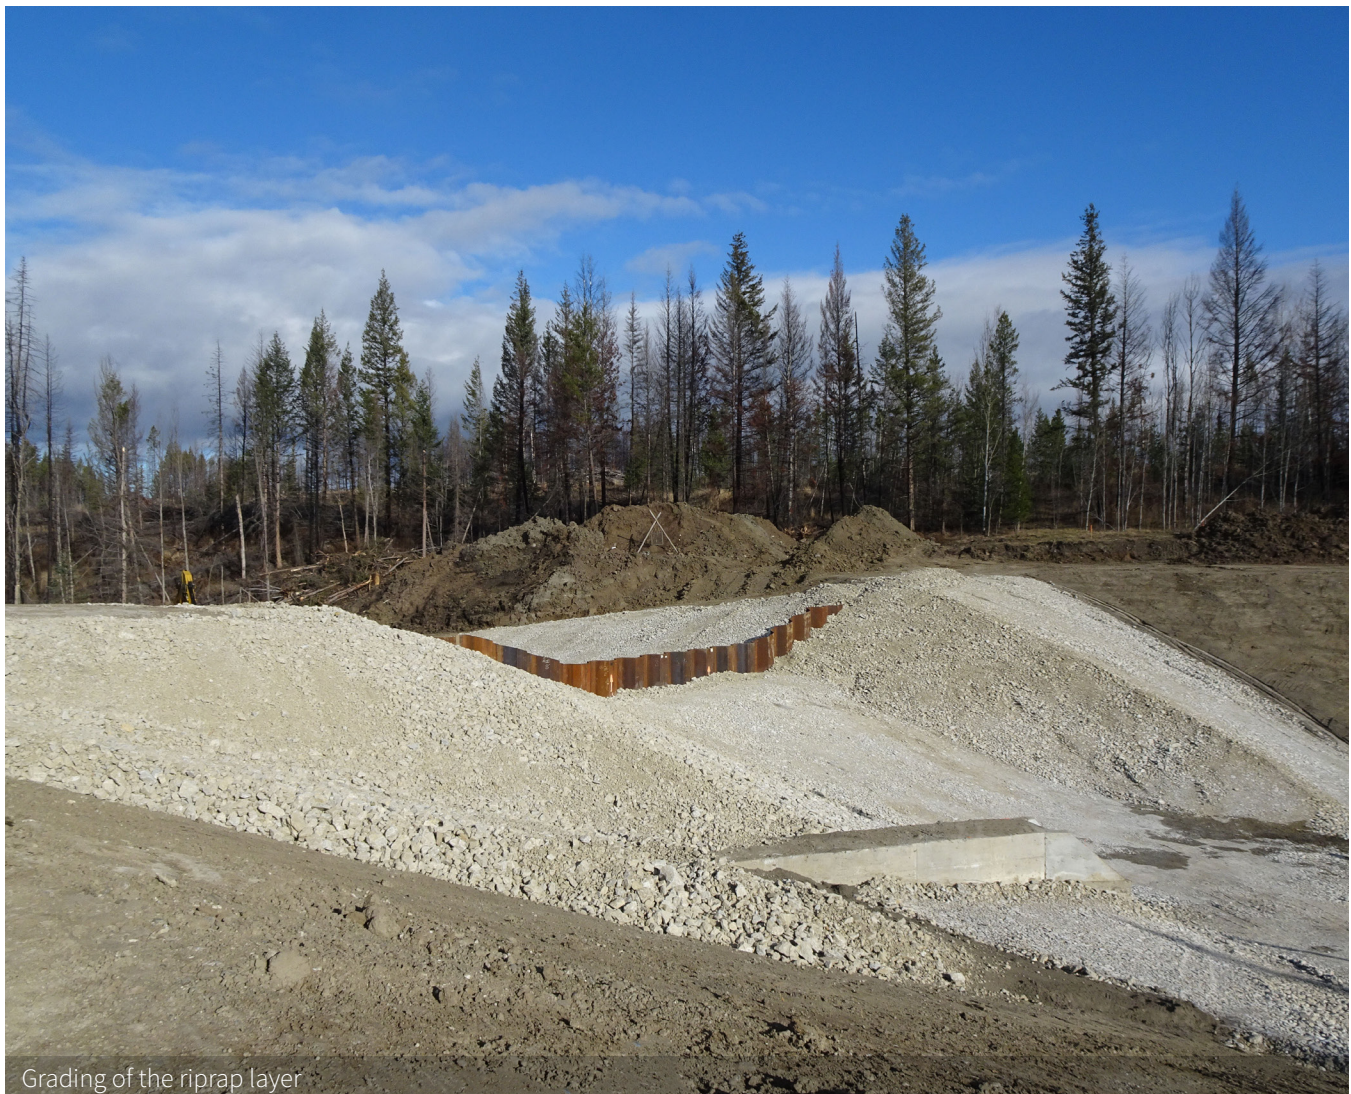
Grading of the riprap layer

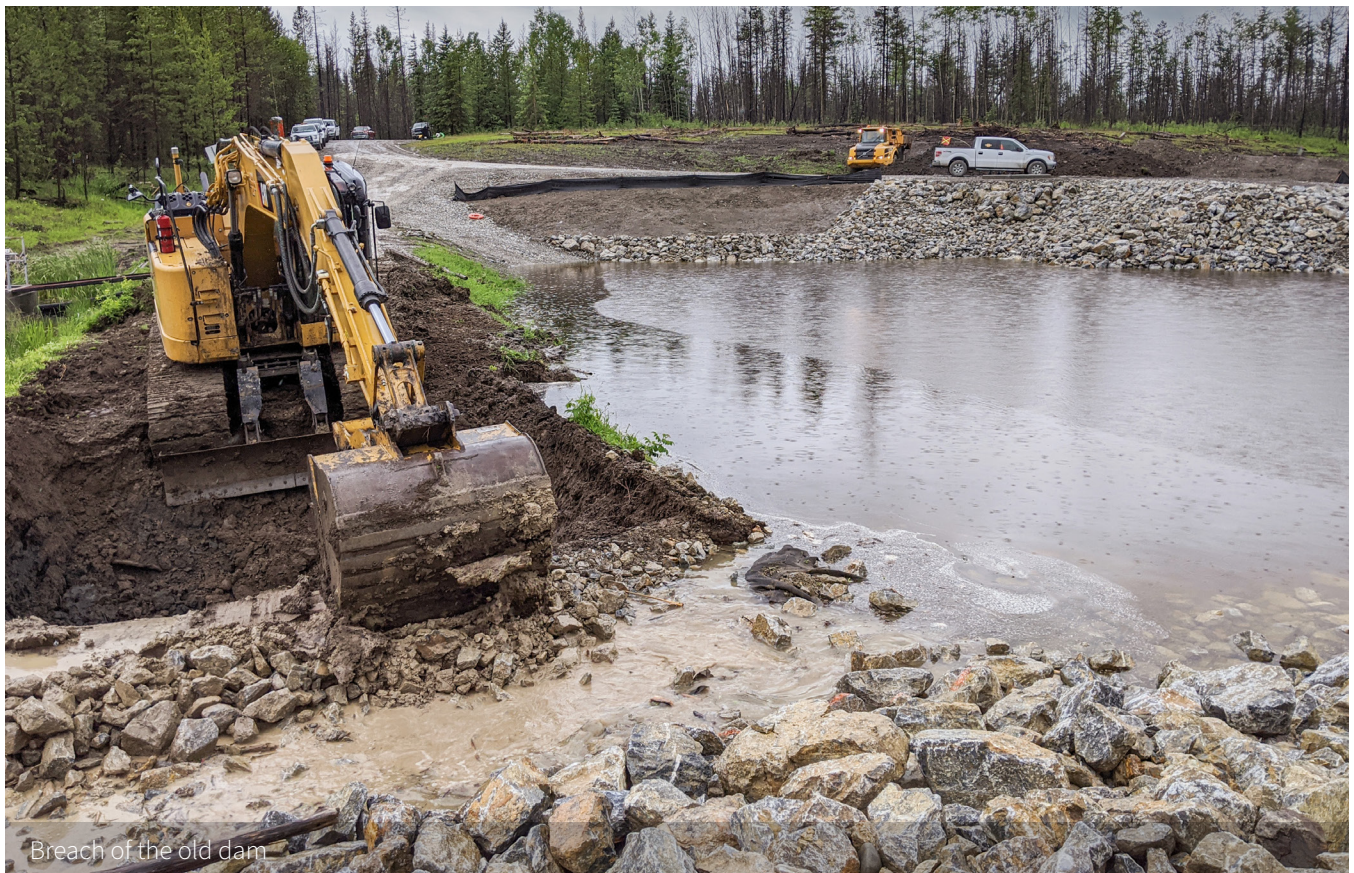
Breach of the old dam

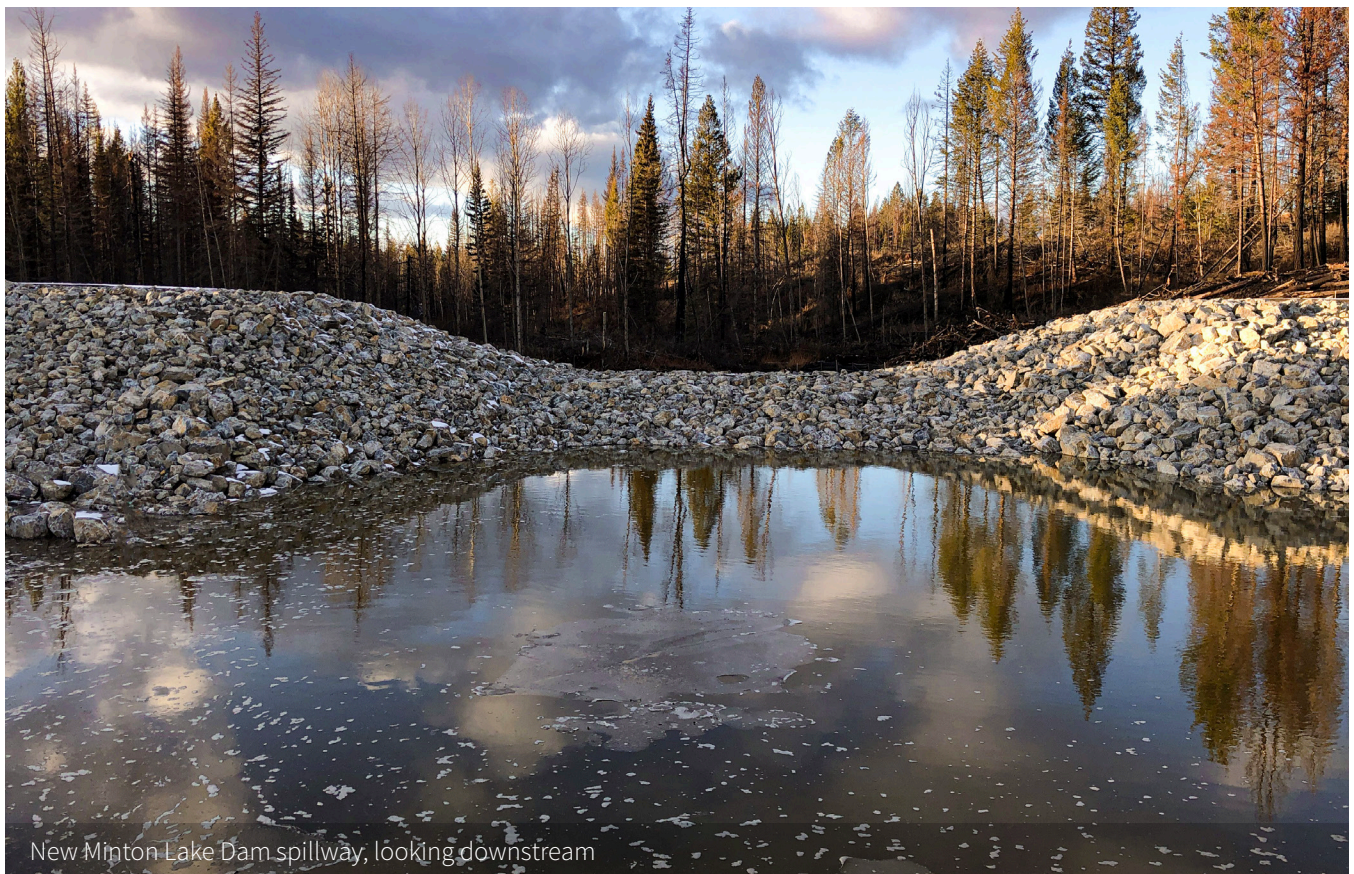
New Minton Lake Dam spillway, looking downstream

The absence of reachable bedrock could have created a condition where conventional concrete spillways were not suitable without rigorous foundation preparation including deep foundations. Instead, Hatch selected a cost-effective method of utilizing the existing glacial till foundation to host the overflow spillway with a central cutoff wall and used conventional riprap for erosion protection. Since the glacial till contained boulders and cobbles, Hatch proposed foundation replacement to allow sheetpile driving. An easily accessible manhole style chamber was designed to provide a means for ease of operation and maintenance of the low level outlet.

The location of the new dam was selected to minimize the disturbance to the environment during construction. In addition, under the assumption of potential presence of fish, the riprap spillway was designed to prevent stranding and to provide vegetative cover and slow velocity. This design provides a more fish and wildlife friendly condition because it reduces the risk of injury and predation.

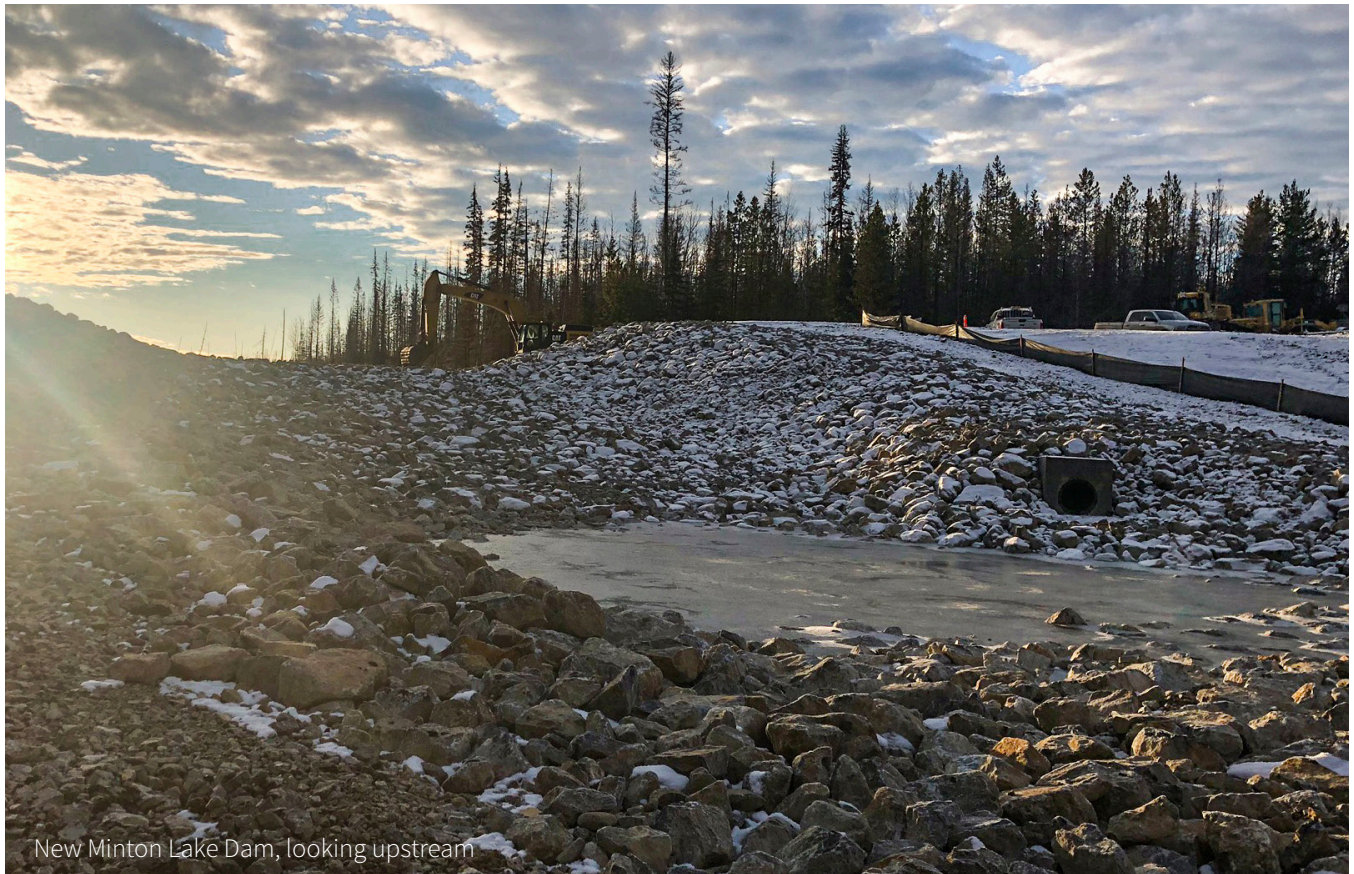
New Minton Lake Dam, looking upstream

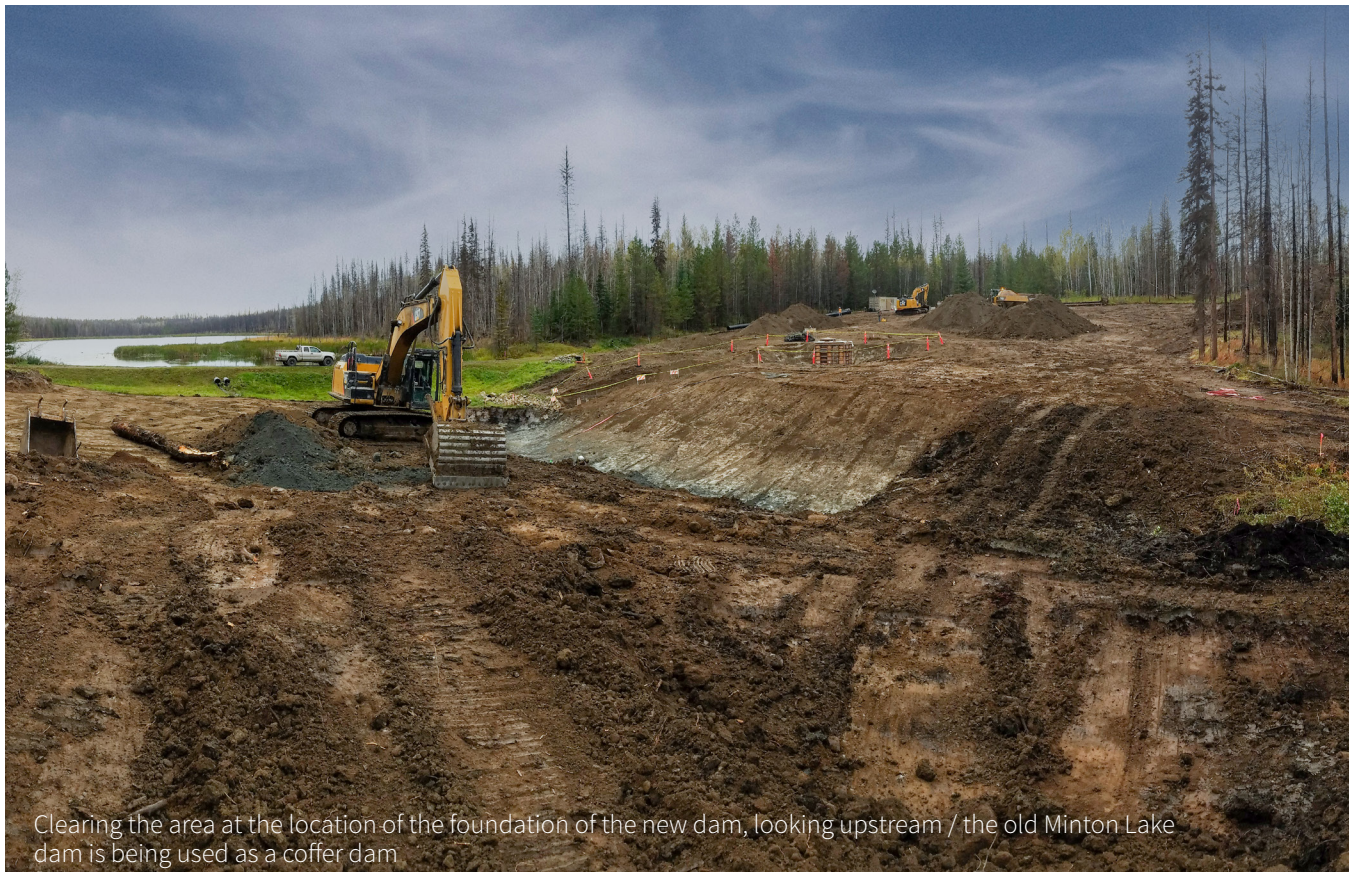
Clearing the area at the location of the foundation of the new dam, looking upstream / the old Minton Lake dam is being used as a coffer dam
