MOULD
REMEDICATION
AND MITIGATION
PROGRAM

Category A: Buildings

Owner: Nunavut Housing Corporation

Primary Consultant: Dillon Consulting Limited

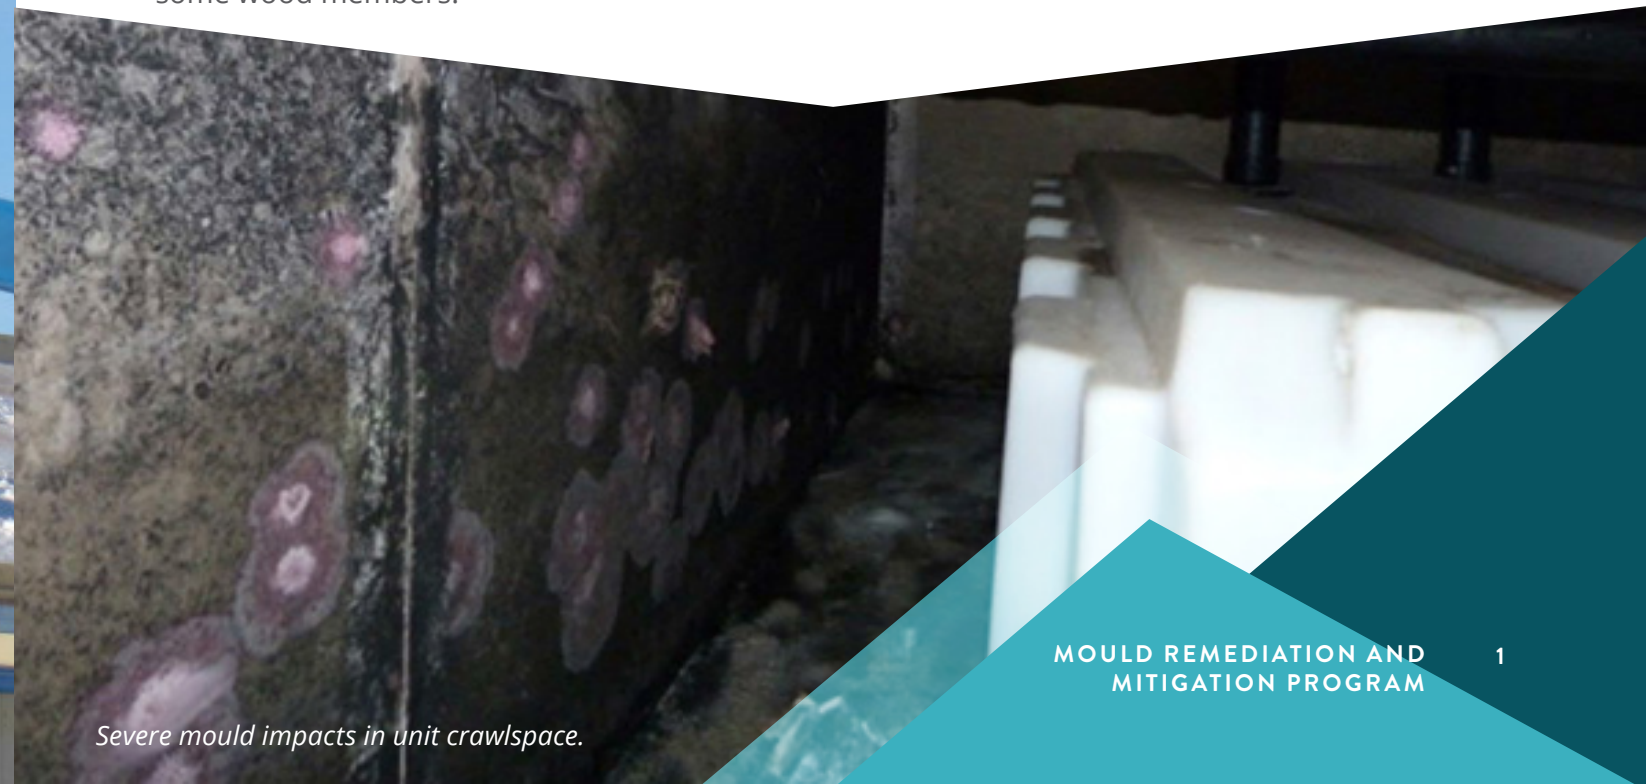
Severe mould impacts in unit crawlspace.

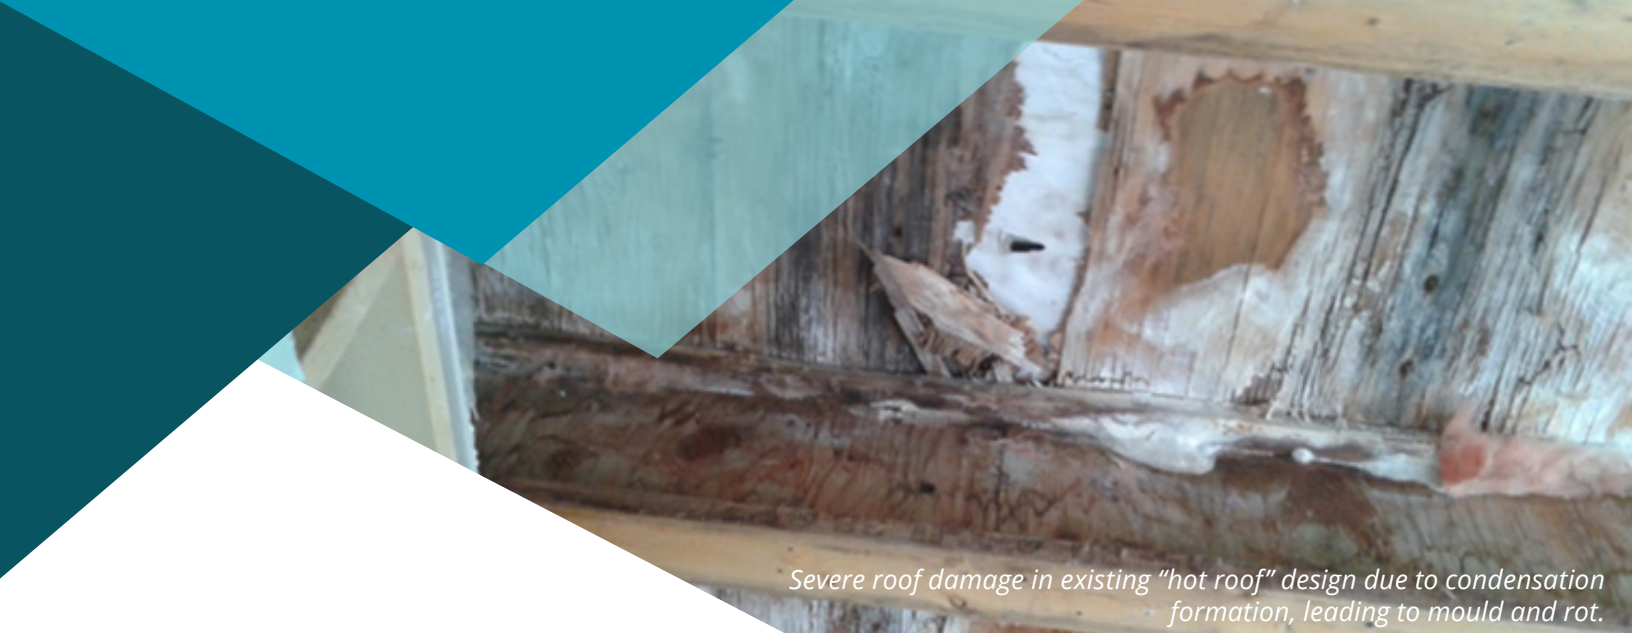
Severe roof damage in existing "hot roof" design due to condensation formation, leading to mould and rot.

One of the common design features of residential units in Nunavut is the use of an unvented cathedral ceiling design, also called a "hot roof" design. It is unknown why this roof design was adopted decades ago; however, it is suspected that snow penetration into traditional vented roof assemblies prompted adopting the unvented roof assembly design. While this design has been successfully employed in other locations, it has been found to be problematic in many cases in Nunavut due to condensation formation within the unvented roof assembly leading to mould generation and in some cases severe rot. Although unconfirmed, it is suspected that high humidity conditions associated with overcrowding, combined with potential vapour barrier issues and extreme cold have led to the observed prevalence of condensation formation within the unvented roof assembly. As described in this summary, a key focus of this project included exploring methods to introduce ventilation into the cathedral roof assembly, while mitigating potential snow penetration through the roof vents.

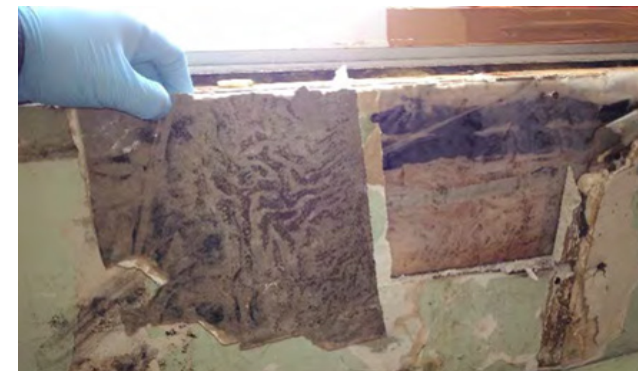
Example of mould formation under damaged windows.

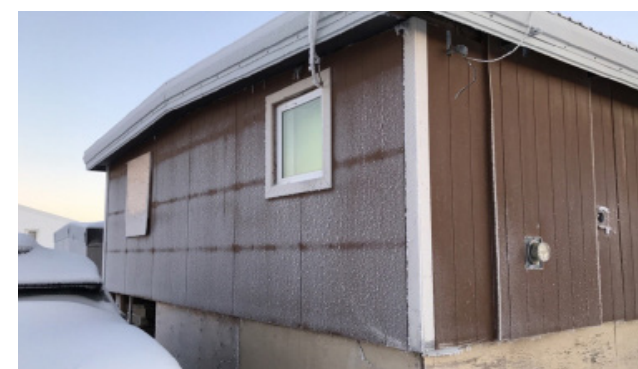
Example of "thermal bridging" through building wood framing.

- Cold being transmitted through wood members resulting in condensation/mould formation (i.e., "thermal bridging");
- Lack of ventilation/air circulation in interior roof cavities utilizing an unvented, cathedral roof design (i.e., "hot roof" design);
- Missing or damaged insulation in walls, ceilings, floors and/or around windows; and,
- Poor vapour barrier seal due to poor construction, wall damage, and/or maintenance work.

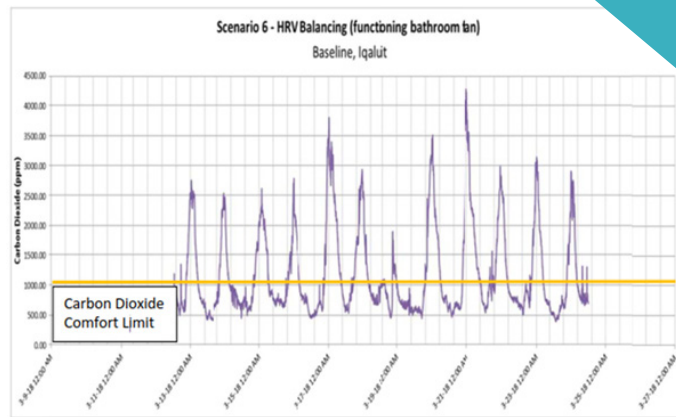
Example of elevated CO₂ concentrations observed in a residential unit in Iqaluit. Note regular spikes in CO₂ on a daily basis associated with increased occupancy in evenings (Dillon, July 2018).

The testing included monitoring of CO₂, temperature, and relative humidity (RH) levels in the homes throughout the day over an approximate two week period. The results of this testing indicated the following:

- A direct correlation between RH and CO₂ levels was observed suggesting that the primary driver for elevated relative humidity was due to human occupancy, particularly in overcrowded units;
- The CO₂ levels measured in the housing units assessed were typically elevated above comfort levels which is considered above 1,000 ppm; and
- Relative humidity ranged from excessively low to high.

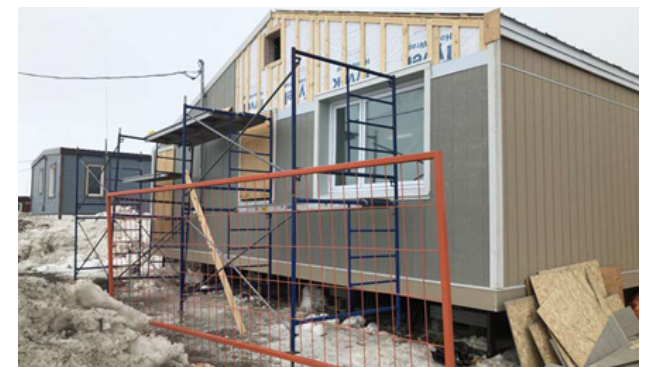
Exterior retrofit near completion - Pilot test unit in Arviat.

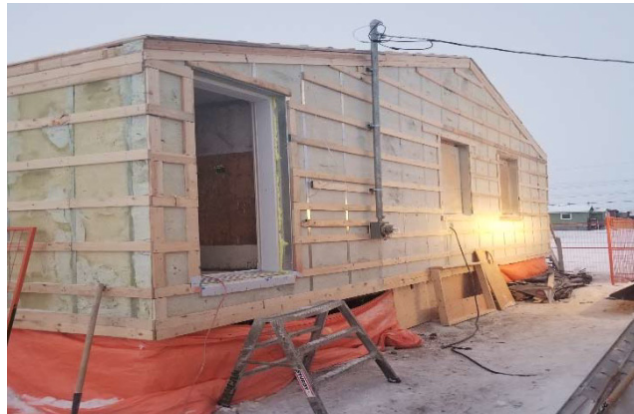
Pilot test unit in Arviat under construction following application of SPF insulation on exterior walls.

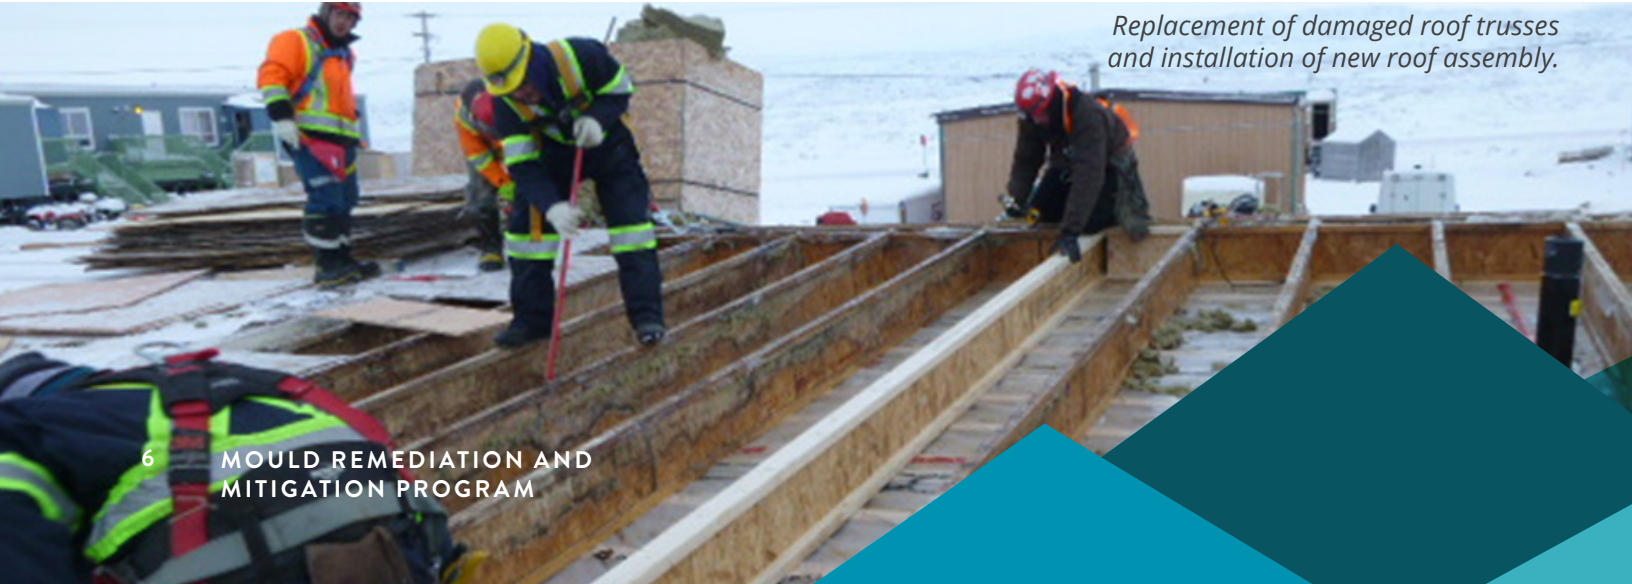
Replacement of damaged roof trusses and installation of new roof assembly.

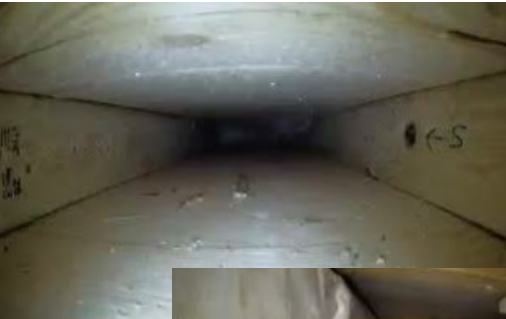
Top: Roof assembly camera image pointed toward soffit vent for snow intrusion monitoring - January, 2020.

In developing the roof ventilation pilot testing program it was recognized that a method would be needed to visually monitor potential snow intrusion through the various venting systems, rather than rely on indirect data such as moisture content. To address this requirement, remote video cameras were strategically located within the roof assembly to facilitate visual monitoring and capture of photographic records of the performance of the venting systems in preventing snow intrusion. In addition, the cameras provide a means of monitoring potential frosting of the roof sheathing over the winter months.

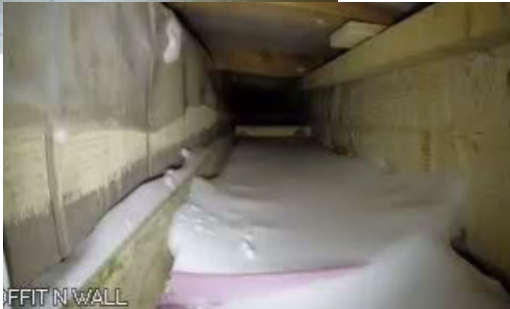
Bottom: Camera mounted within “snow knockout” soffit vent showing snow accumulation. January, 2020.

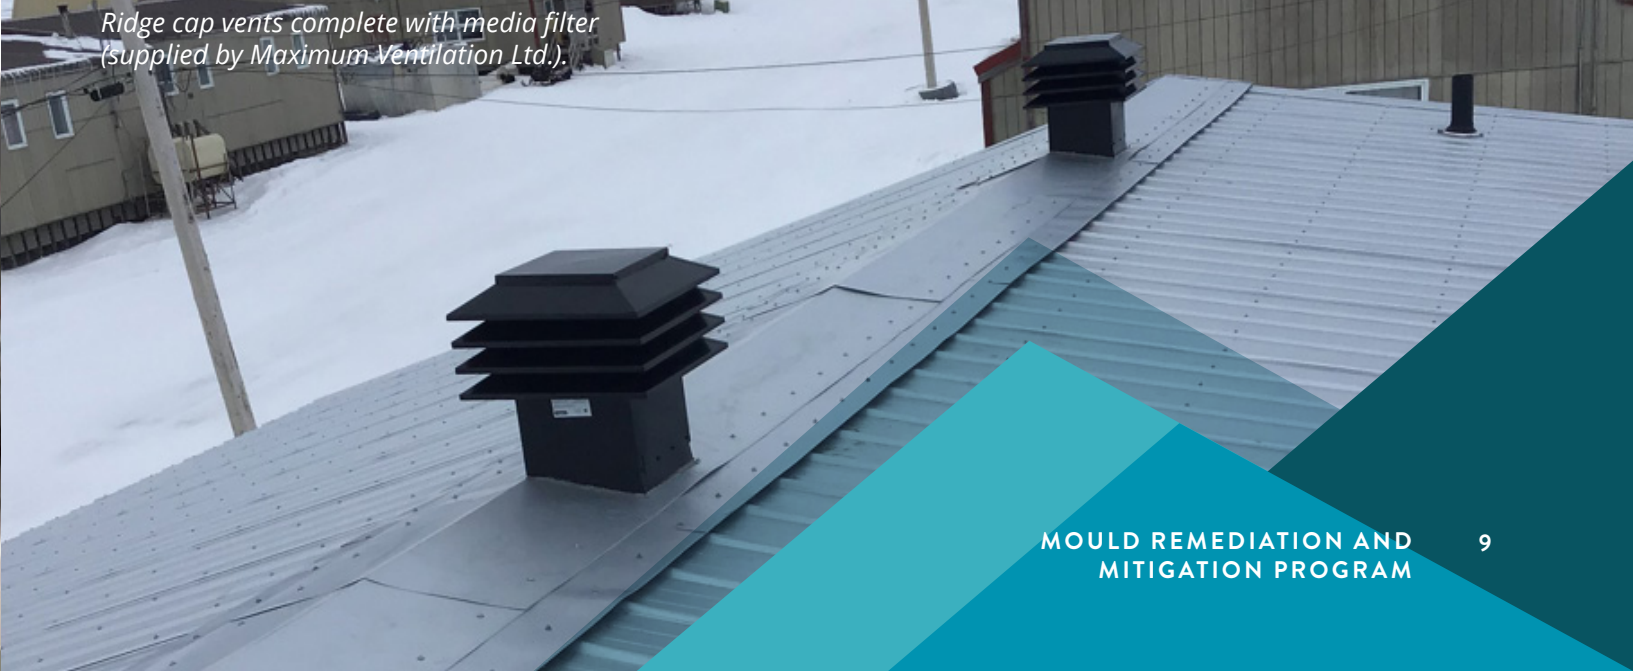
Ridge cap vents complete with media filter (supplied by Maximum Ventilation Ltd.).
