Chaudière Falls Redevelopment Project

John G. Cooke & Associates Ltd.

Canadian Consulting Engineering Awards 2021 – Entry Binder

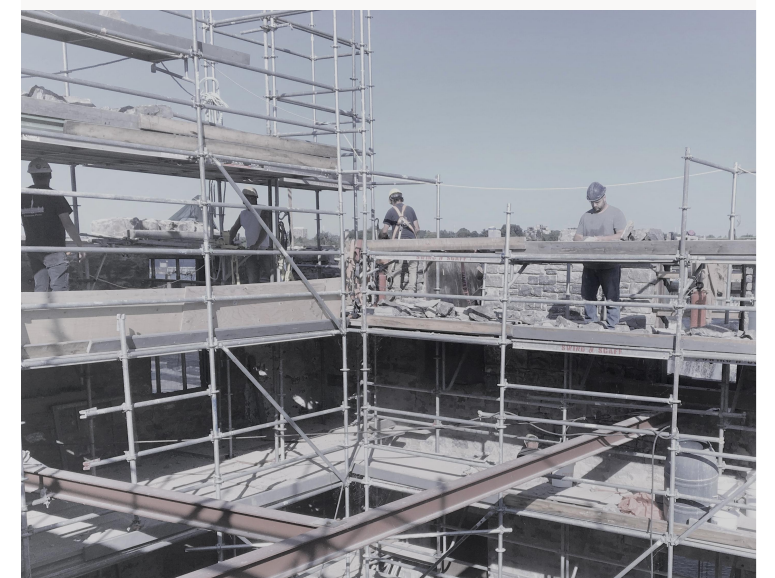
▲ Work in Progress
Hoisting the collapsed structure out of the building (JCAL 2018)

In close collaboration with the contractor, drone technology was used to fly into the collapsed structure to create a visual map of the remains to aid with the removal procedures. Two mobile cranes were used to hoist the collapsed structure out of the building in a top-down manner, while installing temporary steel bracing to support the stone walls to ensure stability.

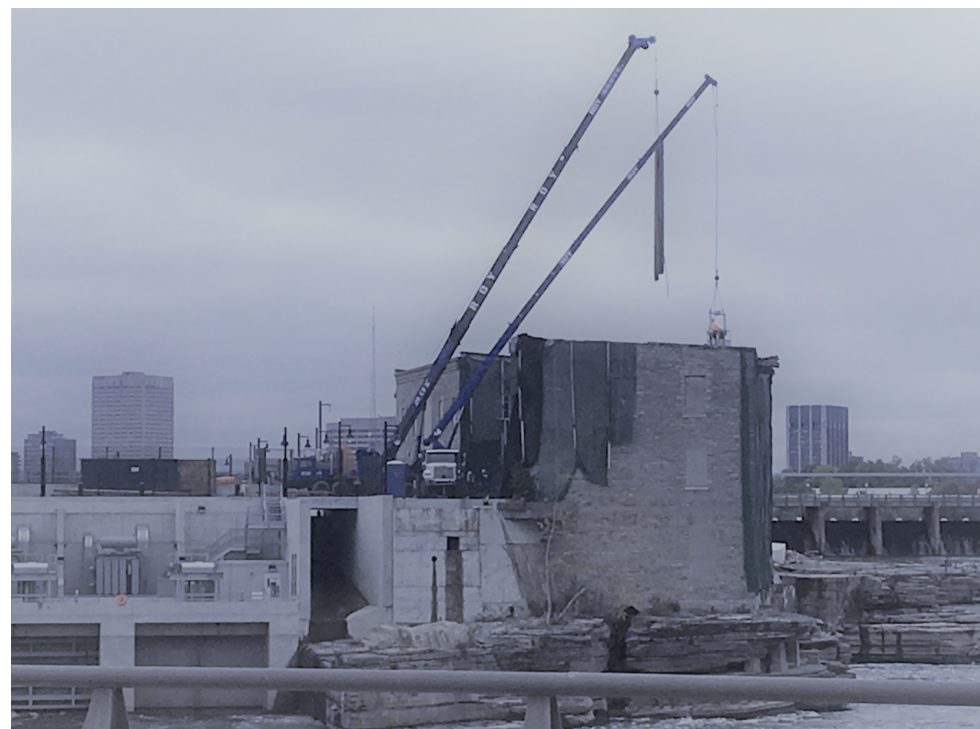
▲ Work in Progress – Masonry Restoration (JCAL 2019)

In addition to one of the stone buildings internal structural collapsing 20 years ago, both buildings had significant deterioration to the exterior walls. The stone walls were fully restored to preserve the buildings for future use. Stone conservation principles were used to match the existing properties of the mortar and stones. The individual stones in the wall had a severely high rate of deterioration due to the long term exposure of mist from the Falls and poor maintenance in the past. As a result, over 6,000 stones were replaced during the project. The replacement stones needed to be installed in small sections not to destabilize the already crumbling walls.
