M1 Canal Rehabilitation

Project Overview

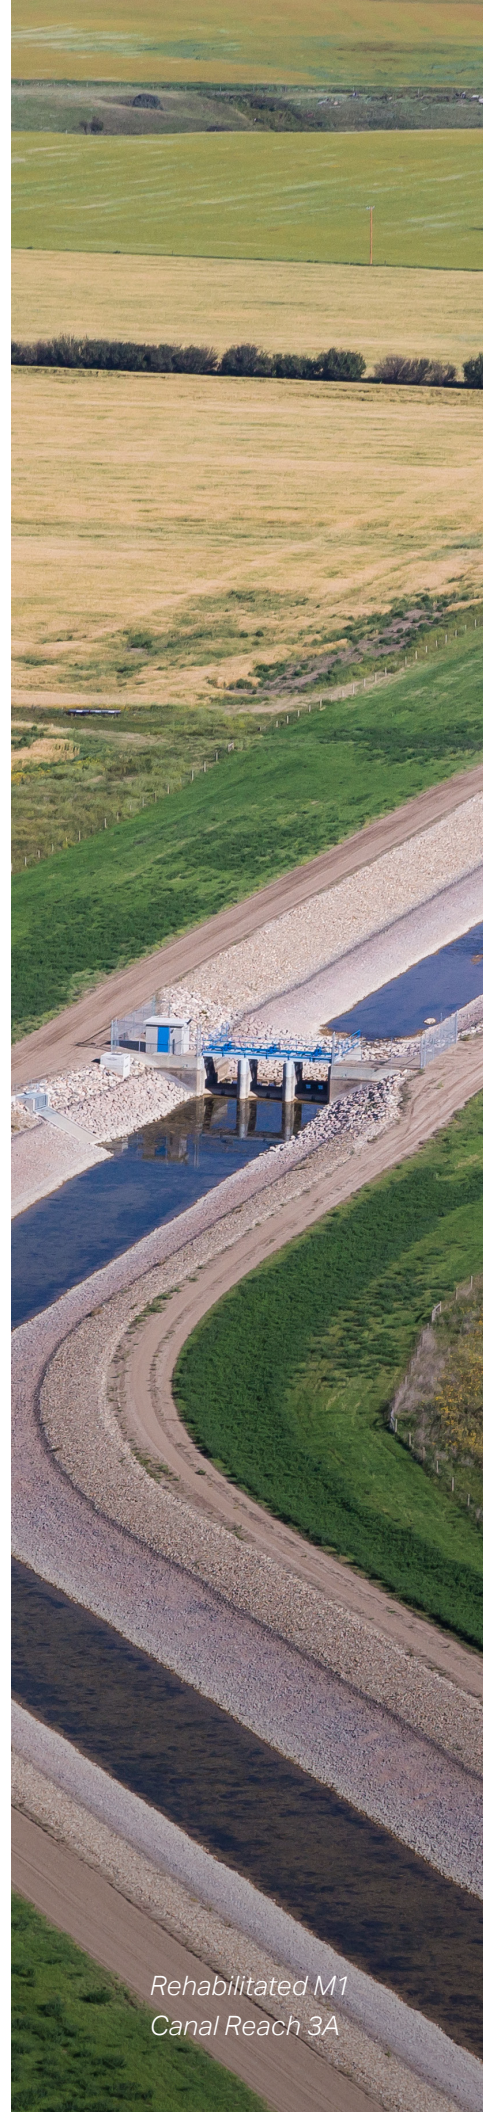
Rehabilitated M1
Canal Reach 3A

In 2021, the M1 Canal Rehabilitation was successfully completed in its entirety. This rehabilitation program involved lining the canal with an RPE liner and granular armour, widening the canal for increased capacity, and replacement, rehabilitation, or new installation of over 100 structures ranging from drain inlet culverts to check structures, cross-drains, and an emergency overflow structure. The project has reinstated the service life of the canal, upgraded to meet current and future flow demands, and enabled the future expansion of irrigation, industry, and mining.

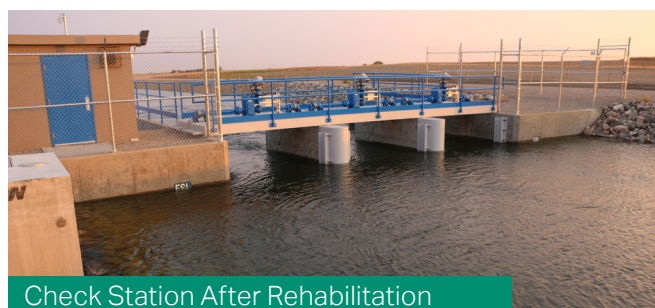
Check Station After Rehabilitation

There has been significant technological evolution since the M1 Canal was originally constructed in the late 1960's. With the major rehabilitation program, considerations were made for upgrading the components to modern systems. The check structures were originally constructed for manual operation of the gate position with a handwheel. The new check structures included electrical controls that automatically set the gate levels based on either the canal flow or to maintain the desired water level. Compared to manual operation, this improves operator safety, eliminates manual operation, and provides almost immediate response to changing flow conditions.

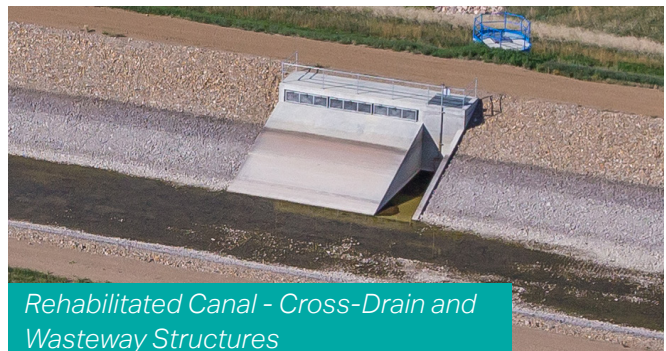
Rehabilitated Canal - Cross-Drain and Wasteway Structures

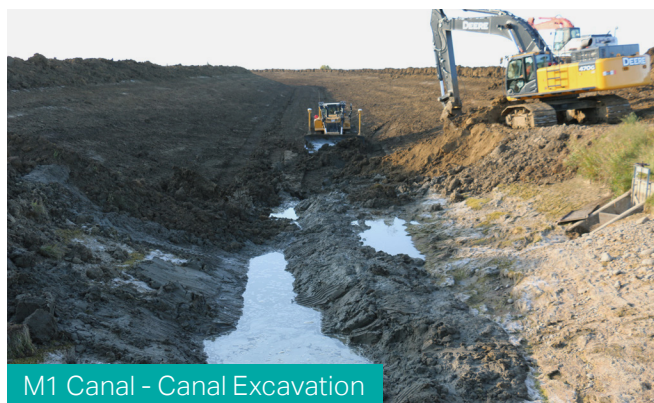
M1 Canal - Canal Excavation

The rehabilitation program for the M1 Canal would correct these deficiencies while also increasing the canal capacity. The canal capacity was increased by 50% from 18.4 m³/s to 28 m³/s to provide capacity for current demands and future expansion in irrigation, industry, and mining. This required significant earthworks to widen the canal from 6.1 m to 9.5 m.
