FORT MCMURRAY 2020 ICE JAM FLOOD WASTEWATER & STORMWATER SYSTEMS RECOVERY

Category | Water Resources

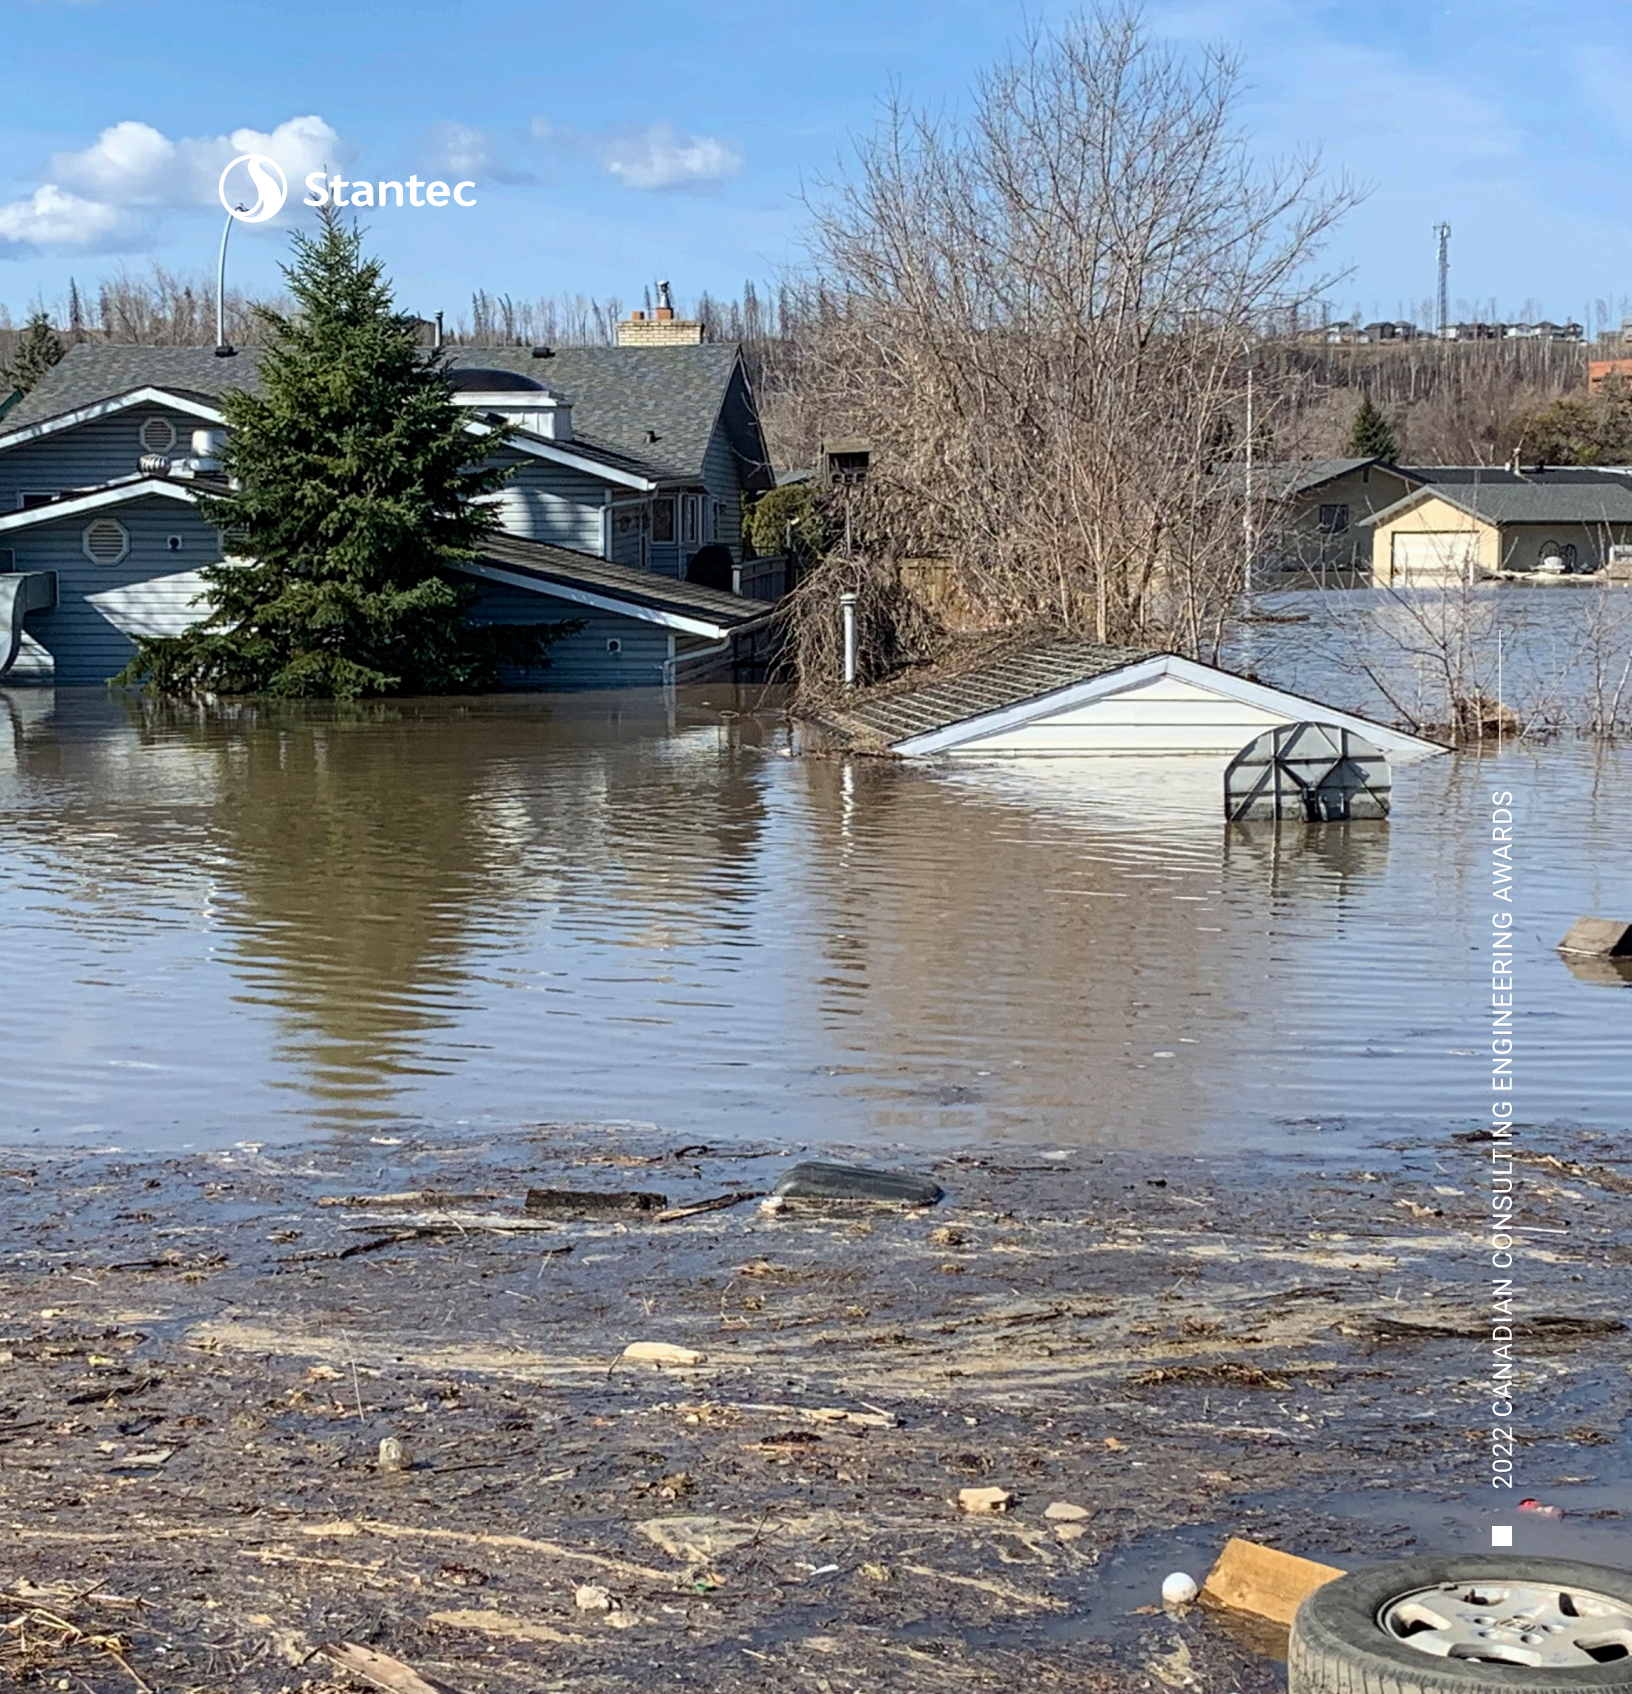
Melting ice block towers above stormwater outfall
in Syne Point Park

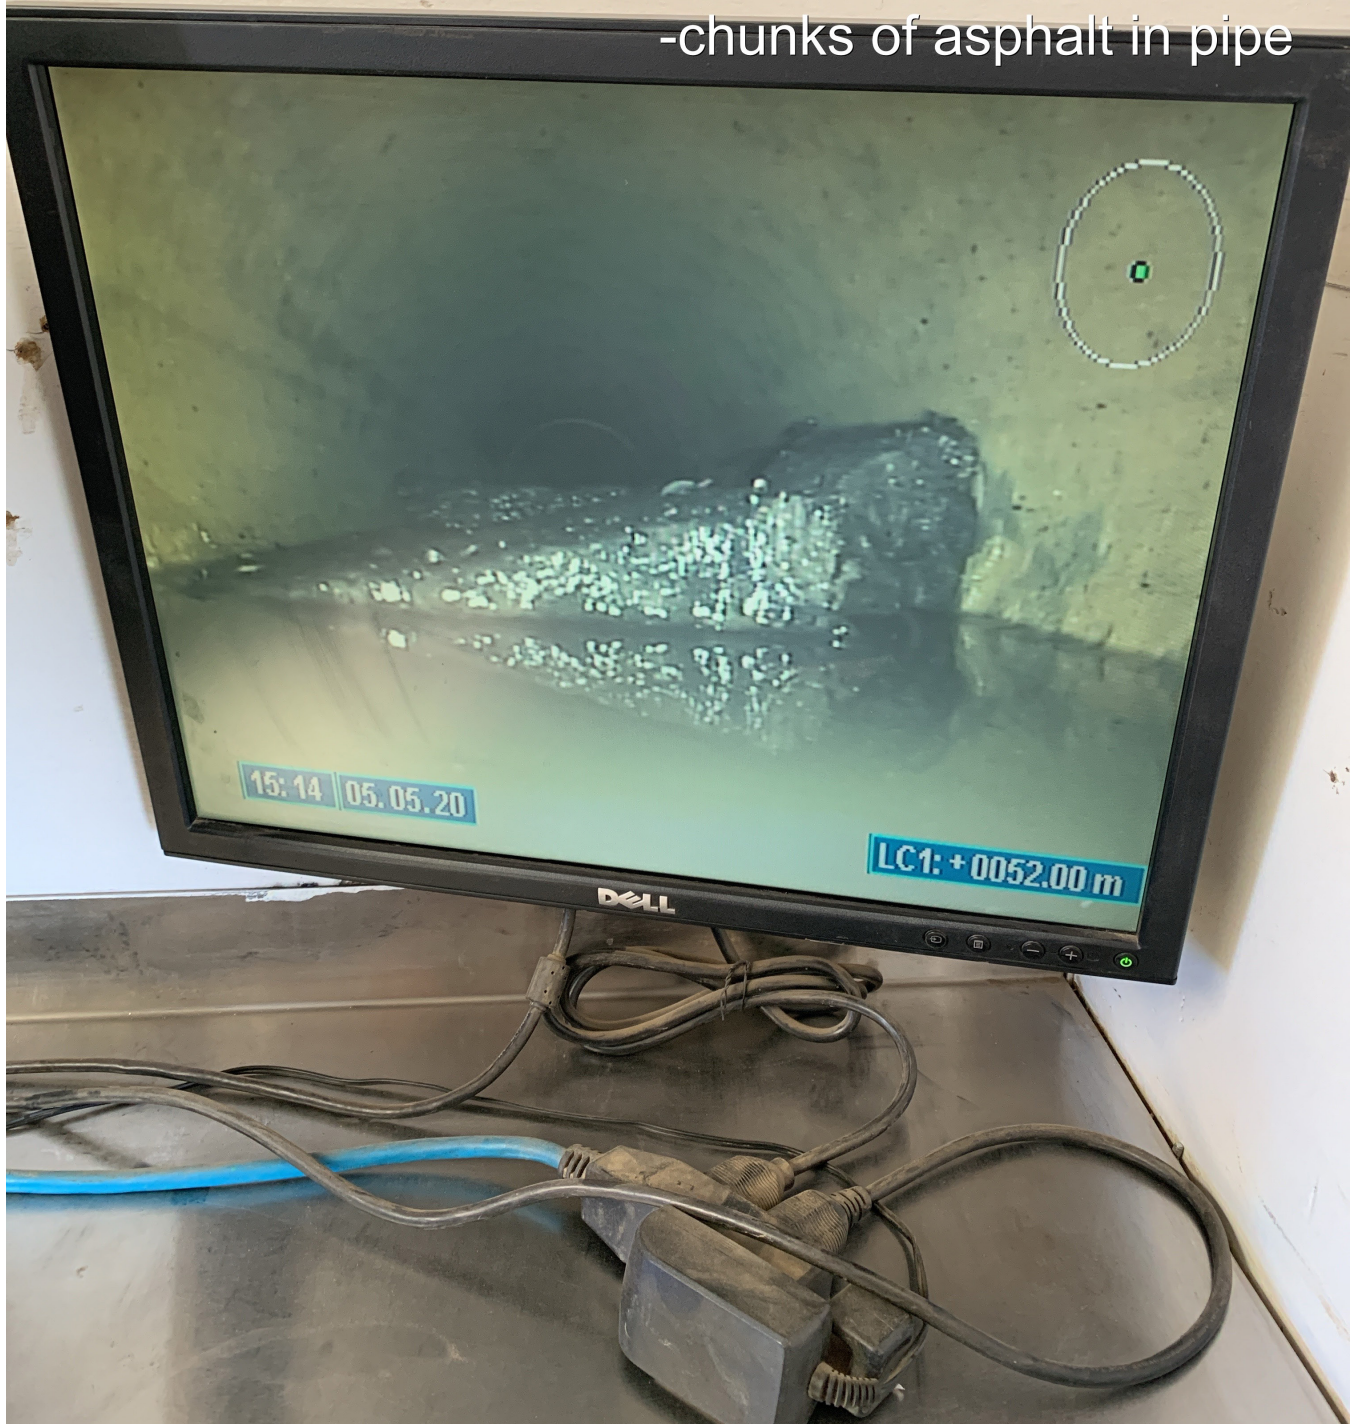
52m from SA3004 towards SA4054

-chunks of asphalt in pipe

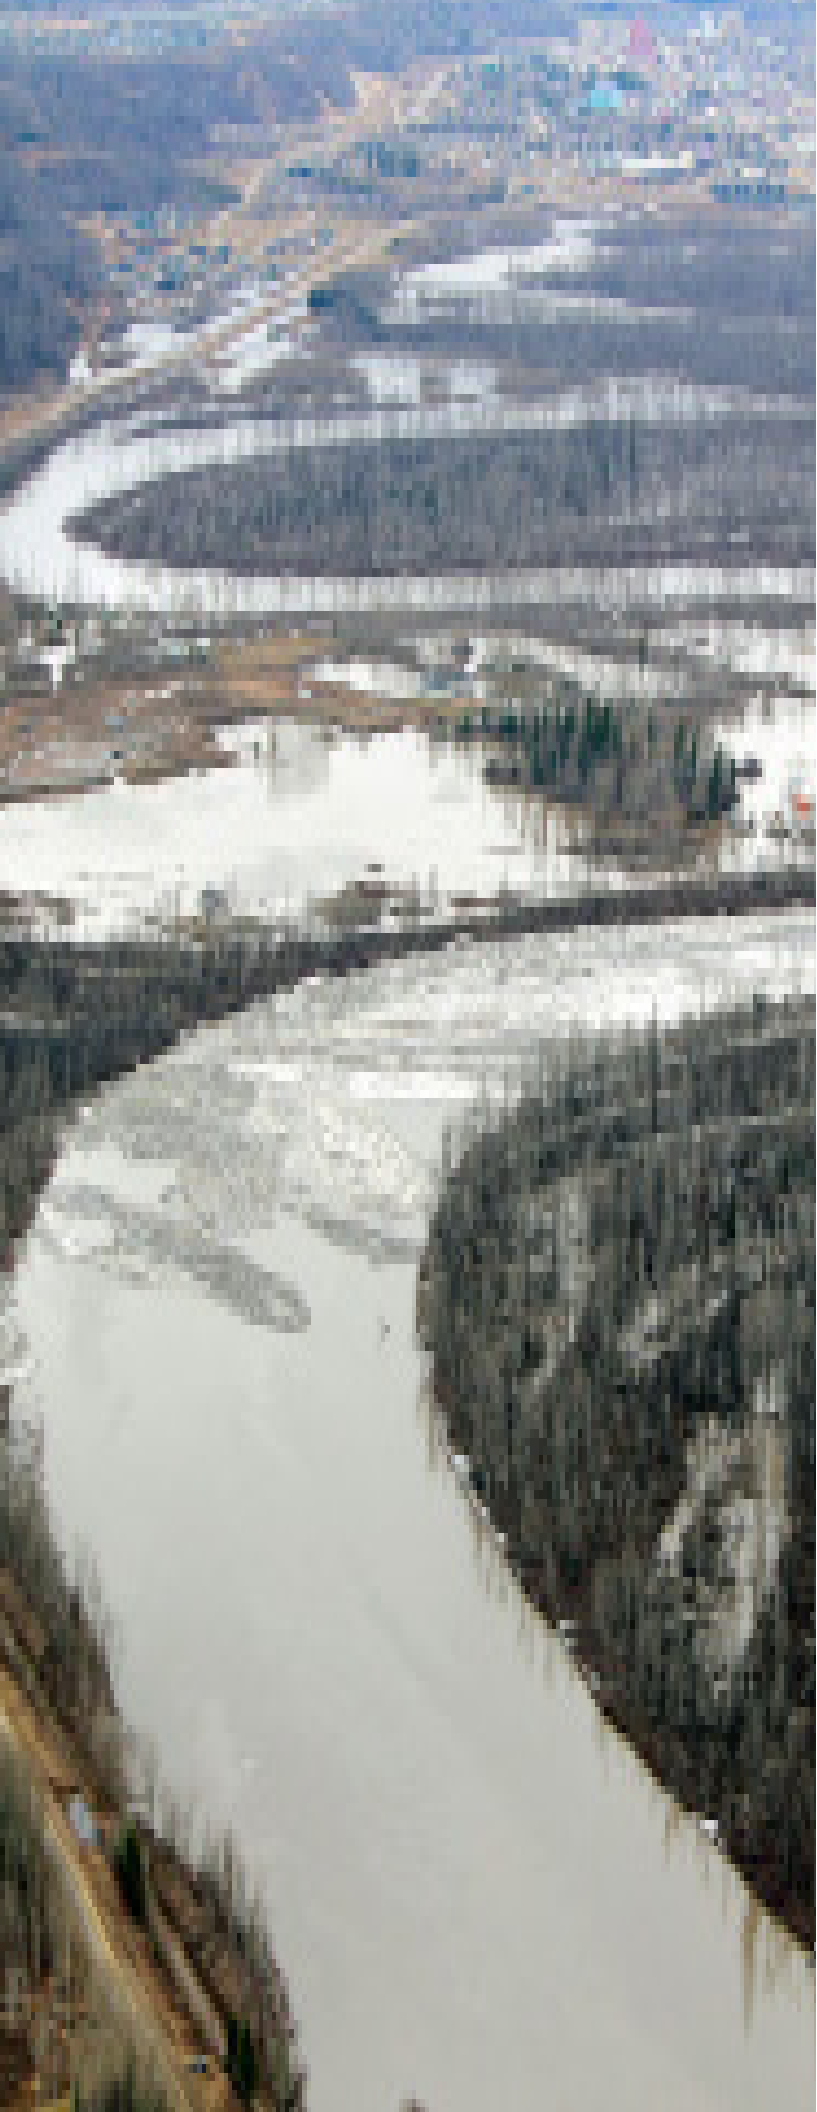
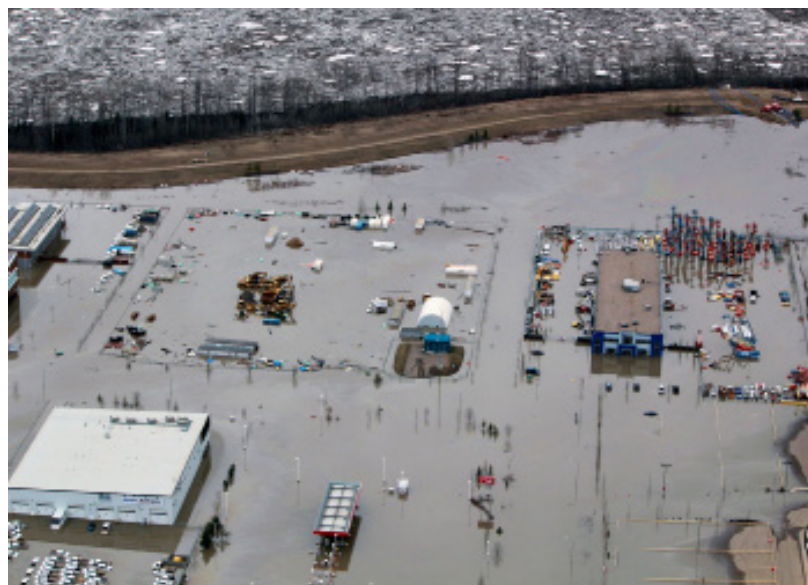
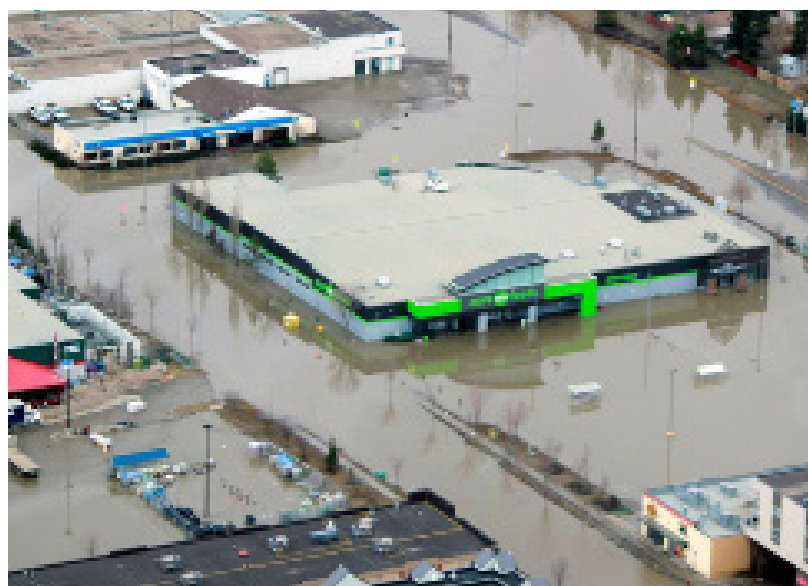
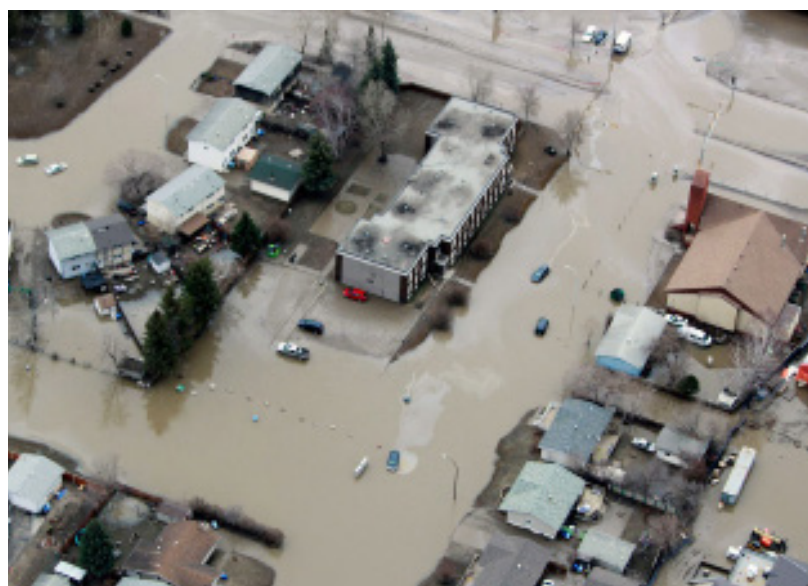
← *Lift Station 1A was kept in operation and called upon to deliver over 10 times its average flow for several days despite damage to the station and power interruptions.*

Our primary response focused on the construction of emergency access to Lift Station 1A and diversion pumping to protect Lift Stations 1A and 1B. Stantec organized the generator repairs to keep both lift stations online, and the condition assessments and operations consulting for the four lower townsite lift stations and wastewater treatment plant. We organized the re-seeding of the WWTP Bioreactors and assessments of the sewer and stormwater systems.
