2023 Canadian Consulting Engineering Awards

IQALUIT WATER CRISIS

Water Resources

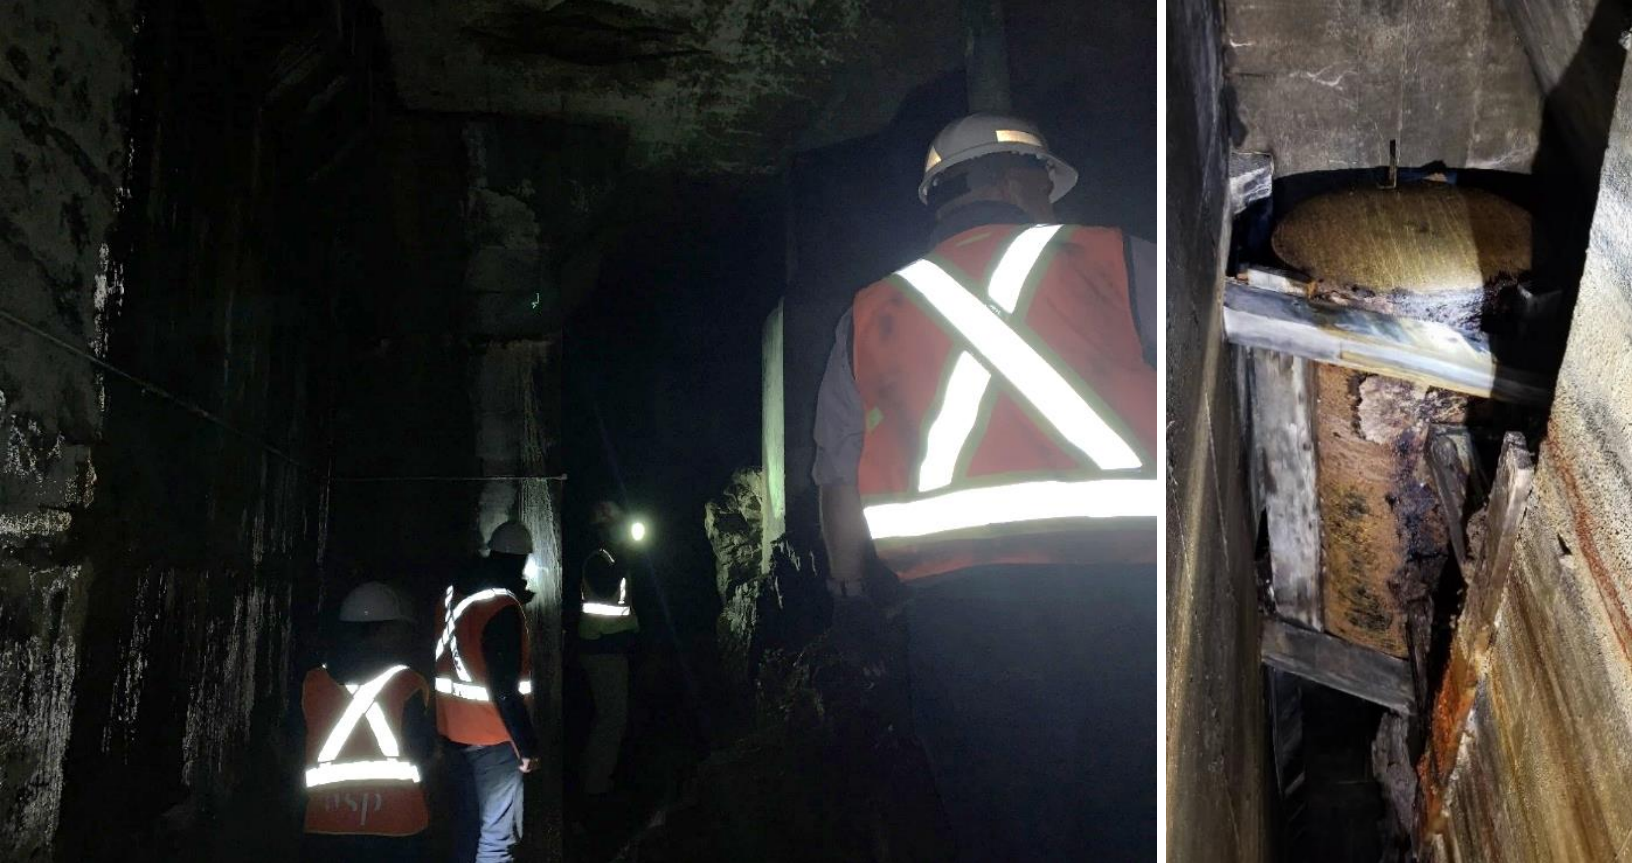
Figure 3: Sub-surface cavity beneath the Iqaluit WTP known as the Void (left) and a 60-year old abandoned underground fuel storage tank (right)

During the investigation, WSP discovered a sub-surface cavity below the WTP (which became known as “The Void”). The Void is essentially the air space between the concrete water treatment plant structure and the surrounding bedrock. Navigating it was a challenge. Not only was it flooded with contaminated water, but there were also several very narrow corridors and sections with limited head room. In the deepest reaches of the Void, WSP personnel discovered a severely rusted underground fuel storage tank with remnants of congealed oil hanging from its bottom, and pooled oil directly beneath the tank (**Figure 3**). Through a series of in-depth theories and consultations with several professional chemists and subject matter experts, the WSP team identified the pathway and was successfully able to bypass the contamination entry point. Within one week, the pristine glacier-like water quality was restored.

- Installation & calibration of a two real-time hydrocarbon detection systems (**Figure 5**);
- Installation of a WTP bypass system that bypasses all below-ground treated water tanks;
- Removal of the leaking historic underground fuel storage tank (**Figure 6**);
- Cleaning of the Void and all below-ground treated water tanks (**Figure 6**);
- Completion of a Phase II Environmental Site Assessment (ESA) to further validate that all contaminants had been effectively removed;
- Development of a field sampling plan and monitoring & reporting plan; and
- Development of standard operating procedures for consumer complaints, contamination investigations, and operation of the WTP bypass system.

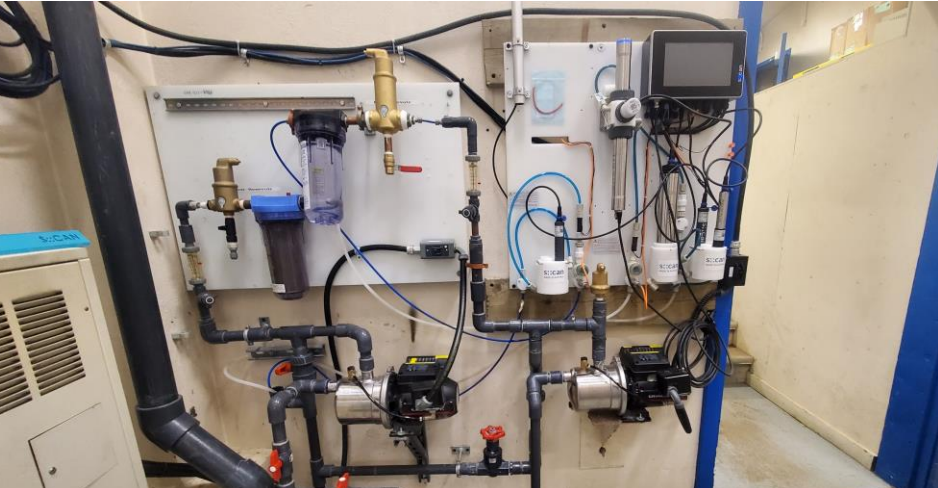
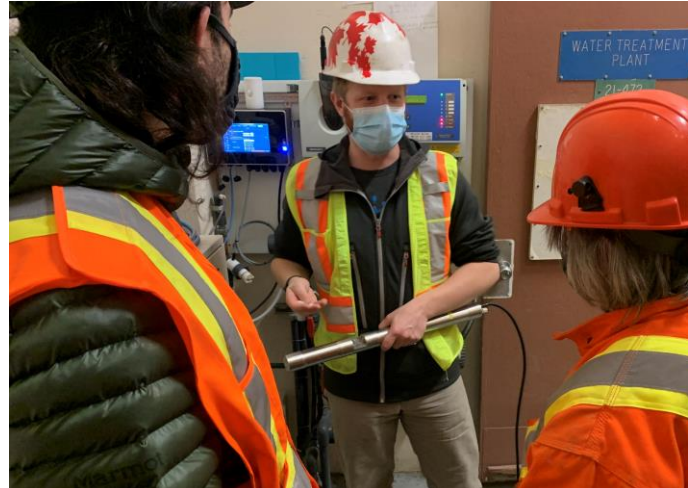
Figure 4: Novel real-time hydrocarbon monitoring system.

In addition to the challenges already described, third-party lab results for petroleum hydrocarbons were taking longer than one week to get back; this meant that critical decisions were being made on week old data, and the City couldn't inform consumers of the risks associated with water quality "today". In response, WSP worked with an equipment supplier to install a spectrophotometer device known as the S::CAN (**Figure 4**). This technology was relatively new to Canada and was the first of its kind in Canada's Northern Territories. WSP professional chemists performed a unique calibration of the device to measure petroleum hydrocarbons. The system could collect and analyze results in "real-time", which was a vast improvement to the one-week lead time on third-party results. Additionally, the system is capable of running grab samples, so operations staff could collect results from any point in the water treatment and distribution systems and obtain immediate results. When a water complaint was received by the City, public works staff would collect a sample from the complainant's tap and provide the consumer with the results on the same day. The system also produces a spectrophotometric "fingerprint", which can be used to compare the likeness between different samples. This device played a pivotal role in the investigation.

The S::CAN played a pivotal role in the investigation and allowed WSP to provide overwhelming evidence that the leaking historic underground fuel storage tank was the sole source of the contamination.

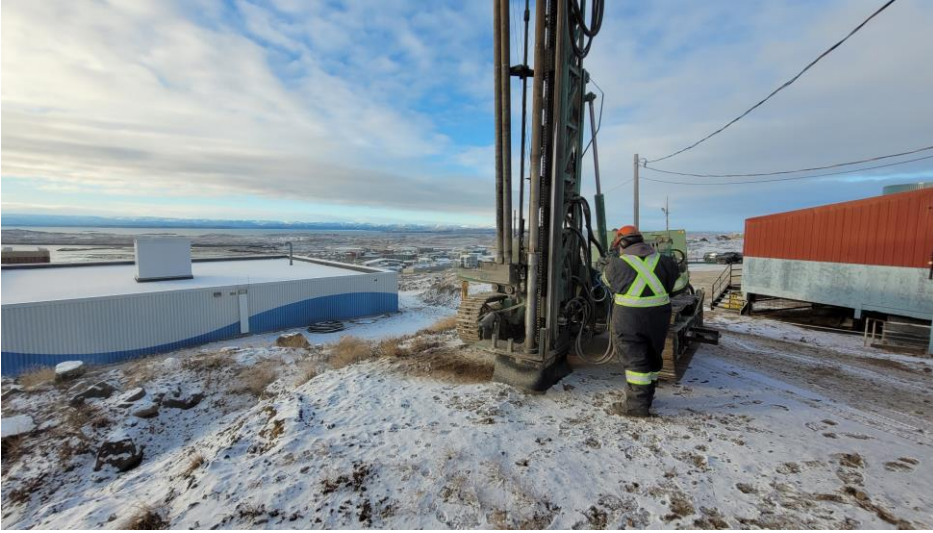
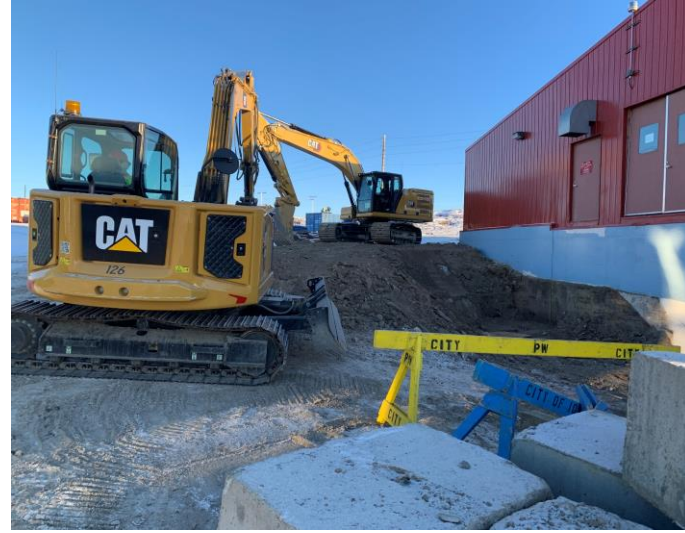
Figure 5: Performing a Phase II Environmental Site Assessment.

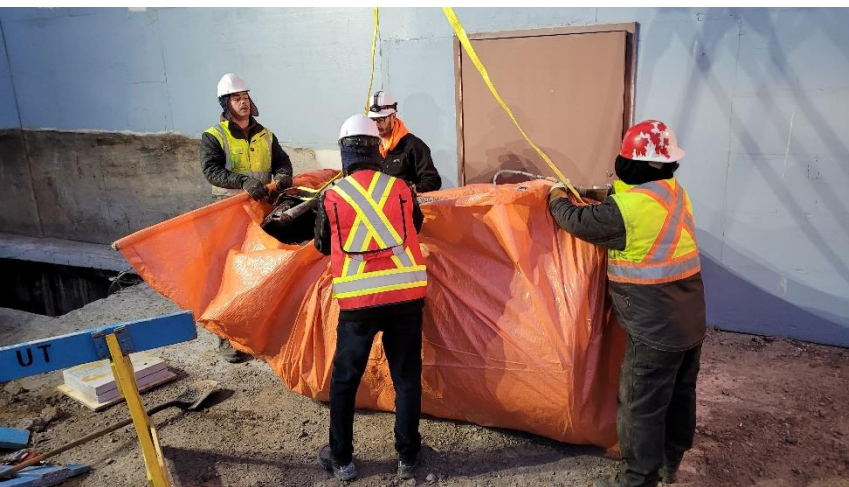
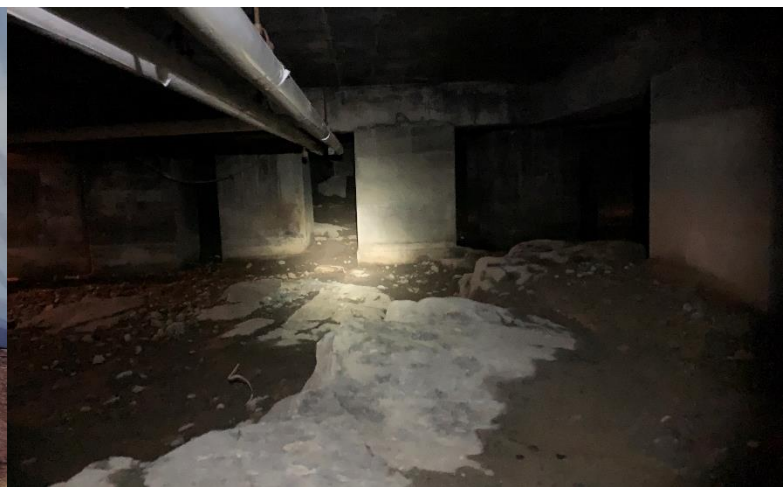
Figure 6: Removal of the historic underground fuel storage tank (left) and the Void after cleaning (right)..

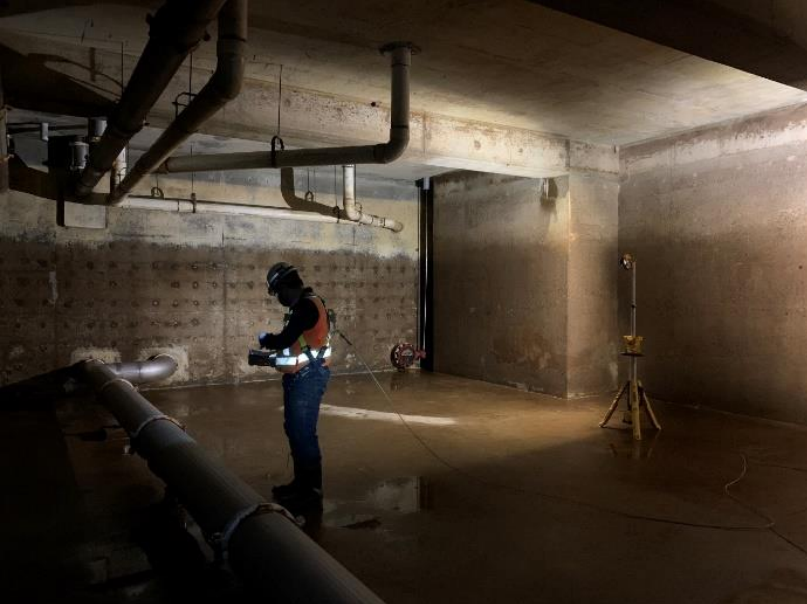
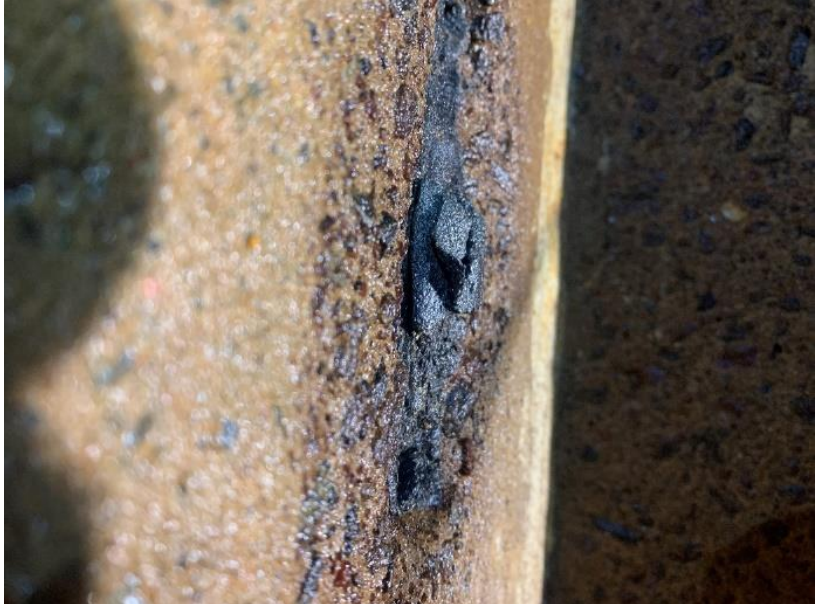
Figure 7: Iqaluit Water Treatment Plant below-ground tank inspections and black tar-like substance

The team of water treatment, materials, and structural engineers performed a detailed re-inspection of all below-ground tanks and noticed immediately that something had changed from the previous inspection. Several portions of some of the tank walls had spalled off, revealing a black tar-like substance within (**Figure 7**). A sample of the unknown substance was run through the S::CAN, and the fingerprint was confirmed as a match for the contaminant in the water. Through the team's review of historical data and documentation, they were able to identify it as a waterstop product that contained petroleum hydrocarbons as a compositional ingredient.

WSP professional chemists devised a novel onsite experiment using a calibrated field spectrophotometer to determine the composition of the black, tar-like substance and assess its risk to the public water supply.

In light of the concerns for the waterstop product, WSP worked with the City to remove all remaining waterstop product from the concrete tanks, and applied both a protective concrete coating and secondary waterproofing coating to all treated water tanks. The structural and materials subject matter experts confirmed that the now 61-year-old water treatment plant in the Canadian Arctic remains in excellent condition, and will be fit for service for many years to come.

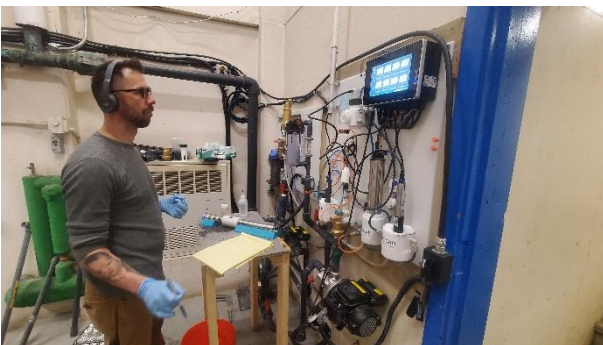
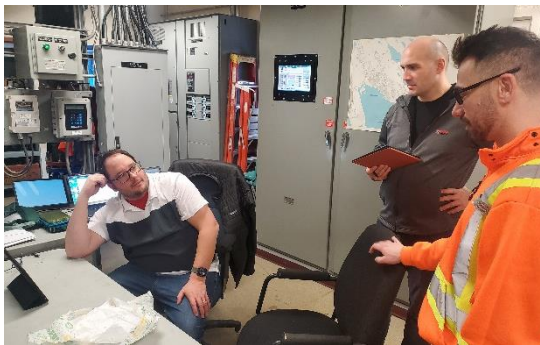
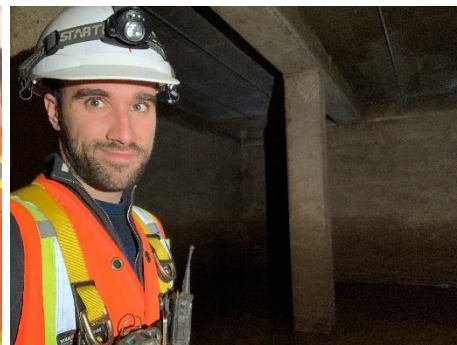
As of November of 2022, all upgrades were successfully implemented and a return-to-service plan was developed & executed. WSP professional chemists, NAPEG certified engineers, and trained water treatment plant operators were onsite throughout the entire re-commissioning to ensure the successful return of the water treatment plant to normal operation.
