CCE Awards 2023

Restoration of the Recreation Bay and Tekakwitha Island in Kahnawà:ke

Firm:
AECOM Consultant Inc.

Client(s):
Mohawk Council of Kahnawà:ke

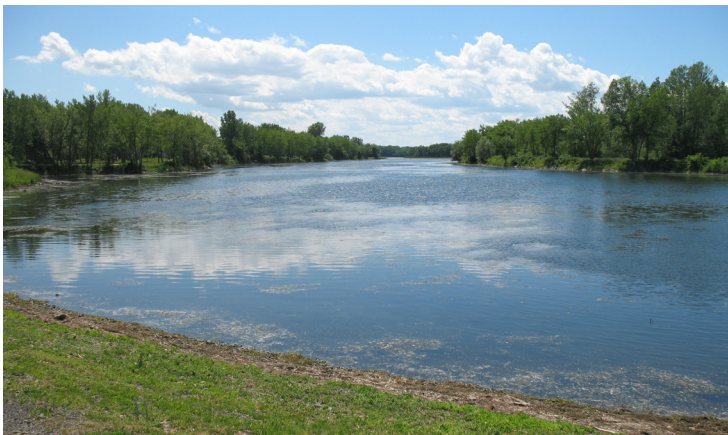
View of the Recreation Bay

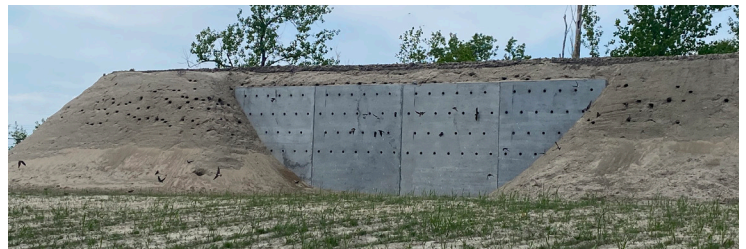
Nesting structure for the Bank swallow

Since the bike path passes along the bay through the new natural habitats, community members can reconnect with nature, enjoy the beauty and tranquility of these habitats, and present opportunities to observe wildlife attracted by specific features such as the artificial nesting structure for the Bank Swallow.

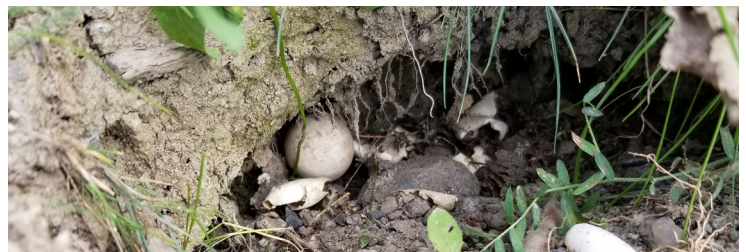
Turtle nest and eggs

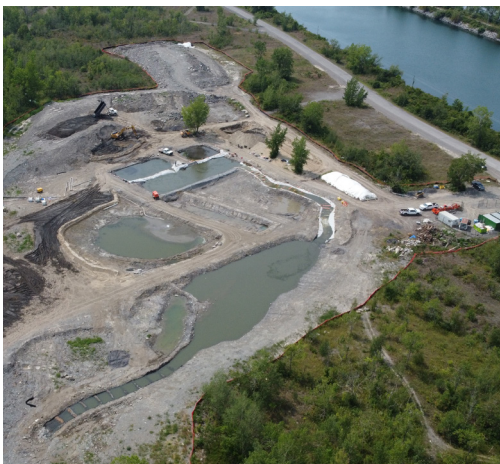
Dredging worksite

Dredging shoal areas and harvesting aquatic plants were two measures identified to increase water flow. Based on sediment characterization and after discussion with MCK, AECOM recommended the use of hydraulic dredging and transport of a sediment slurry to an area on land for consolidation in dewatering bags. However, the contractor proposed an innovative technic to dewater sediments in a more efficient and cost-effective manner. Because of the amount of space available and the excavation required for the creation of the linear pond and marsh feature, a series of basins were created to manage the slurry. Coagulants were added at various stages to progressively remove the sediment from the water column. The overflow was then passed through a polishing channel with additional additives to clump remaining sediment which was then settled in a final chamber. The geology of the island was then

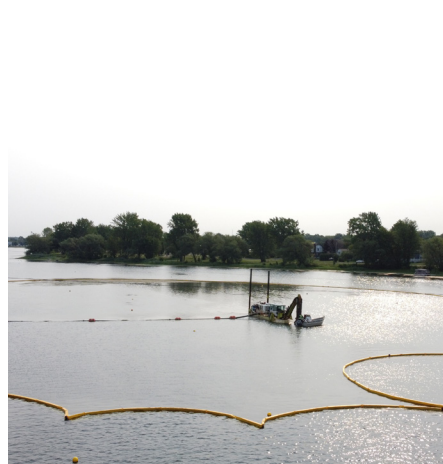
Silt curtain sequesters sediment during dredging operation

Mitigation measures, such as silt curtain and exclusion fences, were deployed during dredging and excavation activities to protect wildlife and adjacent environment. The overall restoration project incorporated principles of sustainable development, with a focus on removing invasive species, minimizing environmental impacts and disturbances and reusing materials where possible.

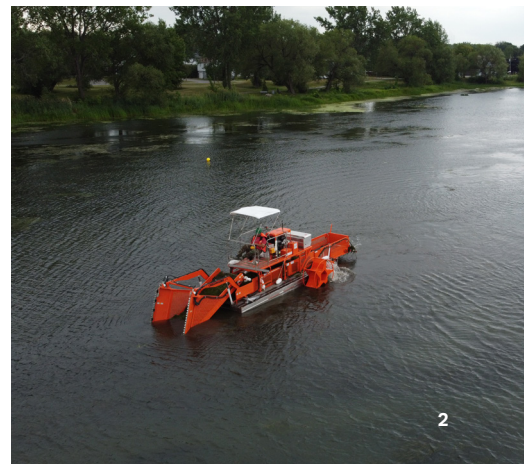
Aquatic plant harvester in action in the bay

To maximize flow velocity and sediment movement through the bay and protect wetlands and wildlife at the same time, aquatic plants were harvested in a defined channel of 54,800 m² located between the dredging area and the St. Lawrence Seaway. AECOM recommended a plant harvesting strategy based on water depth, plant density and surface area, as well as the best equipment to use in the specific context of the bay with the least adverse impacts to fish and turtle habitats, emergent grass beds and shorelines. The timing to proceed with plant harvesting needs to match optimal water level conditions and plant heights in areas to be harvested.

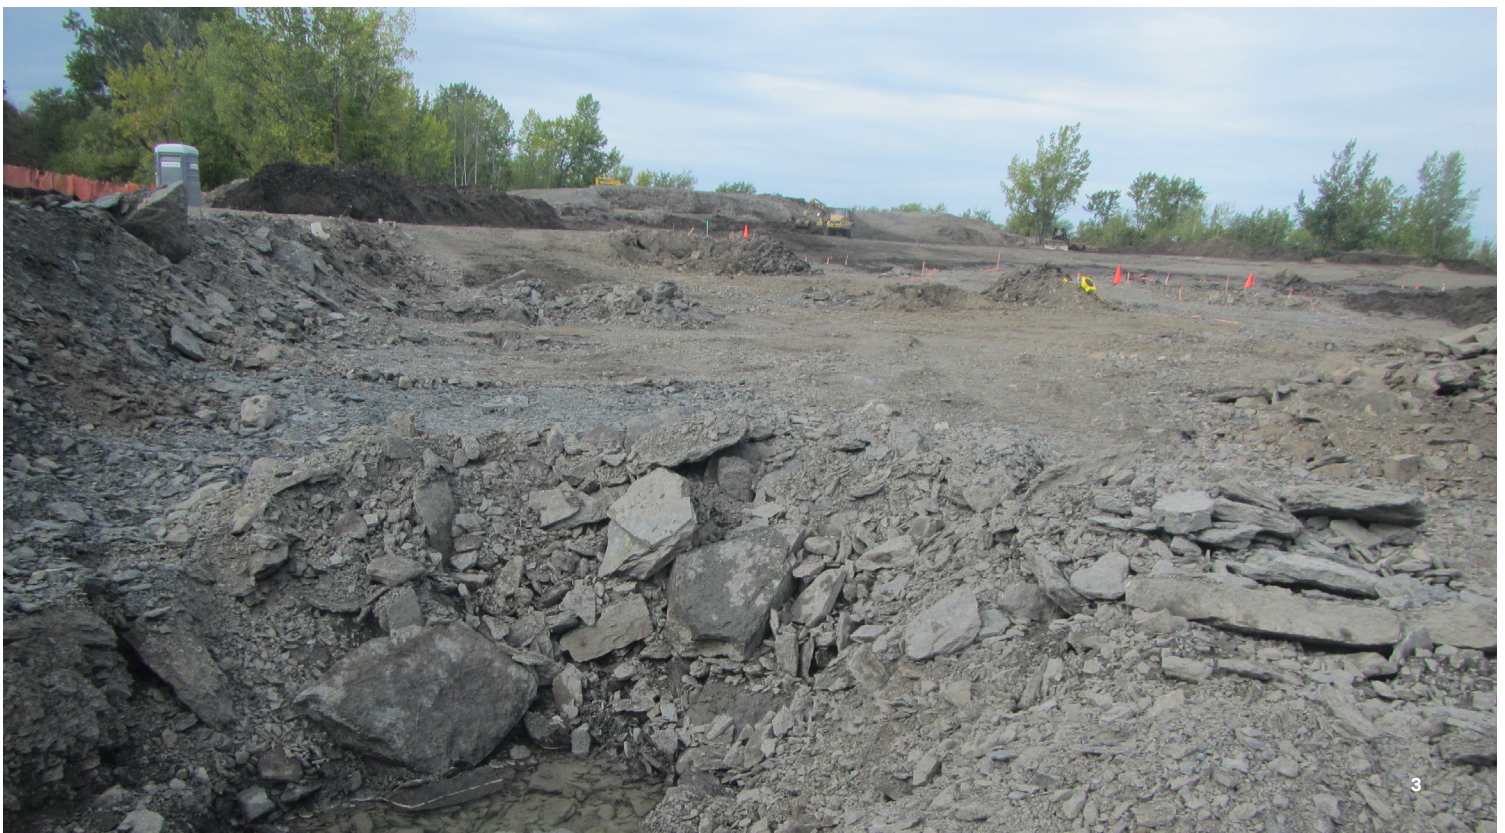
The rocky nature of the soil was challenging during excavations

Since most of Tekakwitha Island is composed of excavated rocks of all sizes and clay from the St. Lawrence Seaway, another challenge was the unpredictability of the soil where excavation was needed. During the creation of the two natural zones and profiling of the shoreline, many times

the contractor came across big rocks which led to large hole that needed to be filled to reach the right elevation when they were removed or to a higher elevation if they were left in place. Depending on the location and the importance to reach the right elevation, decisions were made in the field to allow the contractor to remove these or leave them in place.

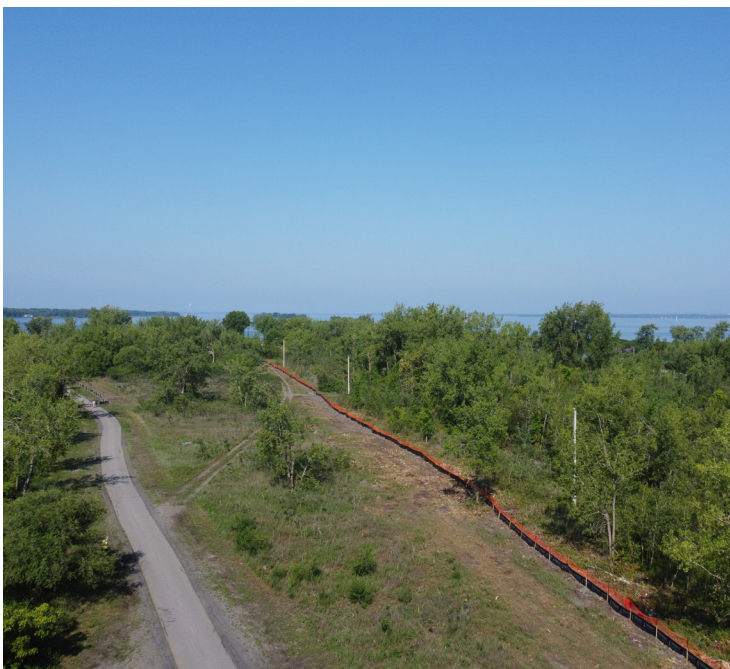
Turtle nesting ground before development

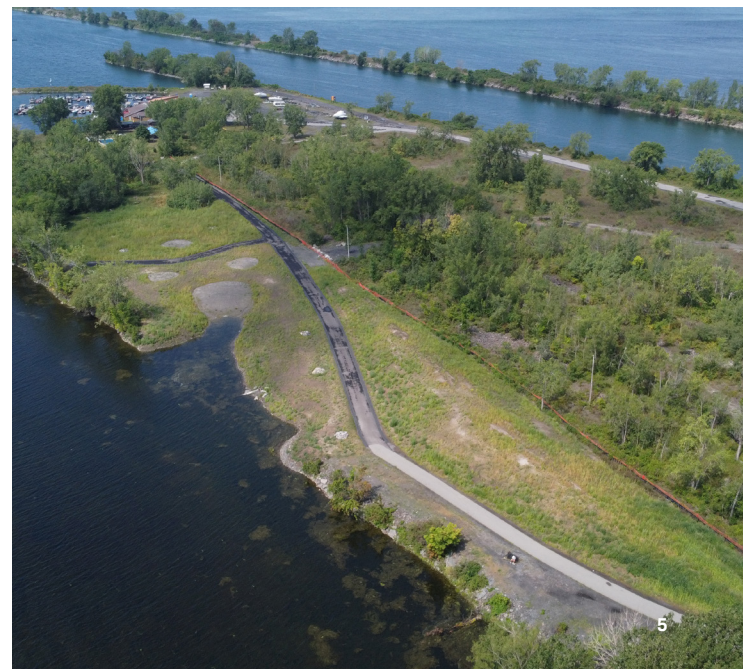
Turtle nesting ground after development

Two natural zones were created on Tekakwitha Island. The first being a turtle nesting ground habitat, of 1.3 ha consisting of a marsh, turtle beach, and scrubland where an adapted seed mixture was sown and about 2,000 shrubs and trees were planted. Rocks of various size provided shelters for the Northern Brownsnake. The second natural zone of 2.4 ha was a wetland complex including a marsh, wet meadow and shrub swamp surrounded by a diverse terrestrial habitat, in which 10,500 plants, consisting of some 55 species, were planted. A deep-water linear pond was excavated in the wetland to ensure permanent water.

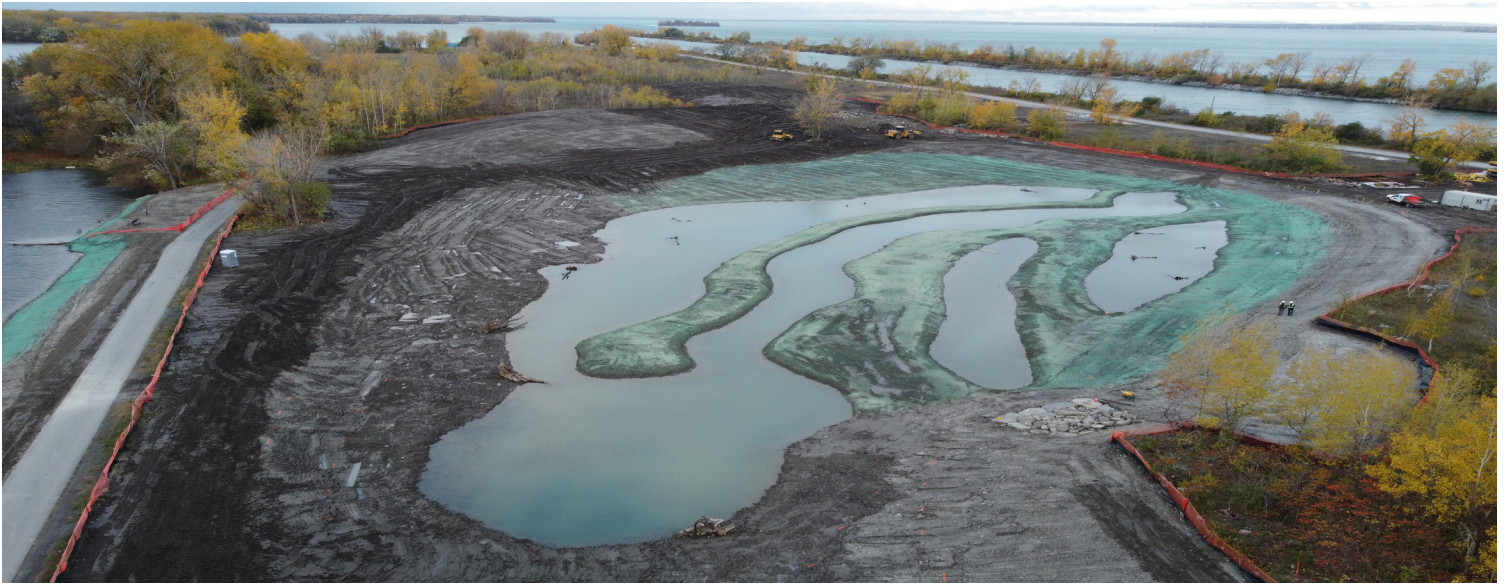
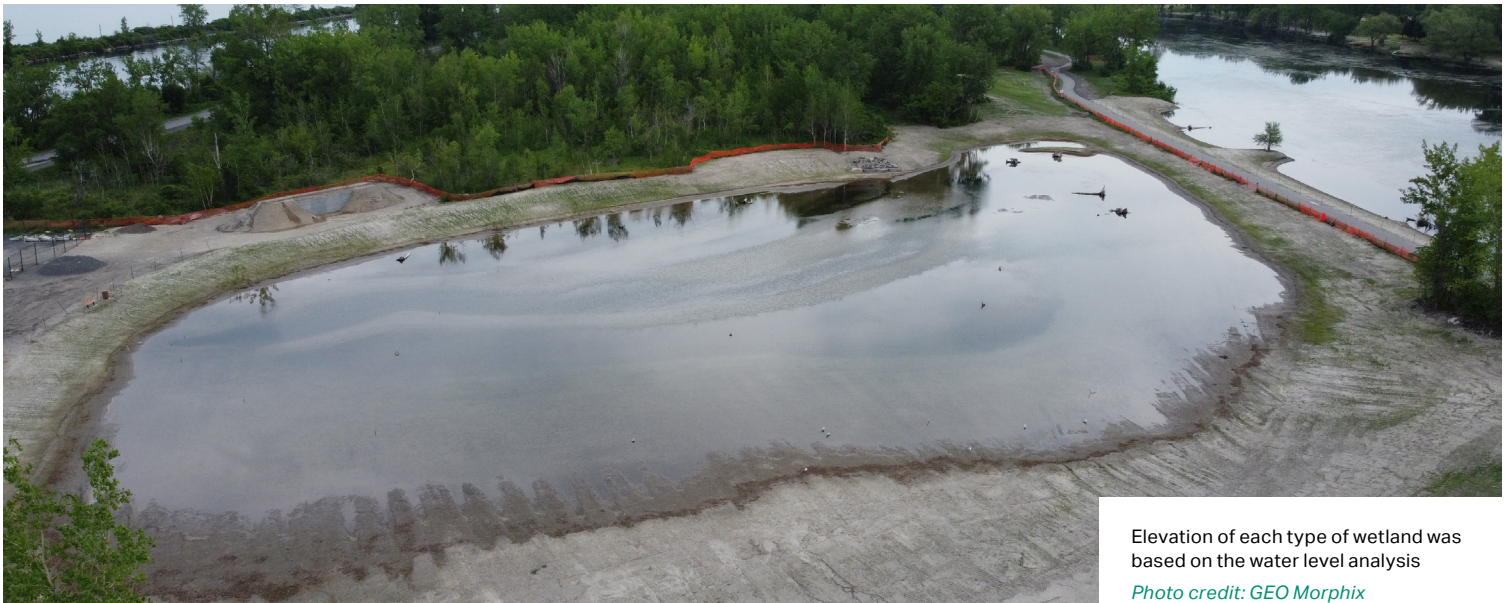
Wetland complex during development

To ensure the perennity of these natural zones, the daily fluctuations of the water level were analysed over a period of 58 years to establish the elevation of each type of wetland. Diverse plant species increase the biodiversity of the area and provide opportunities for food, shelter, and reproduction. The main ecological functions are expected to be fully realized after a few years.

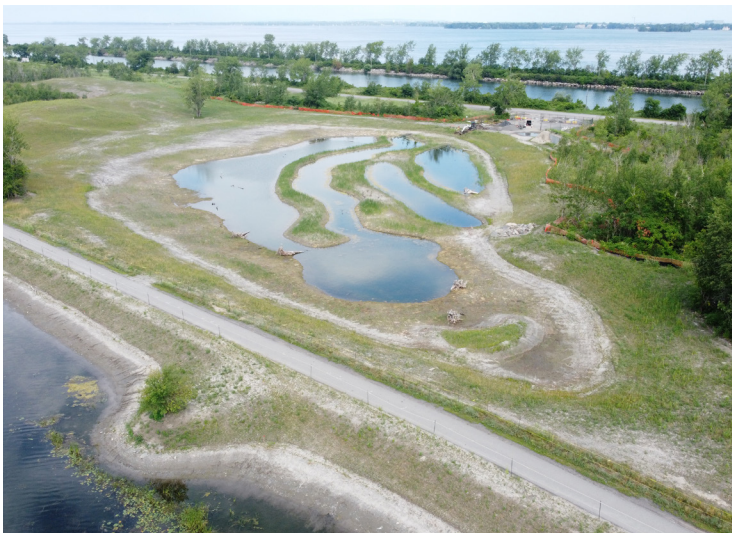
Wetland complex after development

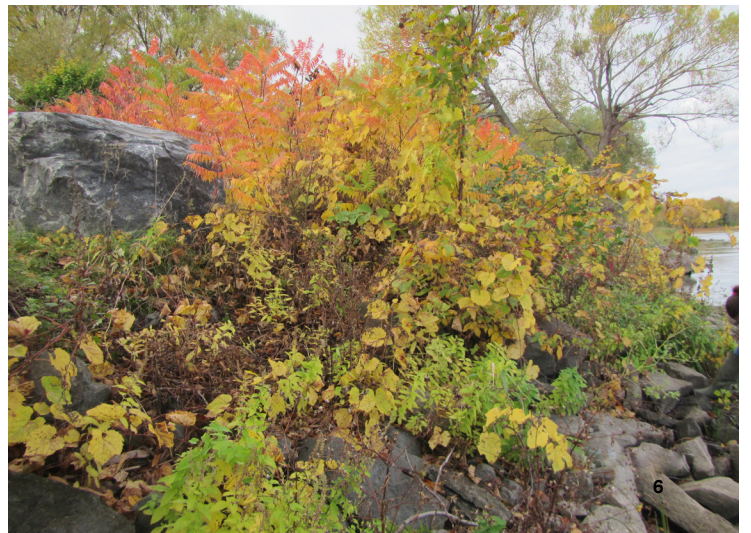
Degraded shorebank

The artificialized shores of Recreation Bay have colonized naturally with species typical of disturbed open habitats. The shorelines were characterized, and optimized interventions were based on shoreline quality to restore only portions in poor condition by controlling, removing, or replacing unwanted vegetation with a more typical and functional riparian vegetation, while maintaining and protecting shoreline portions in good condition. In various locations, access between the bay and the island were improved to facilitate movement by wildlife and community members.

AECOM designed several restoration elements to improve degraded shorelines by replacing unwanted vegetation with more typical riparian vegetation resulting in an increase of biodiversity and wildlife habitats. Other elements were intended to build safe access to the bay for fishing activities, rest areas to embrace the quiet nature of the bay, and a public beach for family gathering and children to play. The creation of two large natural habitats enhanced the ecological value of the island by replacing the original flat land colonized with species typical of disturbed open habitats by planting stands of the bioclimatic domain, including sugar maple-hickory stands, typical of the Montreal

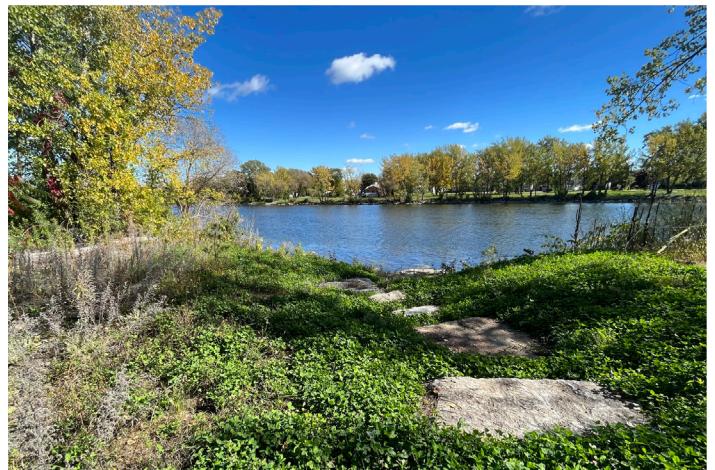
Safe access to the bay were built
