GEOTECHNICAL INVESTIGATION OF THE MOUNT POLLEY DAM FAILURE

CARIBOO REGION, BC

2016 AWARD SUBMISSION
KLOHN CRIPPEN BERGER

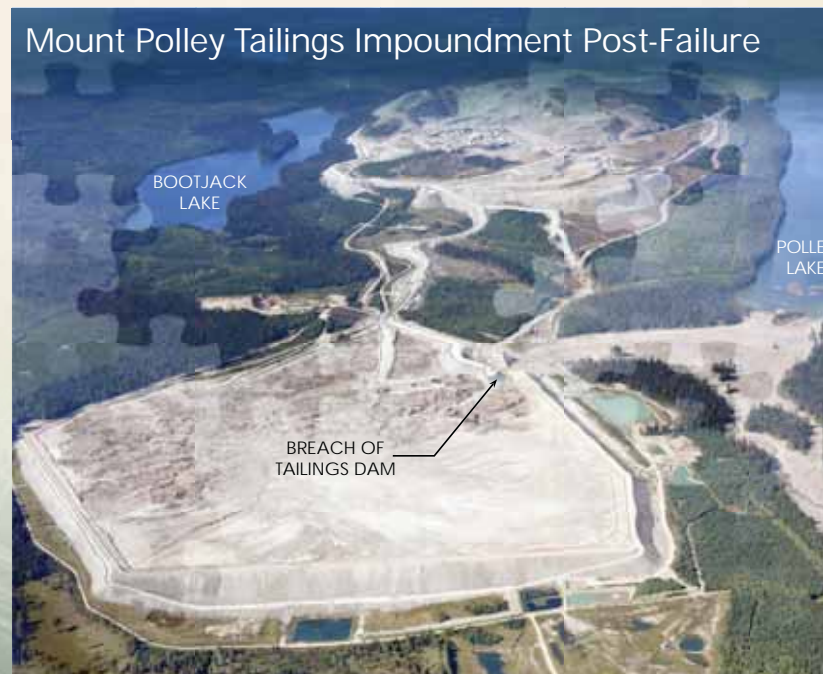
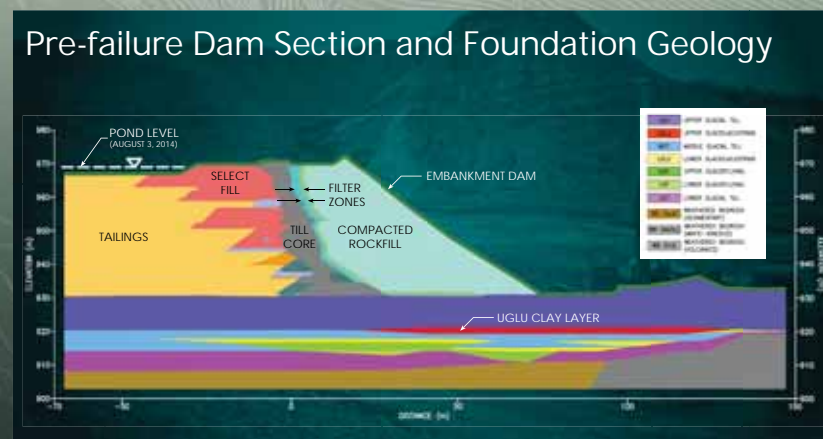
Upper Glaciolacustrine Unit (UGLU)

The site geology is complex with multiple glacial till and glaciolacustrine layers deposited during several advances and retreats of glacial ice sheets over 10,000 years ago. The dam ultimately failed on a weak high plastic clay layer in the foundation referred to as the Upper Glaciolacustrine Unit (UGLU). This clay layer is only 2 m thick and located 10 m below the dam.

The properties and strength of the UGLU were studied extensively in KCB's field and laboratory studies.

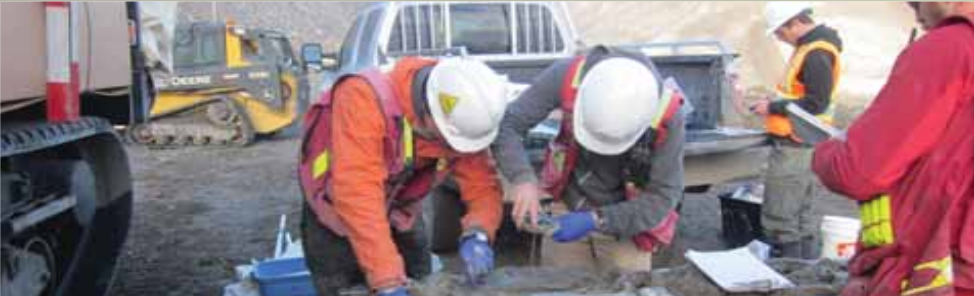
UPPER GLACIOLACUSTRINE UNIT (UGLU)

The site geology is complex with multiple glacial till and glaciolacustrine layers deposited during several advances and retreats of glacial ice sheets over 10,000 years ago. The dam ultimately failed on a weak high plastic clay layer in the foundation referred to as the Upper Glaciolacustrine Unit (UGLU). This clay layer is only 2 m thick and located 10 m below the dam.

The properties and strength of the UGLU were studied extensively in KCB's field and laboratory studies.
