# MORRISON DAM REHABILITATION

CANADIAN CONSULTING ENGINEERING AWARDS 2018

## MORRISON DAM REHABILITATION CORONACH, SASKATCHEWAN

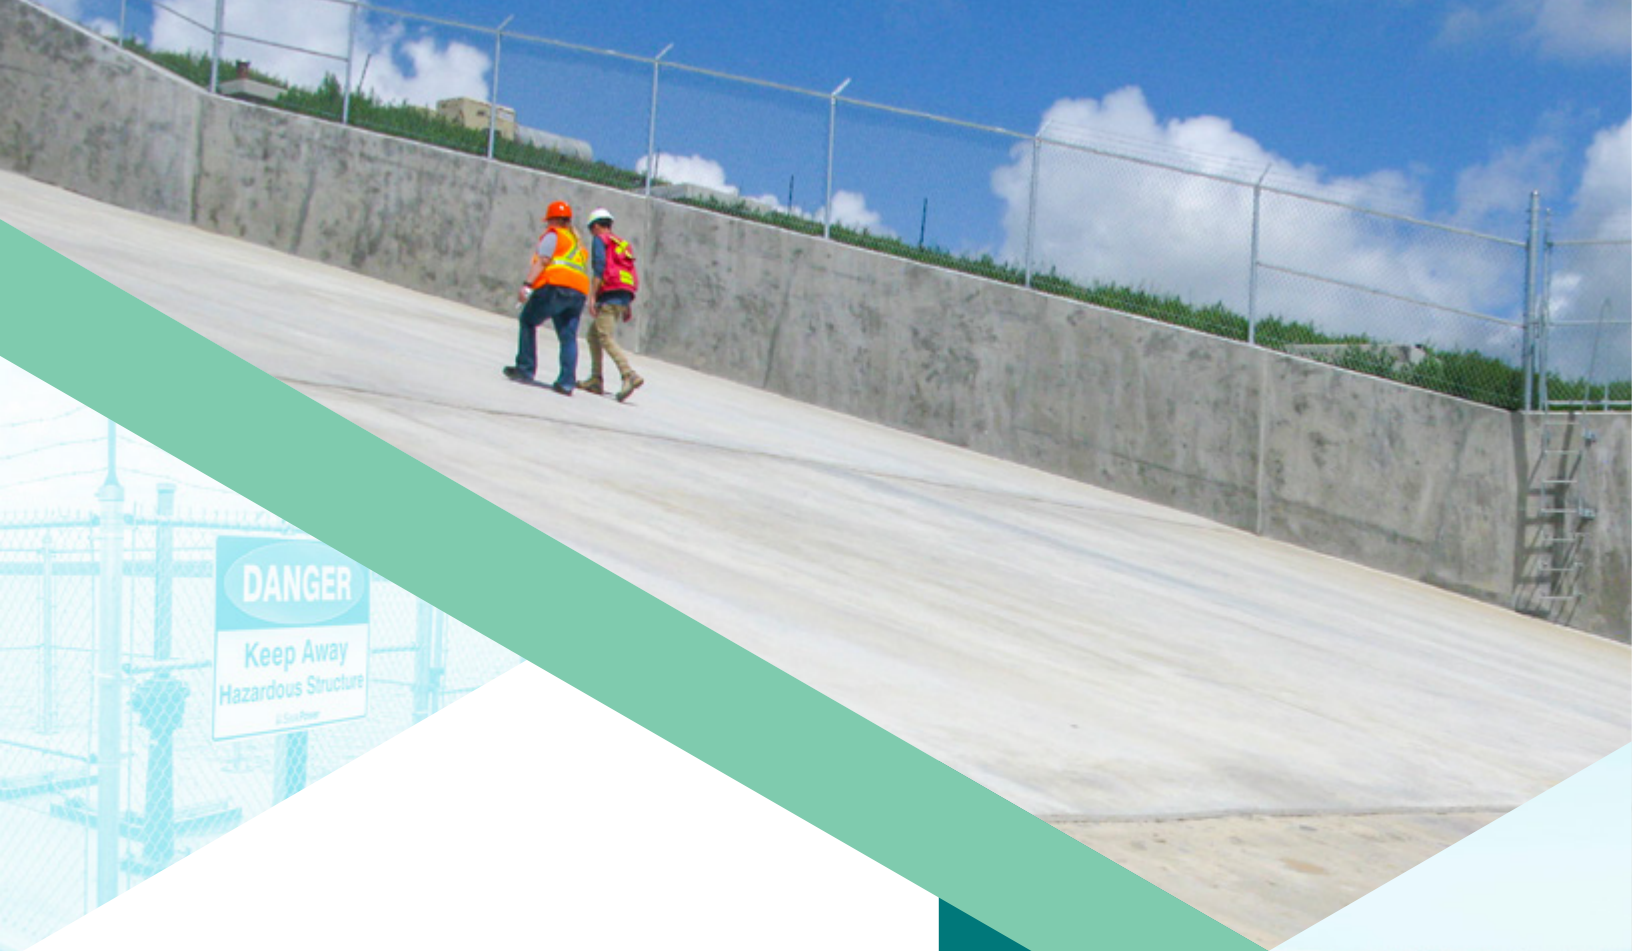
Quality control testing was carried out by the contractor using a field laboratory on site for viscosity and strength testing. Permeability testing was carried out off site to confirm design requirements. A trial jet grouting was also carried out prior to production grouting to establish the rate of drilling, aperture size for jetting and spacing between columns to achieve sufficient overlapping and a minimum wall width. Both the SCB trench and two rows of jet grouting were designed for a minimum wall width of 900 mm.

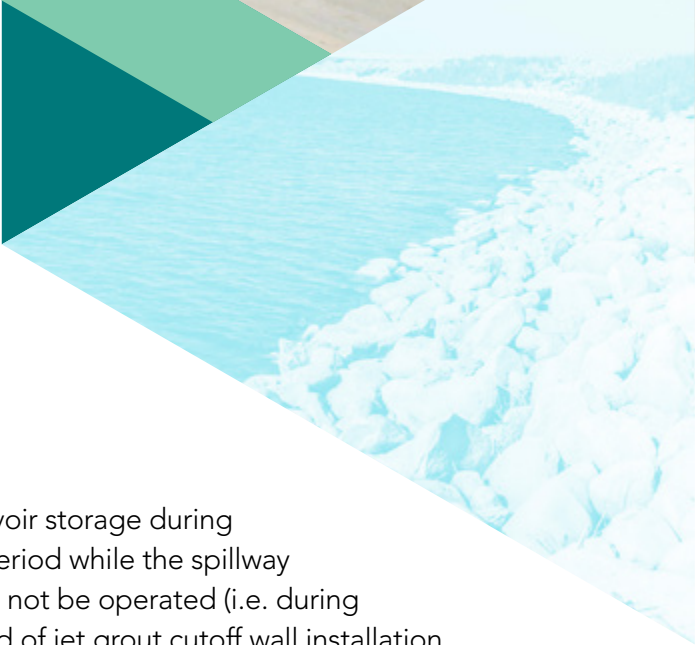
A full drawdown of the reservoir in advance of construction was not possible, however a partial drawdown of 600mm was carried out to provide

reservoir storage during the period while the spillway could not be operated (i.e. during period of jet grout cutoff wall installation through the spillway slab). The sheet pile wall cofferdam construction was therefore carried out in the “wet” with the reservoir approximately within 600mm of its FSL. This required the installation of turbidity control measures and fish salvage operations to meet environmental requirements.
