Millbrook Dam Rehabilitation & Upgrade

2020 Canadian Consulting Engineering Awards

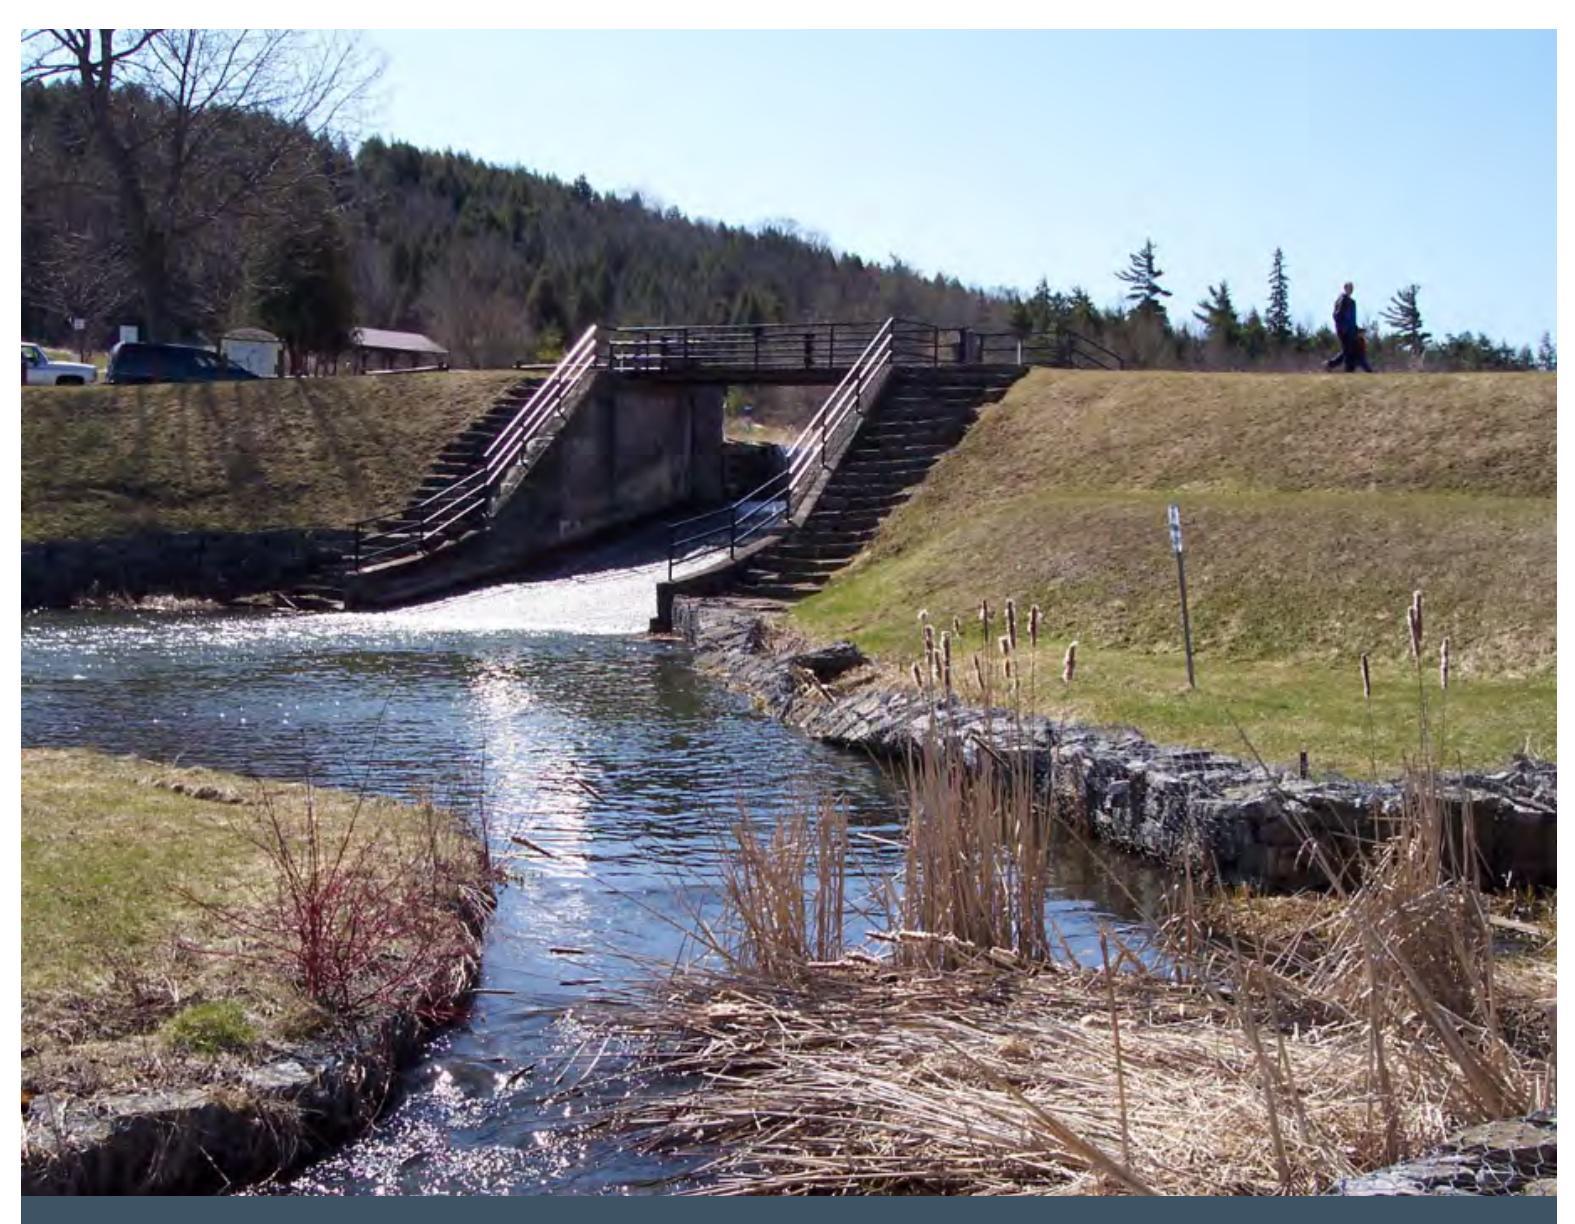
Millbrook Dam circa 2003, pre-rehabilitation and upgrade

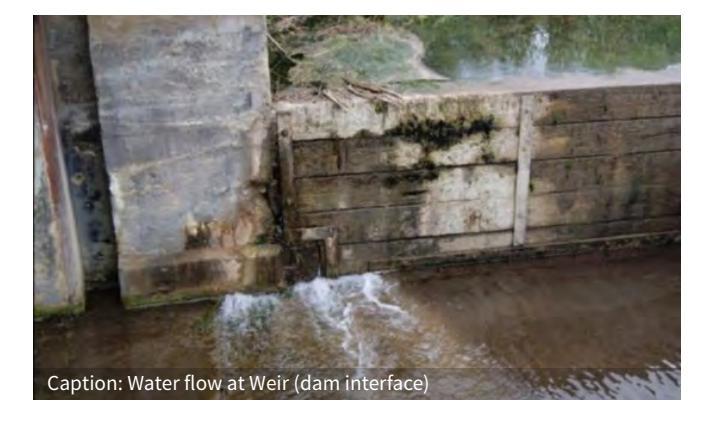
The hydraulic design of the new concrete spillway was verified using Computational Fluid Dynamics (CFD) software FLOW-3DTM. A three-dimensional CFD model of the weir, spillway chute, and stilling basin was developed to:

- Evaluate discharge capacity of the proposed U-shape concrete weir at key reservoir water levels.
- Verify spillway chute water velocity and depth under IDF conditions.
- Verify the adequacy of the stilling basin design—energy dissipation—under the range of design conditions and sensitivity to tailwater level.

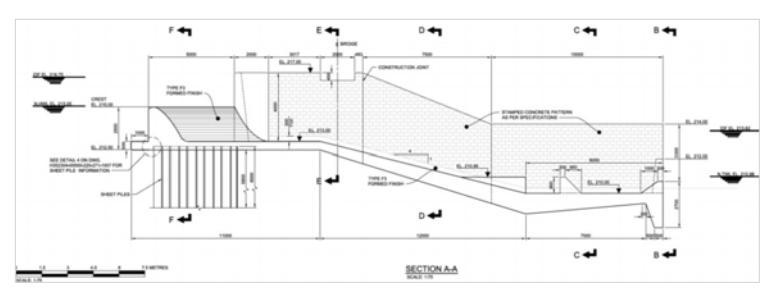
Concrete spillway profile

- Maximize the flow through the concrete spillway structure at a reservoir water level of 216.5metres (crest level of embankment dam) minimum of 1:5000-yr flood. This was accomplished through the use of a u-shaped weir that doubled the capacity of the concrete overflow weir spillway.
- Pass the major portion of the IDF flow through the enlarged concrete spillway structure and over a hardened embankment at the peak reservoir water level, 216.75 metres.

The 'As Low as Reasonably Practicable' (ALARP) principle (CDA 2011) was applied to develop a spillway hydraulic capacity solution that OMNRF would accept for LRIA approvals. The concrete spillway capacity was maximized through the use of a u-shaped weir that doubled the capacity of the concrete spillway, and the remainder of the flow was passed over the hardened embankment dam at the peak reservoir water level.

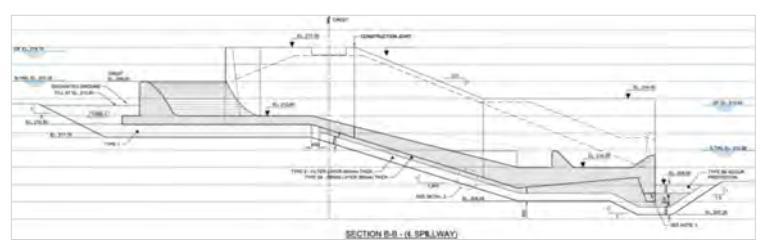
Engineered multi-layer foundation

Because of native silty-clay material that was to form the foundation for the new concrete spillway, a multilayer engineered foundation was required to relieve pore pressure under the concrete spillway and maintain an intact foundation under all water level conditions.

To form the foundation for the new concrete spillway, a multi-layer engineered foundation was designed to allow for over-excavation of the native soils and replacement with engineered soil to support the concrete spillway.

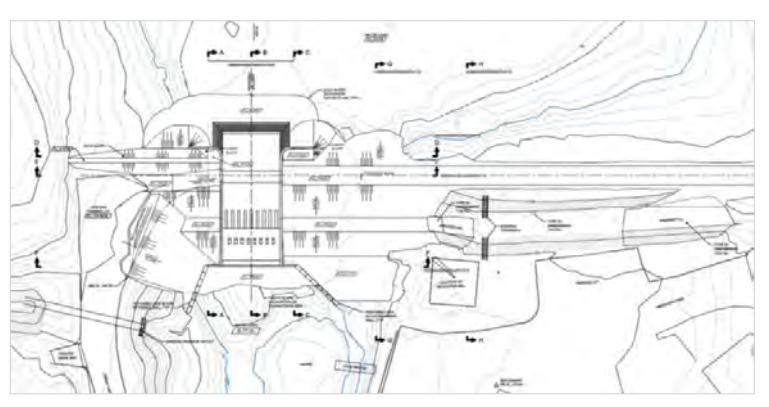
Millbrook Dam general arrangement

A sheet pile wall design was incorporated under the concrete U-shape weir and side walls to provide improved seepage cut-off and vertical stability under the weir and sidewalls, and horizontal stability for the entire concrete spillway chute under design loads by engaging a large weight/depth of the weak native foundation materials to prevent siding.
