#### **KLOHN CRIPPEN BERGER**

2023 AWARD SUBMISSION

## SPRAY LAKES ROAD COAL-MINE VOID REPAIR

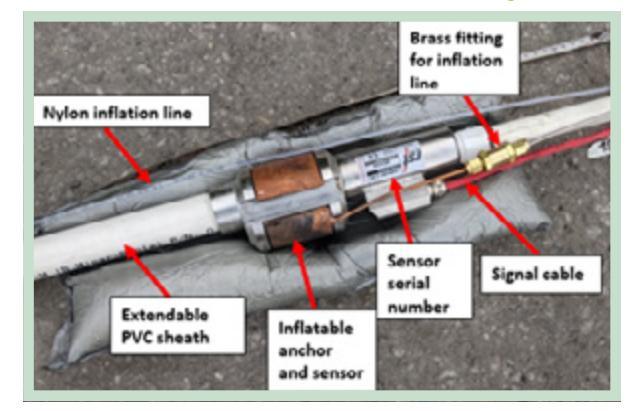
Extensometer head plate installed at highway sub-base before gravel and asphalt placement

KCB's design also included vibrating wire inline extensometers (VWIE) for long-term monitoring

of the mine roof below the highway. The use of VWIEs to monitor for ground deformations was a first-time installation for AT and allows for early detection of any roof collapse below the highway.

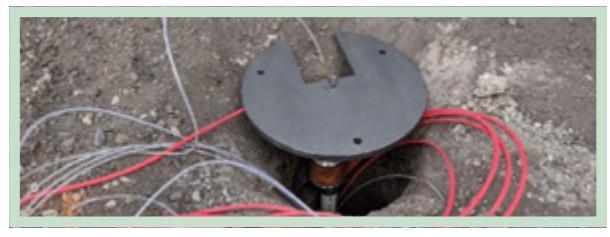
Downhole camera survey of coal-mine void in an investigation borehole

The coal-mine void was investigated with geophysical investigations and drilling. Downhole video cameras were used in boreholes to view the mine void and a downhole LiDAR camera was used in the boreholes to survey the extent of the open coal mine void below the highway. This was the first time AT used a LiDAR camera to survey a coal mine void.

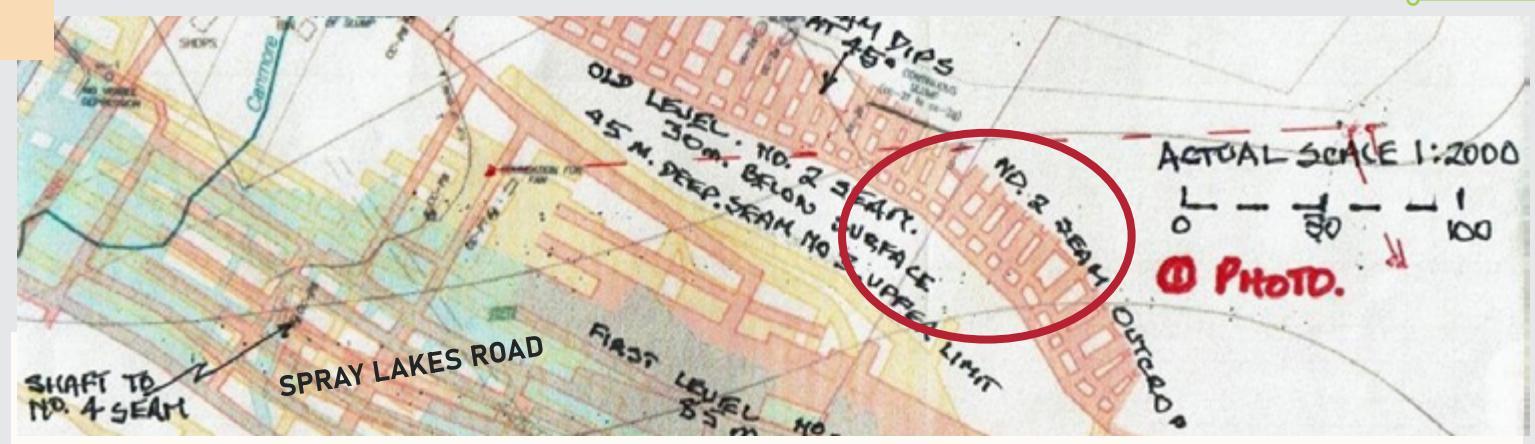
Historic mine plan from the Canmore Geoscience Centre. Red circle indicates project location.

KCB combined the borehole and geophysical data with historic coal mine record drawings from the Canmore Geoscience Centre and created a three-dimensional model of the coal-mine void using Civil 3D software. The model included aerial LiDAR topographic data provided by the Town of Canmore (ToC) and borehole log and geophysical data. KCB also hired the last Chief Mine Engineer at Canmore Collieries to assist with understanding the spatial variability of the coal mine.

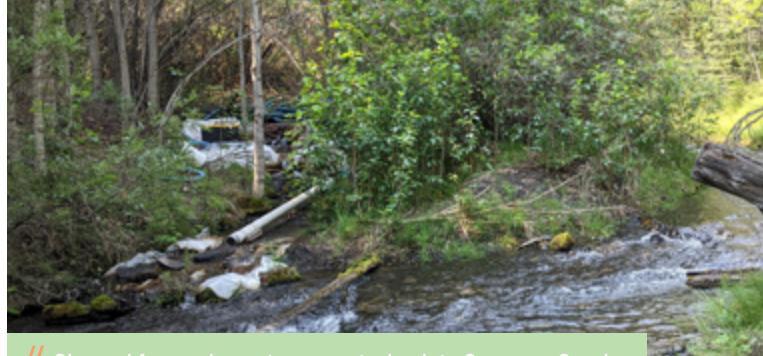
II Channel from mine entrance entering into Canmore Cree

Groundwater outflows from the mine into Canmore Creek were monitored throughout construction, with no measured impact on water quality. A portable water treatment plant was set up at the mine entrance as a contingency measure. Drilling safety procedures were developed by DCL and their subcontractor to mitigate air quality and explosion risks from coal mine gases. Downhole camera surveys were conducted to view the coal-mine void and to assess the extent of concrete placement.

Continuous monitoring of water quality was a contract requirement. Monitoring locations included the outflow from the mine entrance and Canmore Creek, with water quality monitoring conducted before and during construction. Due to the potential for pH to increase after concrete placement, the contractor was contractually required to respond to changes in water quality at the time of occurrence to meet regulatory requirements. DCL's team selected a portable water treatment plant as their mitigation scheme in the unlikely event that mine discharge water became impacted by concrete placement in the coal mine void. Due to the measures included in the design (i.e., not placing concrete below water table, use of custom mix design for concrete) changes to water quality were not detected during construction, with no adverse impacts to Canmore Creek.
