CCE Award Submission

Edison Mine

Bat Friendly Progressive Rehabilitation

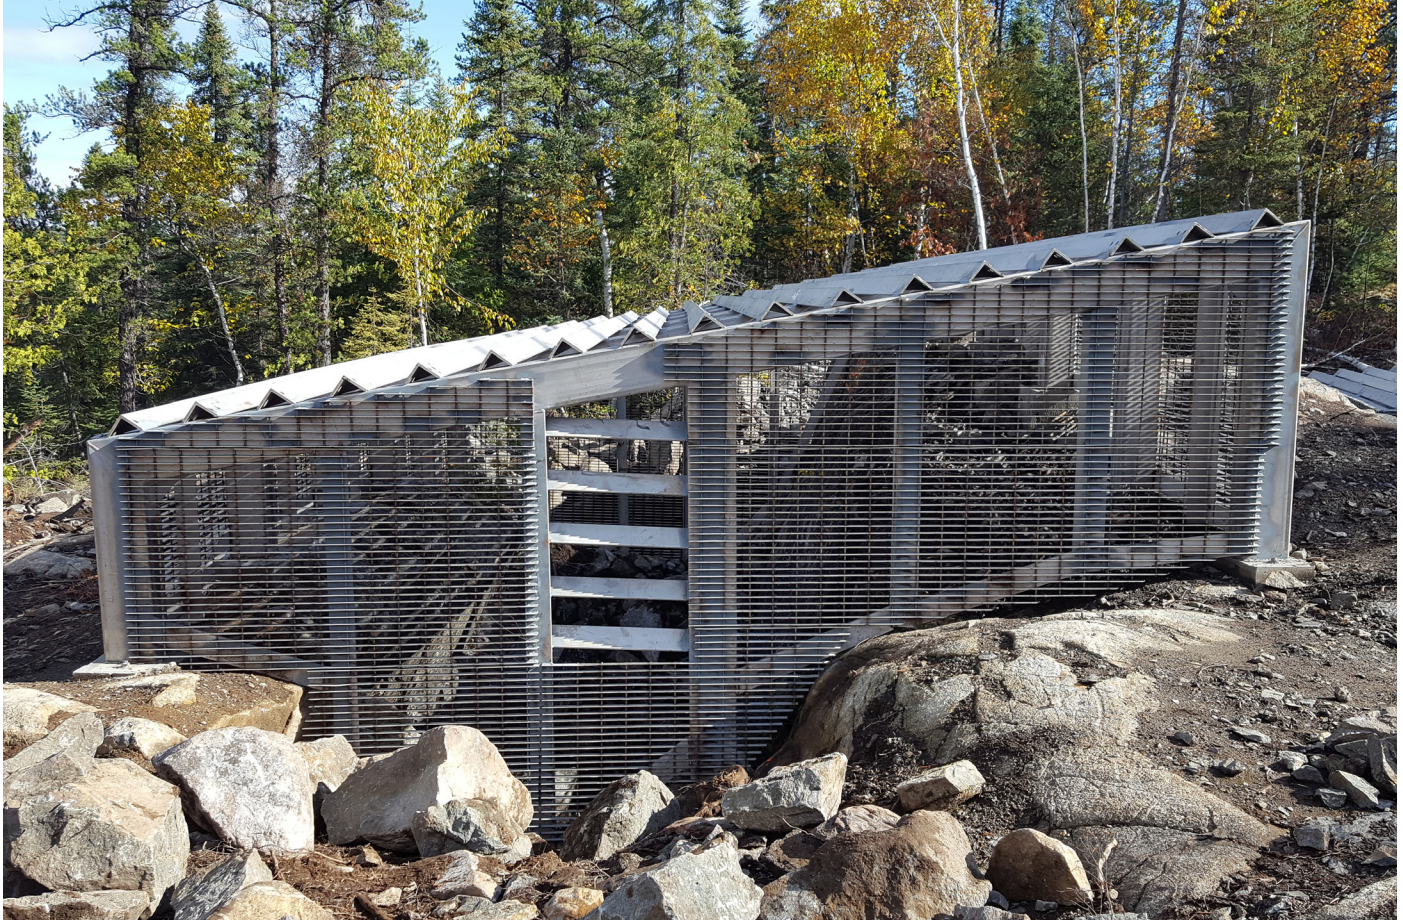
Completed Edison Open Cut Cupola – 146 mm spacing between all steel members

- Constructed of stainless steel for longevity
- Adequately anchored to competent bedrock
- Design load that accounts for dead weight of structure, snow loading, tree impacts and vehicle (ATV/snowmobile) traffic
- Prevent inadvertent access to the mine
- Steel spacing of 146 mm as to not impede the flight path of bats

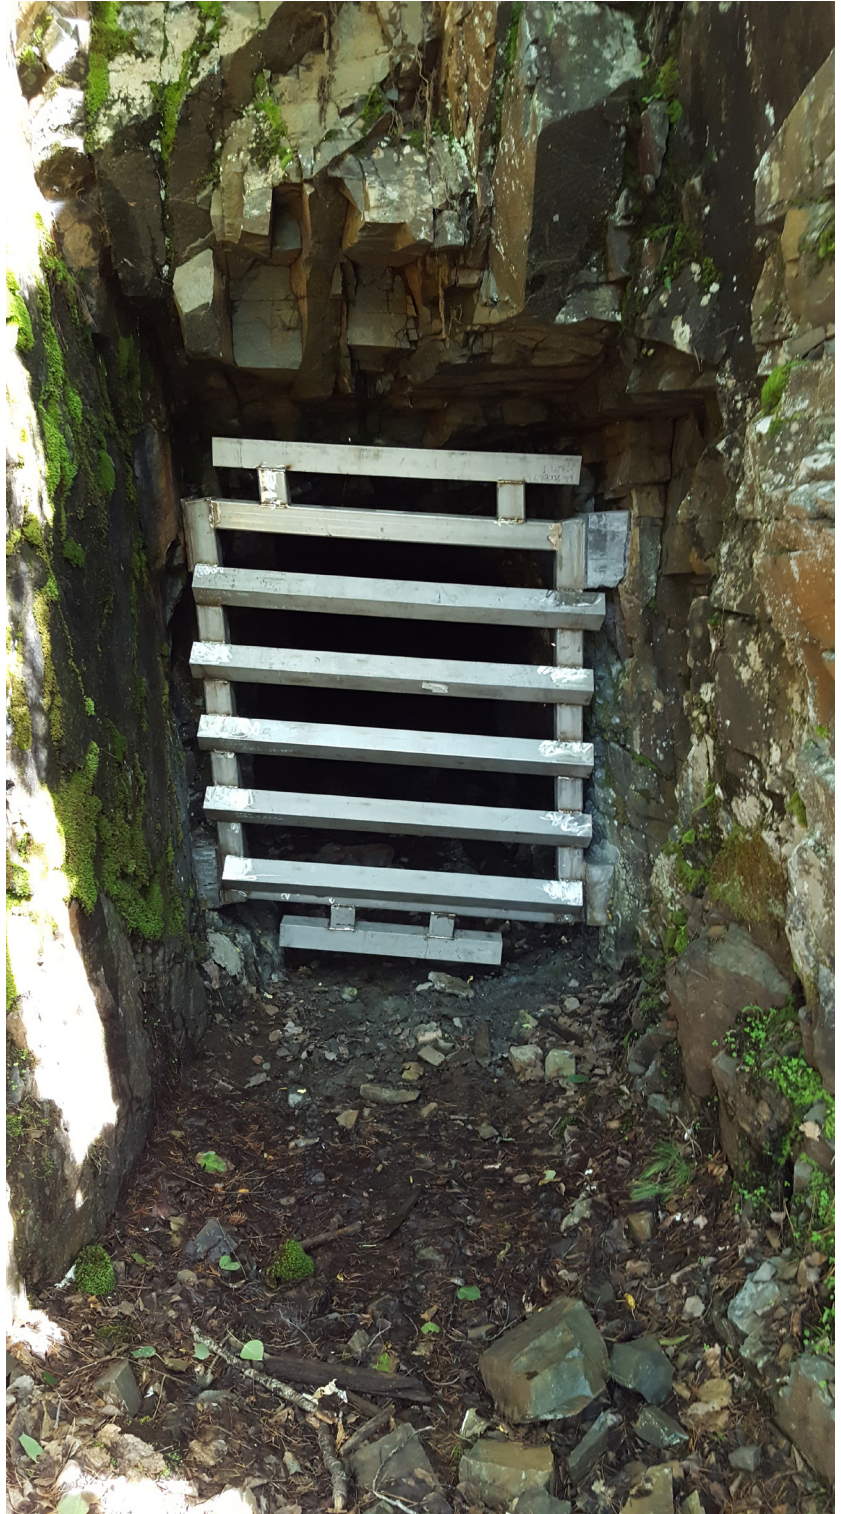
Adit Bat Gate securely anchored into bedrock walls

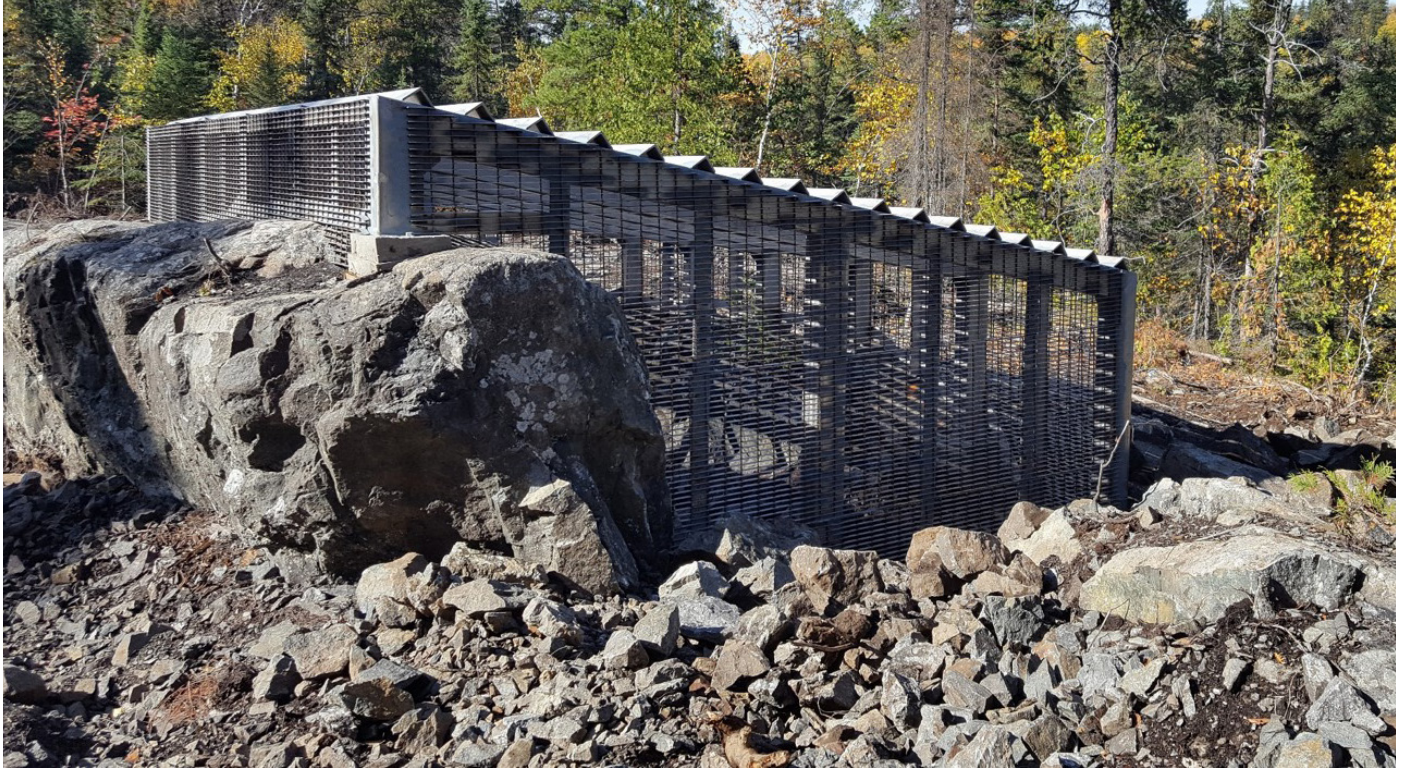
Undulating topography created design challenges that were overcome with detailed 3D LiDAR scans

Bat friendly progressive rehabilitation of physical mine hazards in Ontario is a young industry practice. The Mining Act provides rehabilitation requirements pertaining to conventional rehabilitation options (i.e. fencing, backfilling and engineered caps) but does not provide specific design requirements for bat cupolas or bat gates. Golder needed to create a site specific bat cupola and bat gate design that would satisfy the MNDM and MNRF. The remoteness of the site and undulating topography made data collection and design work difficult. To aid in the design, Golder completed LiDAR scans and generated a detailed 3D model of the mine openings.

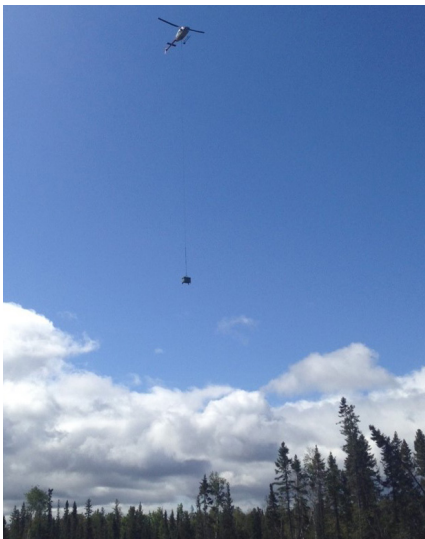
45 helicopter lifts were completed to move 25,000 lbs of material and equipment

The mine site is located in a remote forested area of northern Ontario only accessible by boat followed by a 5 km hike along a historic mining trail cut through the rough terrain of northern Ontario. Given logistical challenges of the remote location, cost-effective and efficient solutions needed to be implemented to safely transport all personnel, materials and equipment to site. A barge was used to transport larger equipment (excavator, ATV's/UTVs) 12 km up the Montreal River. Once all equipment was unloaded along the shore of the river, it was driven across the rough 5 km trail to site. A helicopter was used to complete 45 lifts and transport 25,000 lbs of material and equipment required for the fabrication and installation of the two bat cupolas and bat gate. A lifting sequence had to be generated to ensure helicopter capacities were met while optimizing the delivery of all material and equipment.

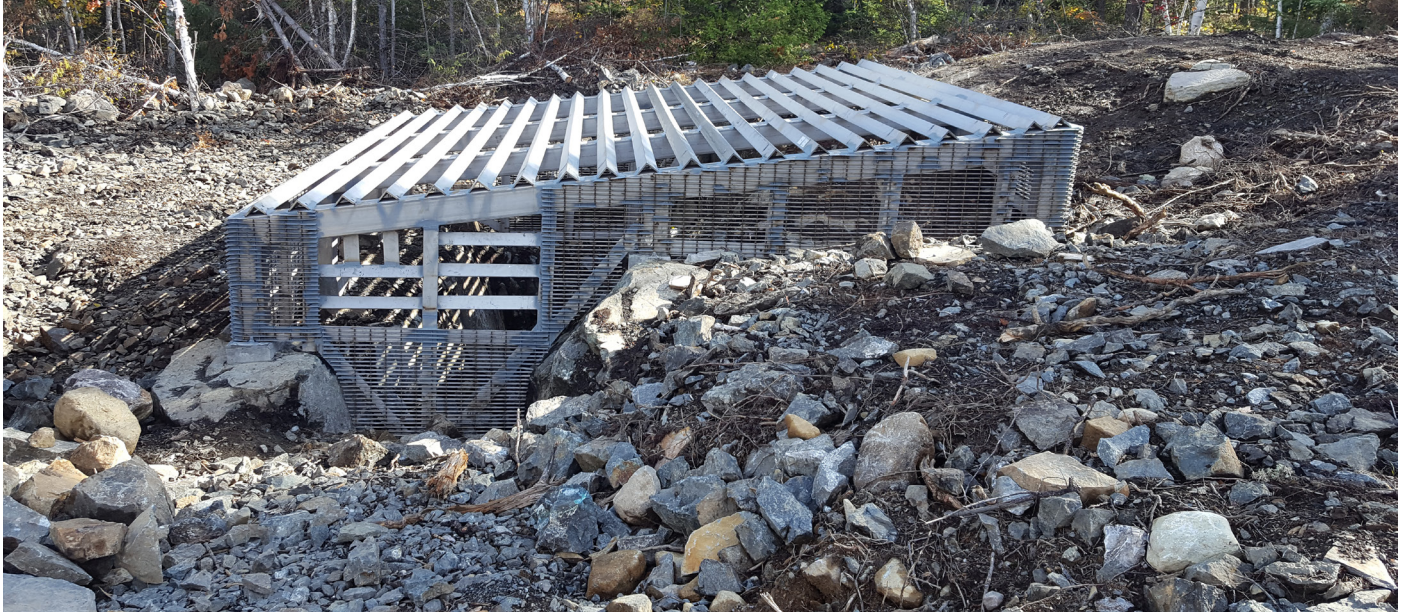
Completed Edison Shaft Cupola – Complete Stainless Steel Construction
