Route 117 Rehabilitation Kouchibouguac National Park

Canadian Consulting Engineers Award
2017

75-Word Project Summary

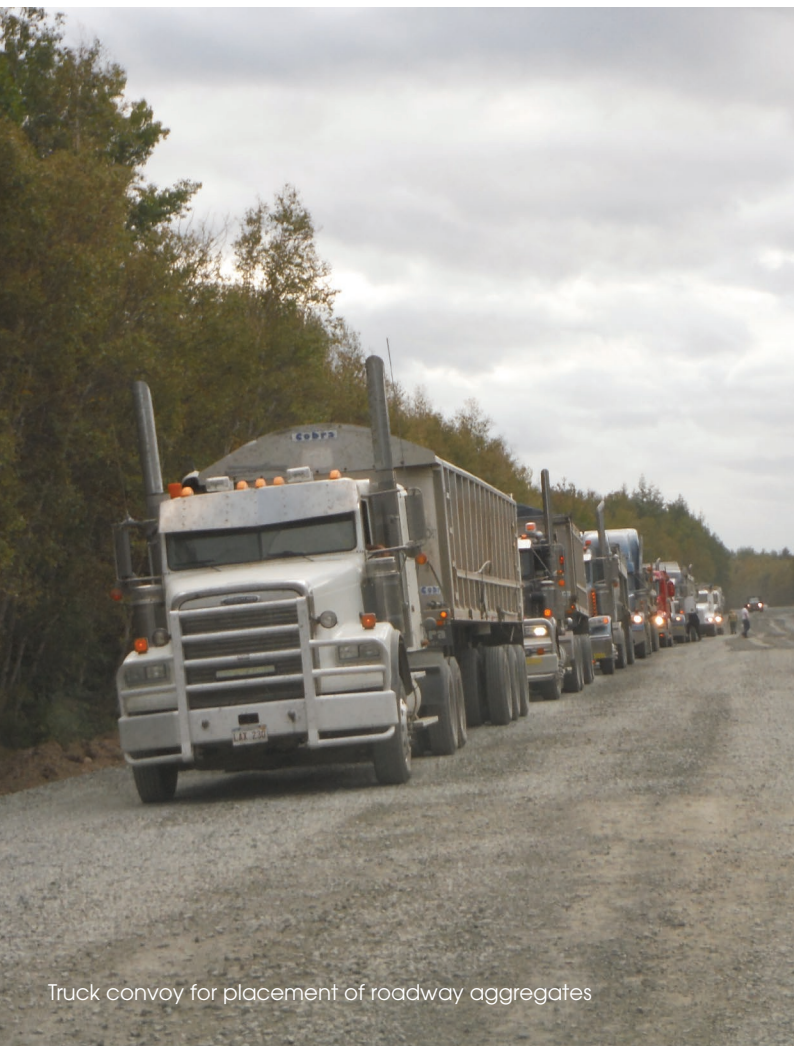
Truck convoy for placement of roadway aggregates

- **Volume of Work:** This project involved 2,000 linear metres of new culverts, placement of 340,000 tonnes of granular roadway materials (enough to fill 65 Olympic sized pools) and 50,000 tonnes of asphalt. Moving this volume of product to, from, and around the construction site was a challenge given the active site use and remote location.

- **Cost Constraints:** Given the size and remote project location, the transportation of suitable aggregates for asphalt mixes, granular base/subbase and bedding/backfilling had the potential to increase costs significantly as the closest aggregate source was 100 km from the site. Significant reuse of aggregate materials reduced the cost substantially.

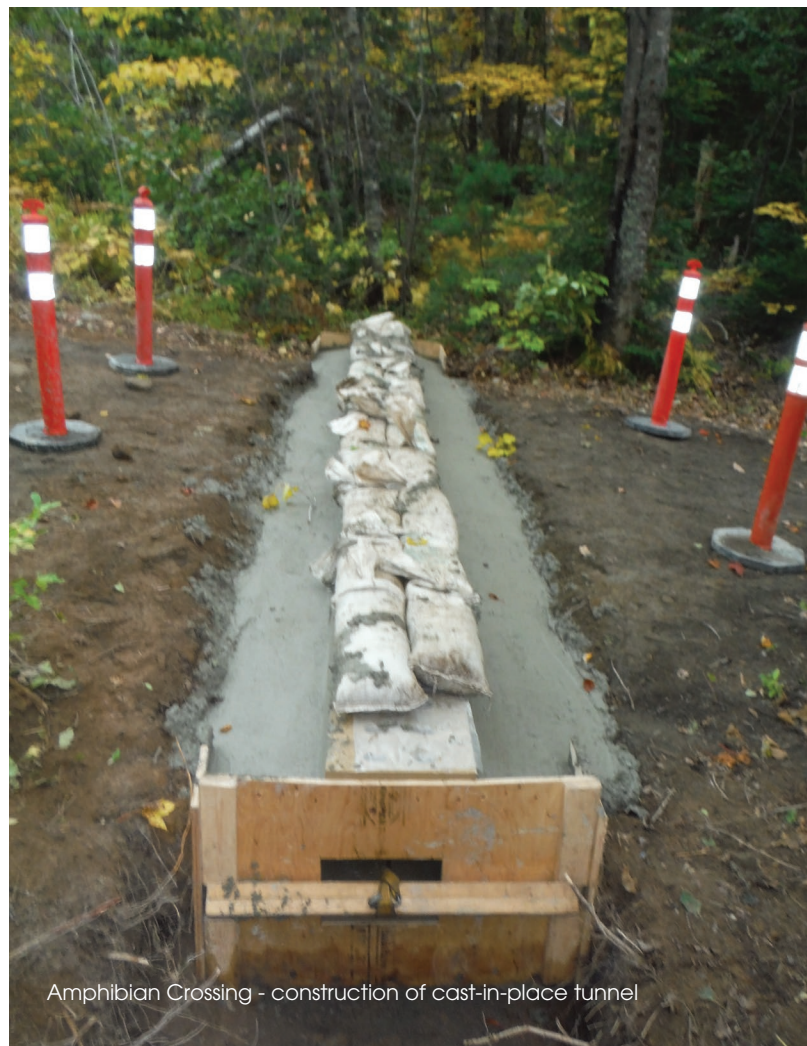
Amphibian Crossing - construction of cast-in-place tunnel

- **Amphibian Crossings.** Park biologists have found that amphibians and wood turtles—a species at risk—routinely crossed the highway at three peak times during the year, all linked to breeding patterns. Four amphibian crossings, or tunnels were designed and strategically installed under the road along the 23.7 km route reducing highway-caused mortality.

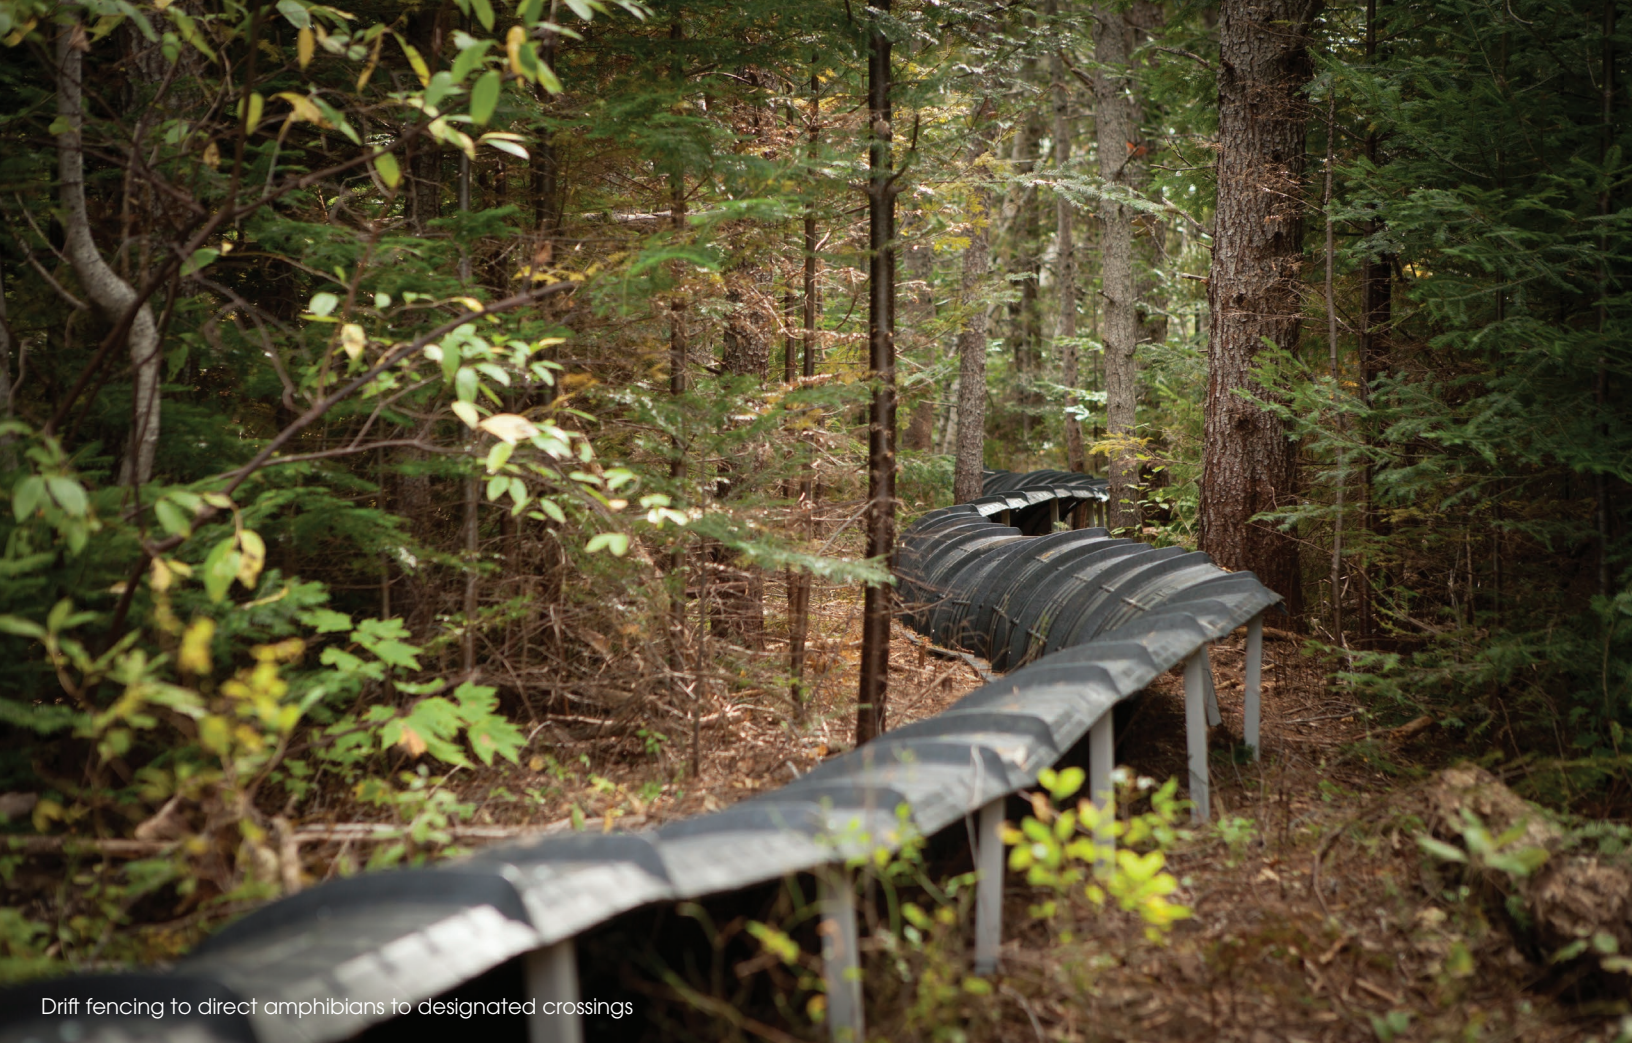
Drift fencing to direct amphibians to designated crossings

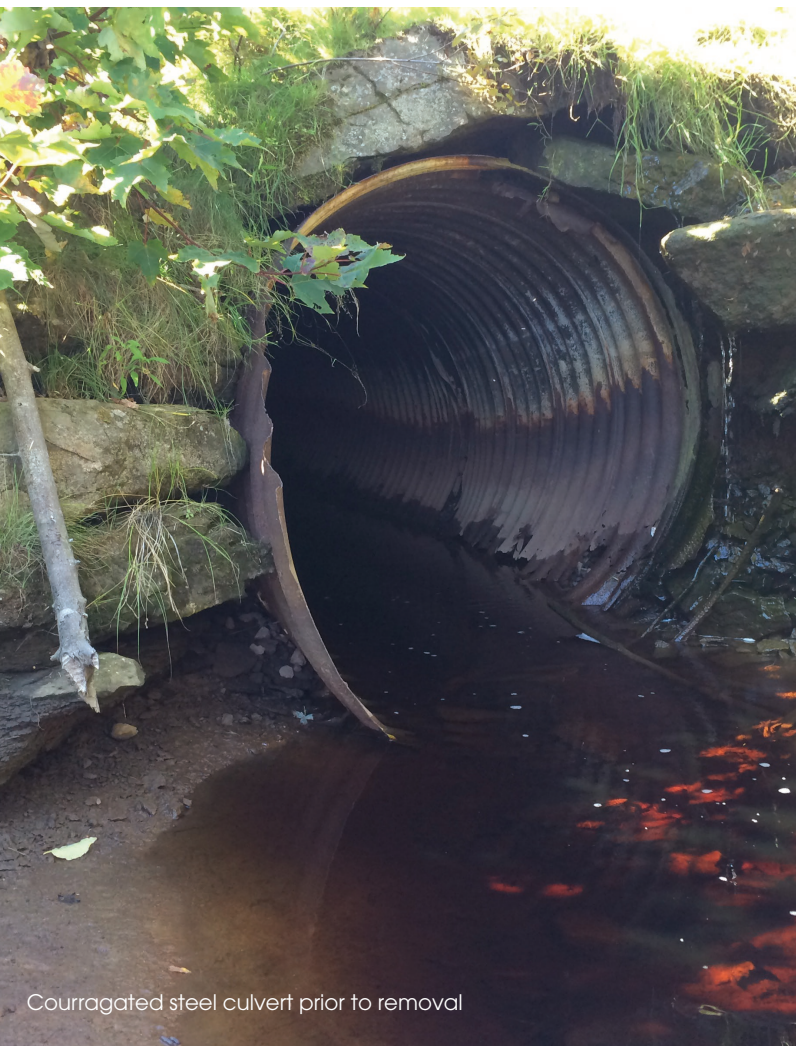
Corrugated steel culvert prior to removal

- **Safe Removal of Hazardous Material.** The existing asbestos-covered corrugated steel culvert pipe and Creosote-treated wood culverts were removed and disposed of at an approved facility. This reduced the risk to aquatic species, habitat, vegetation and wetland environments by eliminating the potential exposure to environmental contaminants.

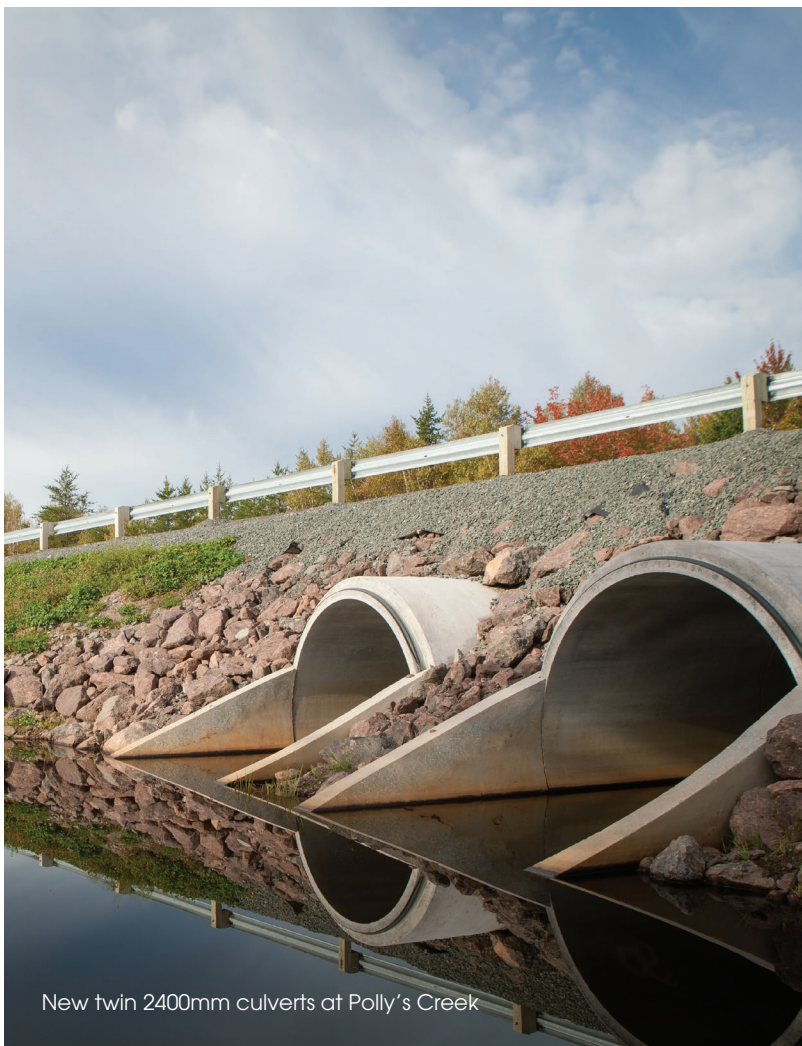
New twin 2400mm culverts at Polly's Creek

- **Fish Passage.** 32 of the 64 replaced culverts featured fish baffles (current deflectors) which provide fish movement, helping fish to complete migration (which happens against the current), and provides them with a refuge during the spring and autumn high tides. As such, the roadway no longer prevents marine and freshwater fish and other aquatic species from reaching spawning grounds, nursery, and food supply.

- **Respecting the sensitive ecosystem of the Park.** We reduced waste by reusing the existing pavement materials in the new design where possible. We also designed for the installation of 64 new culverts underneath Route 117, reconnecting five streams whose flow had become obstructed, allowing aquatic habitat to resume their natural migratory patterns.
